July 2006

PREPARED FOR :: The City of Gig Harbor

Anderson Boatyard

This Historic Structures Report was commissioned by the City of Gig Harbor to guide planning and work in rehabilitating the Eddon Boatyard.

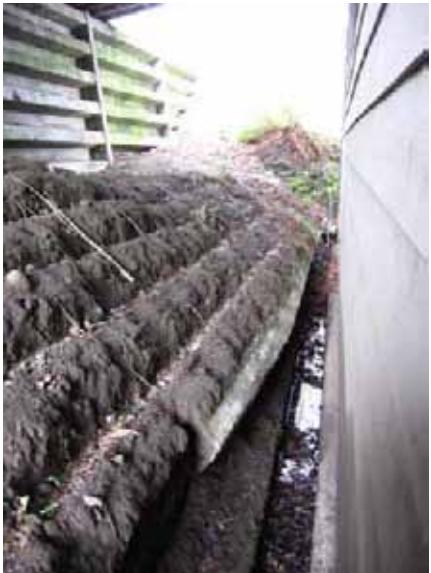
considerable deterioration of the wood and in many sections, it has collapsed or members are missing.

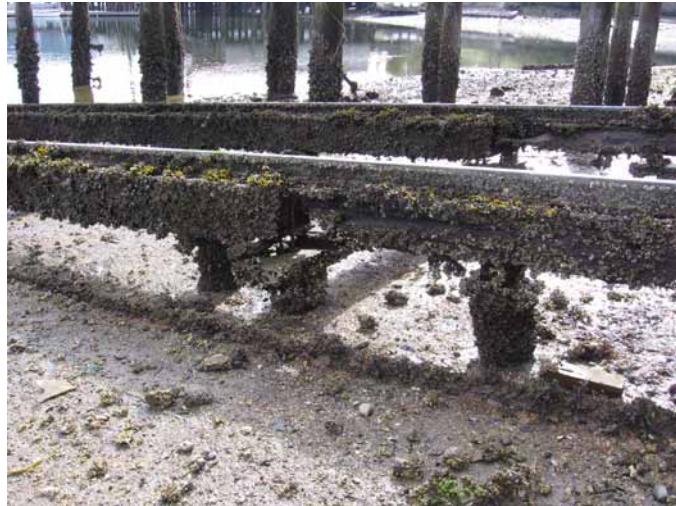
**CP 2**

FOUNDATION PIER CONDITION BENEATH RAILS FOR CARRIAGE. APRIL 2006. SOURCE: EYSAMAN & COMPANY.

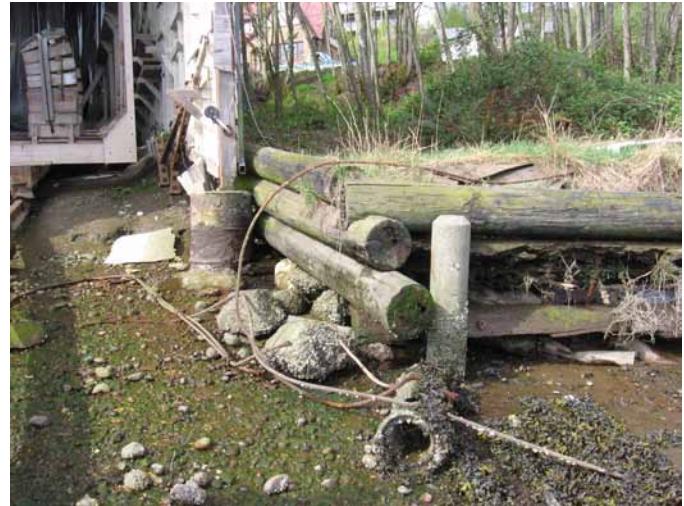
**CP 3**

FOUNDATION CONDITIONS. APRIL 2006. SOURCE: EYSAMAN & COMPANY.

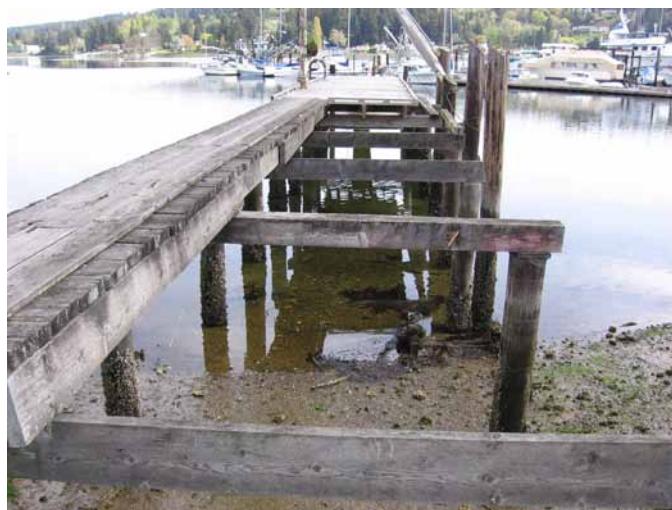
**CP 14**

PIER CONDITIONS EVIDENT AT LOW TIDE. APRIL 2006. SOURCE: EYSAMAN & COMPANY.

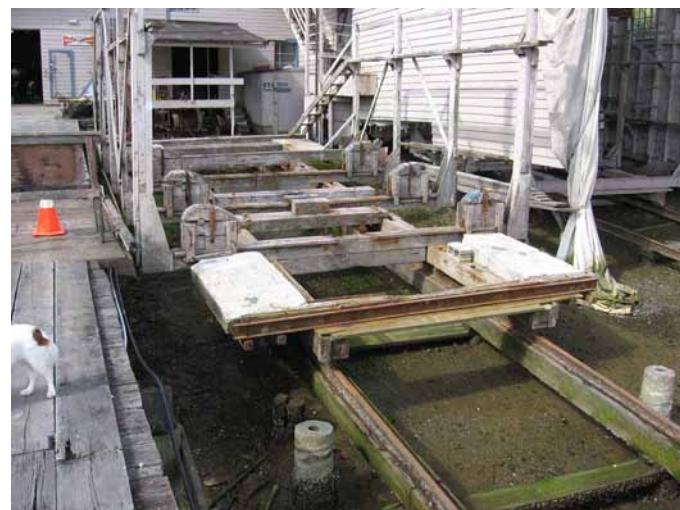
CP 17

EXTERIOR CARRIAGE CONDITIONS. APRIL 2006.
SOURCE: EYSAMAN & COMPANY.

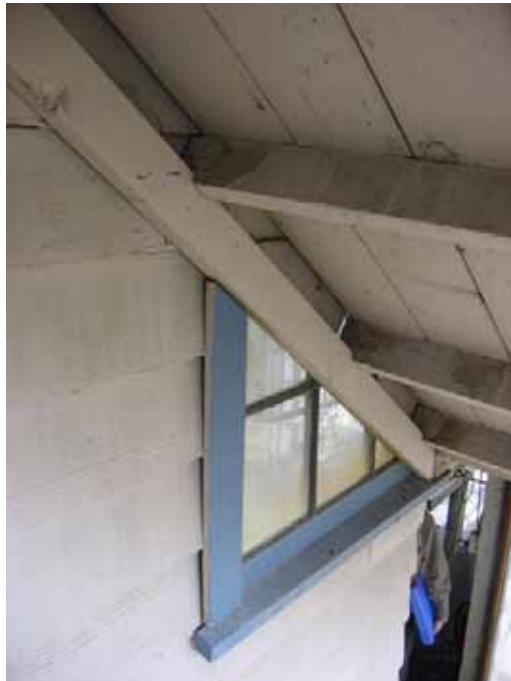
**CP 22**

EXTERIOR STAIRWAY CUTTING ACROSS WINDOW OPENING. APRIL 2006.
SOURCE: EYSAMAN & COMPANY.

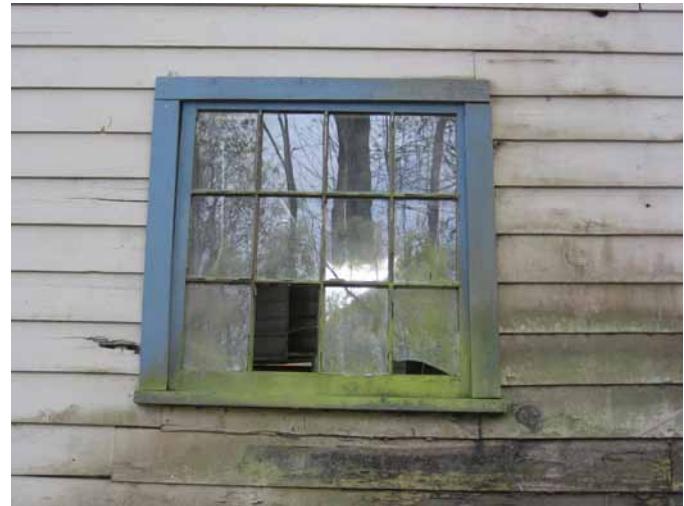
**CP 24**

GLASS LOSS AND MATERIAL DETERIORATION. APRIL 2006. SOURCE: EYSAMAN & COMPANY.

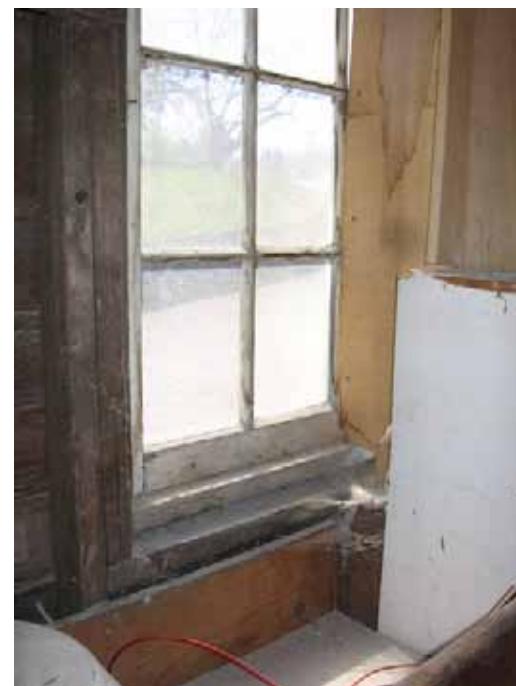
CP 25

INTERIOR WINDOW CONDITIONS. APRIL 2006.
SOURCE: EYSAMAN & COMPANY.

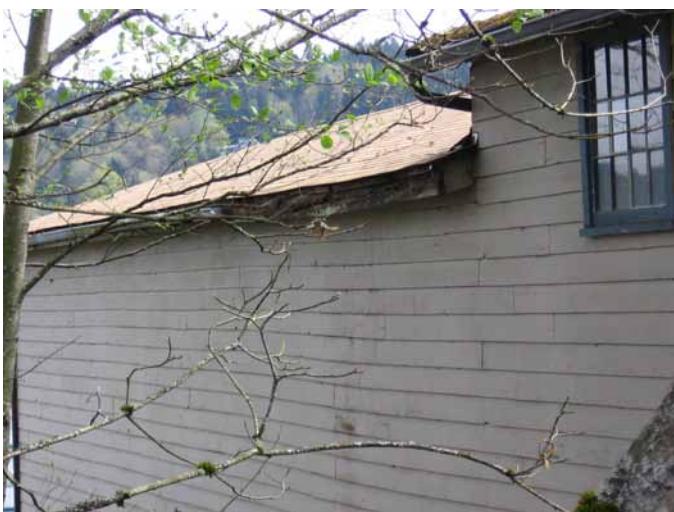
**CP 28**

Continuous contemporary style aluminium gutters run along all eaves. They are in serious disrepair along the north elevations where downspouts are missing. Metal downspouts on the south side cross the lower roof. Water is directed to a concrete base drainage channel. This concrete formed channel, at the base of the west and south elevation, directs water around the structure. It collects water from

FAILED GUTTER. APRIL
2006. SOURCE: EYAMAN & COMPANY.

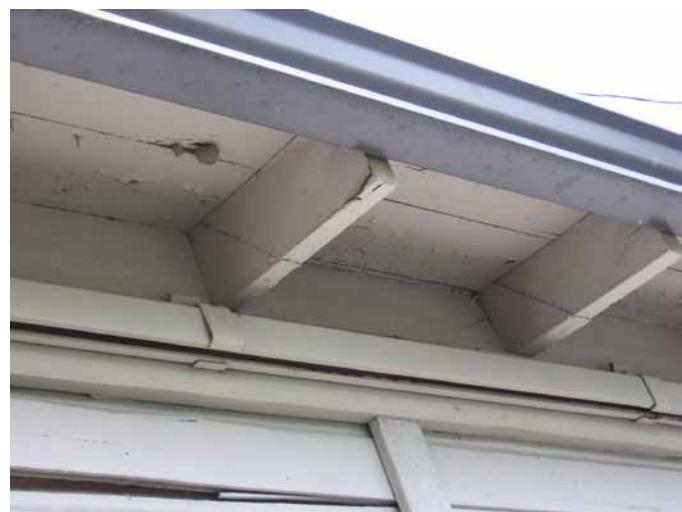
CP 29

EAVE CONDITIONS. LIMITED FAILED PAINT. APRIL
2006. SOURCE: EYAMAN & COMPANY.

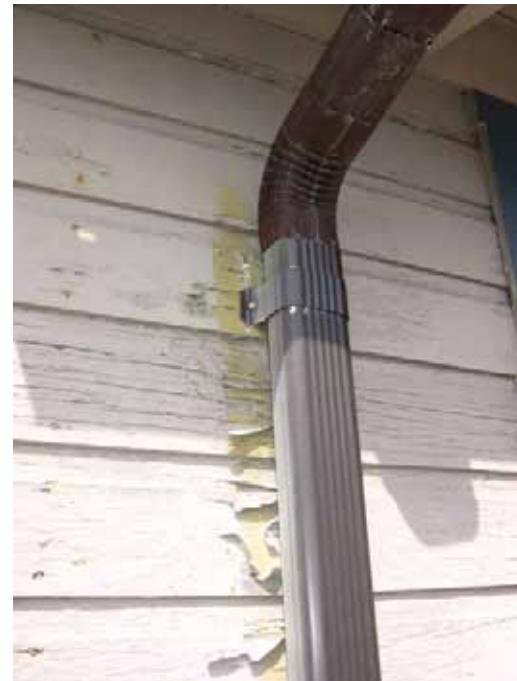
CP 35

WATER DAMAGE BEHIND
DOWNSPOUT. APRIL
2006. SOURCE: EYSAMAN
& COMPANY.

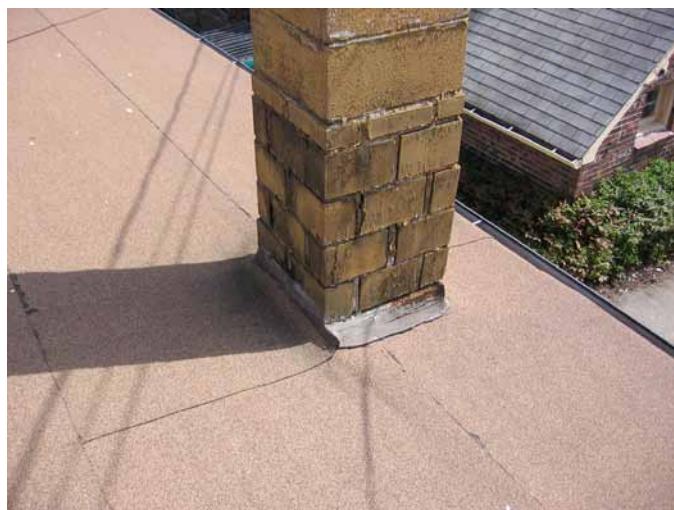
**CP 38**

CHIMNEY MORTAR FAILURE
AND FLASHING FAILURE.
APRIL 2006. SOURCE:
EYSAMAN & COMPANY.

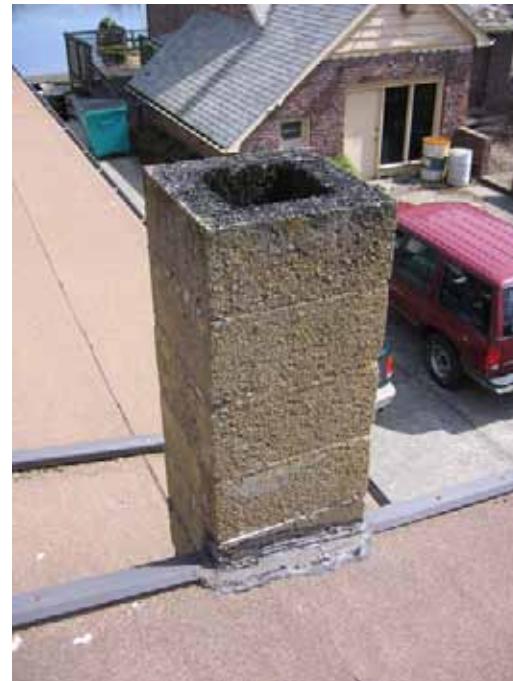
**CP 40**

MATERIAL LOSS AT
CHIMNEY. APRIL 2006.
SOURCE: EYSAMAN &
COMPANY.

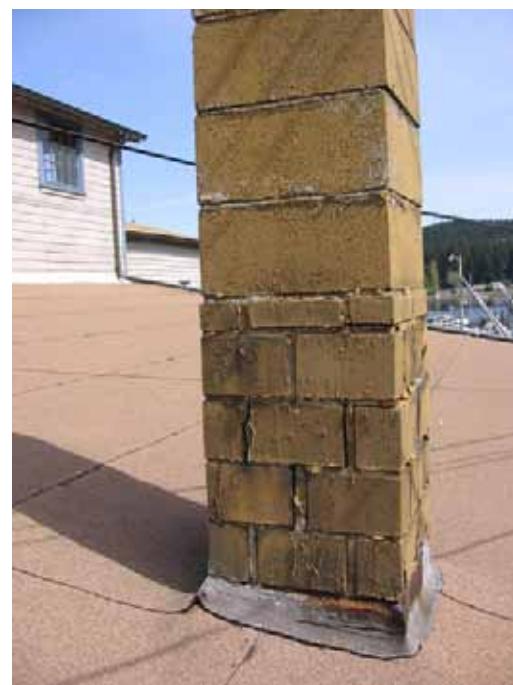
CP 41

FAILED CHIMNEY FLASH-
ING. APRIL 2006.
SOURCE: EYSAMAN &
COMPANY.
