ARBORIST REPORT

**The Reserve
Gig Harbor, WA
Tax Parcels 0222323134 and 0222323135**

**August 23, 2022
Updated September 27, 2022**

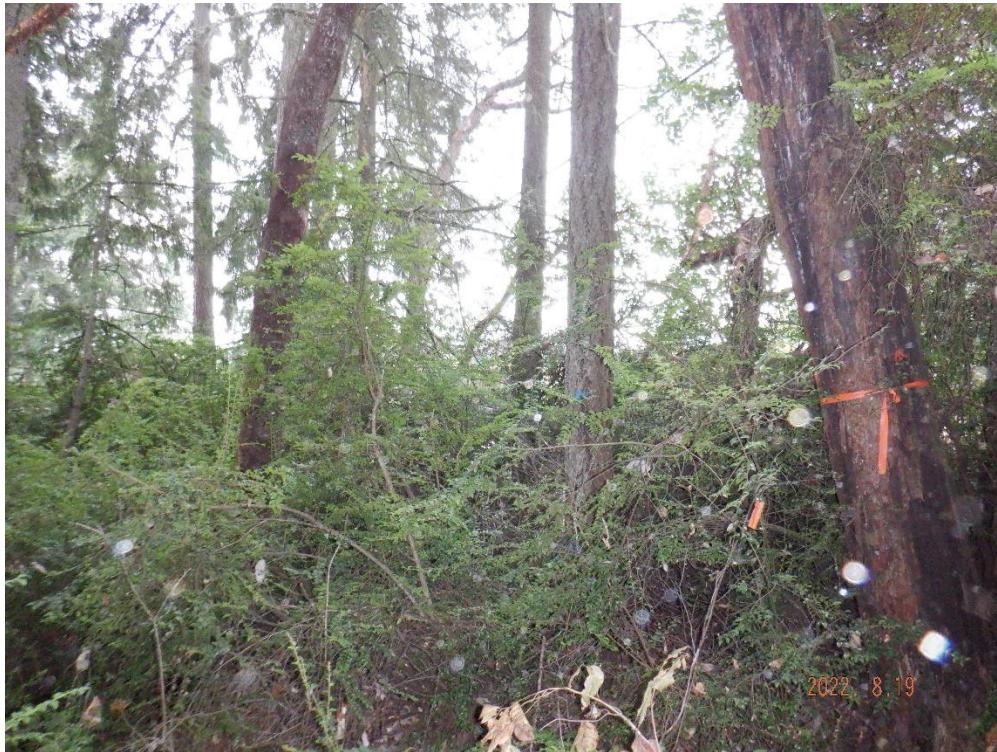
Southeast corner of property

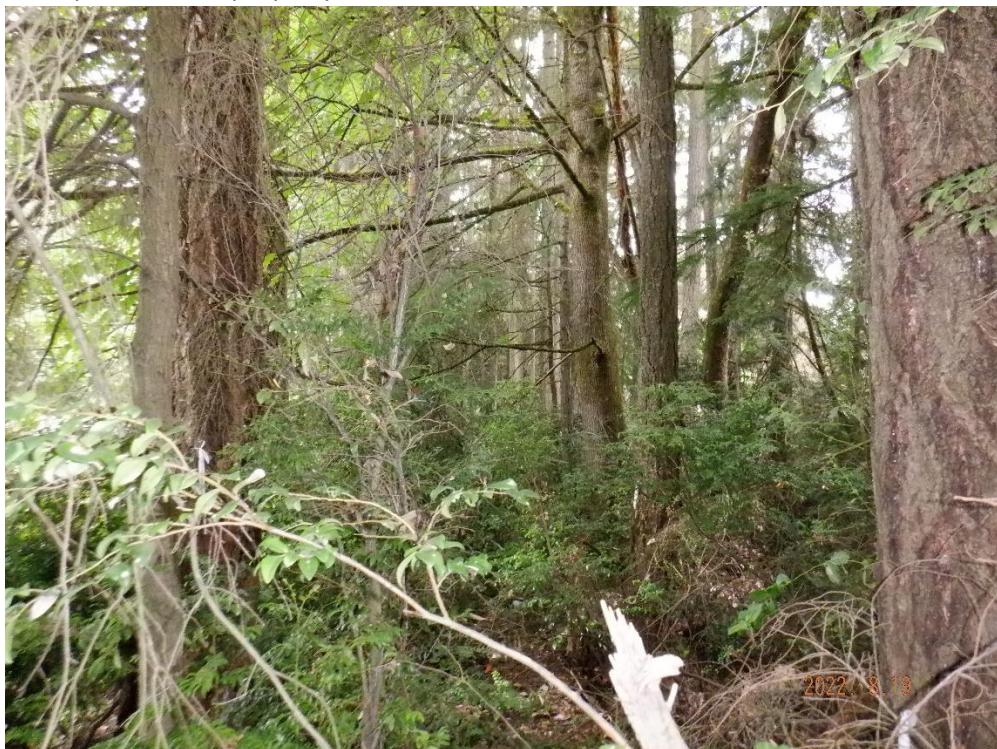
West perimeter of property

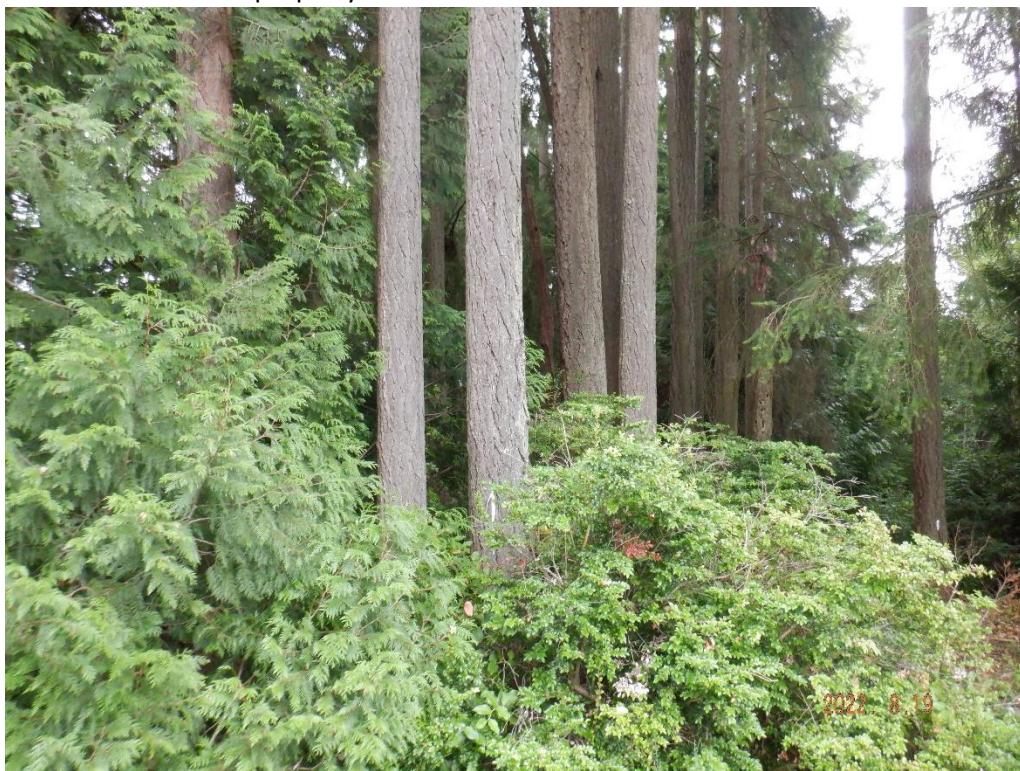
Northwest corner of property

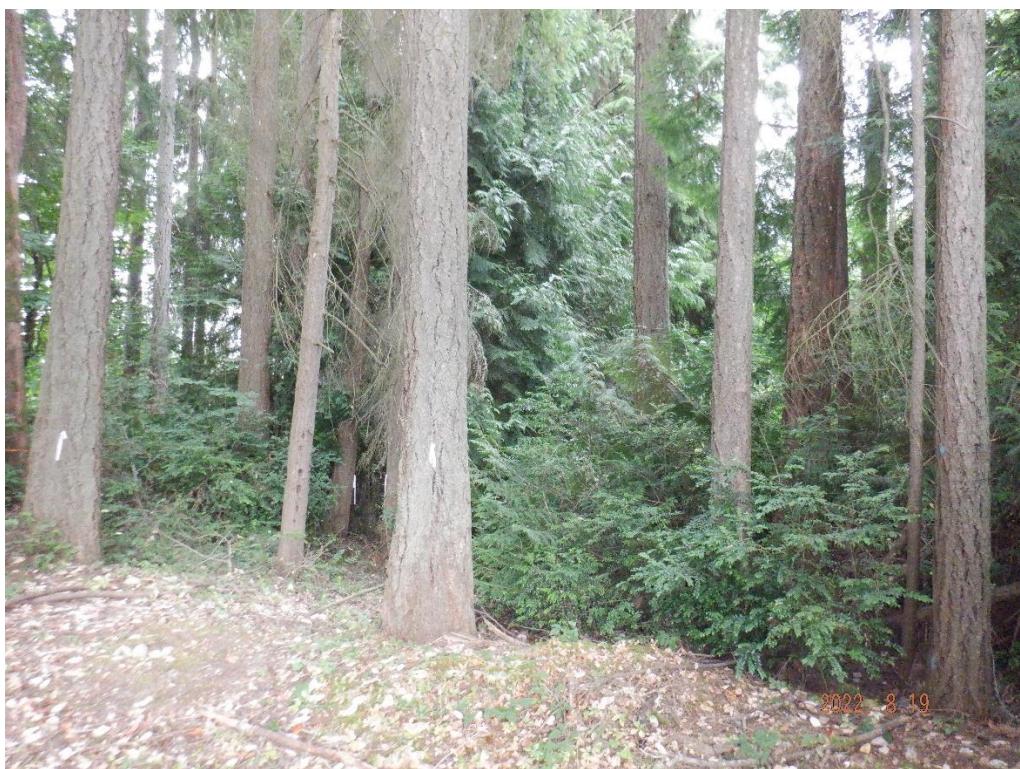
The Douglas fir is in fair to good condition for the most part. There is a root disease pocket in the northwest corner of the site, outside of the landscape buffer. Laminated root rot is suspected. Some trees have recently died in this area and others have been blown down in the past. The landscape buffer does not appear to be impacted at this time.

Root disease area in northwest corner of site

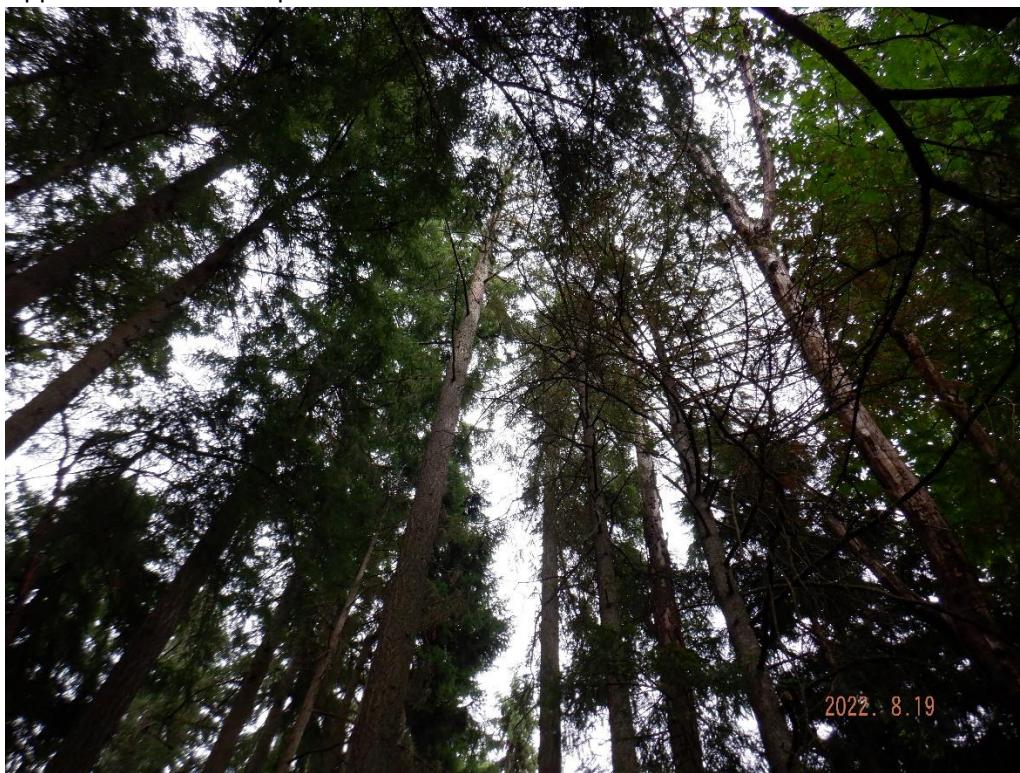
Upper crowns of trees pictured above

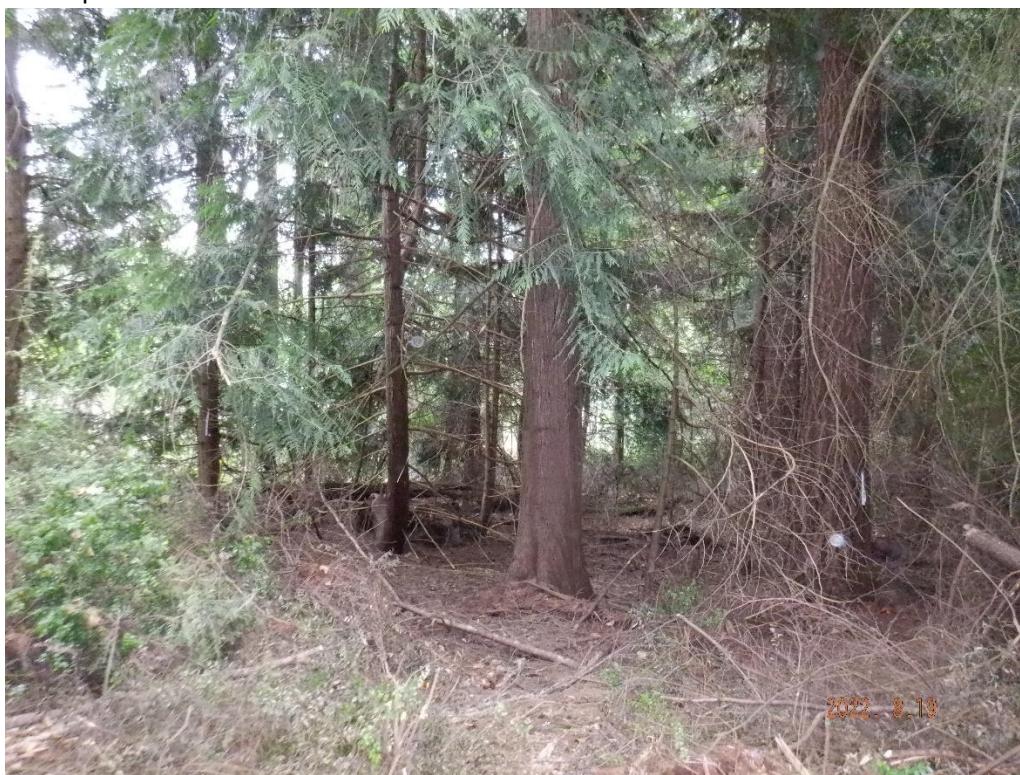
North perimeter

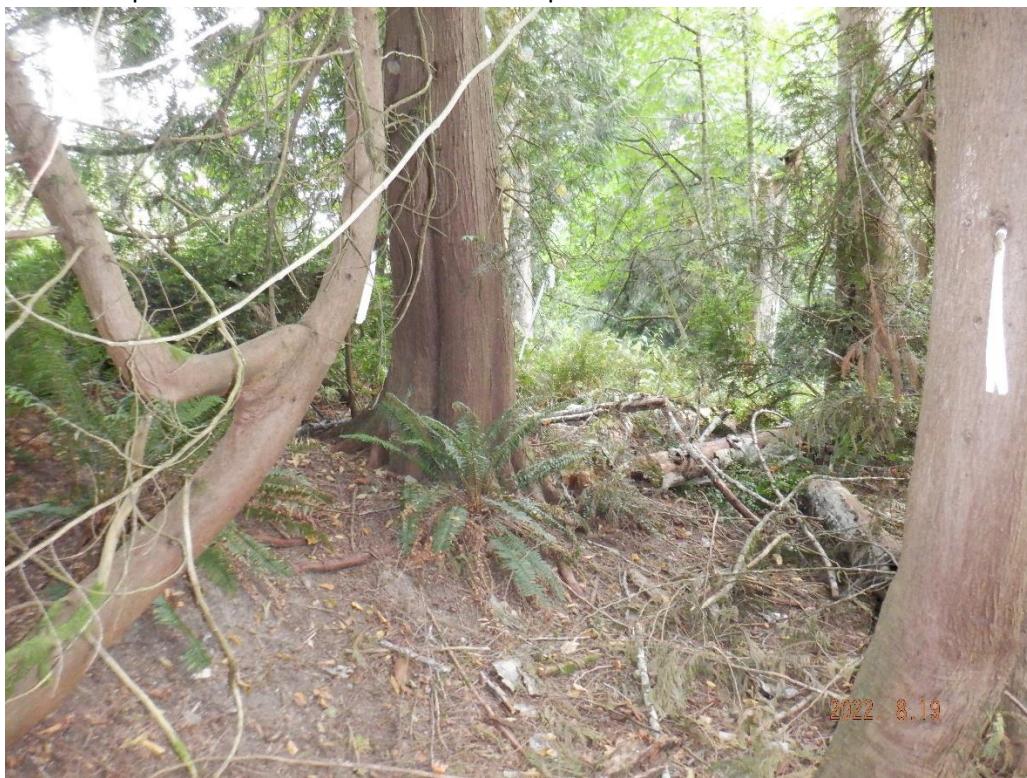
Northeast portion of buildable area above slope break

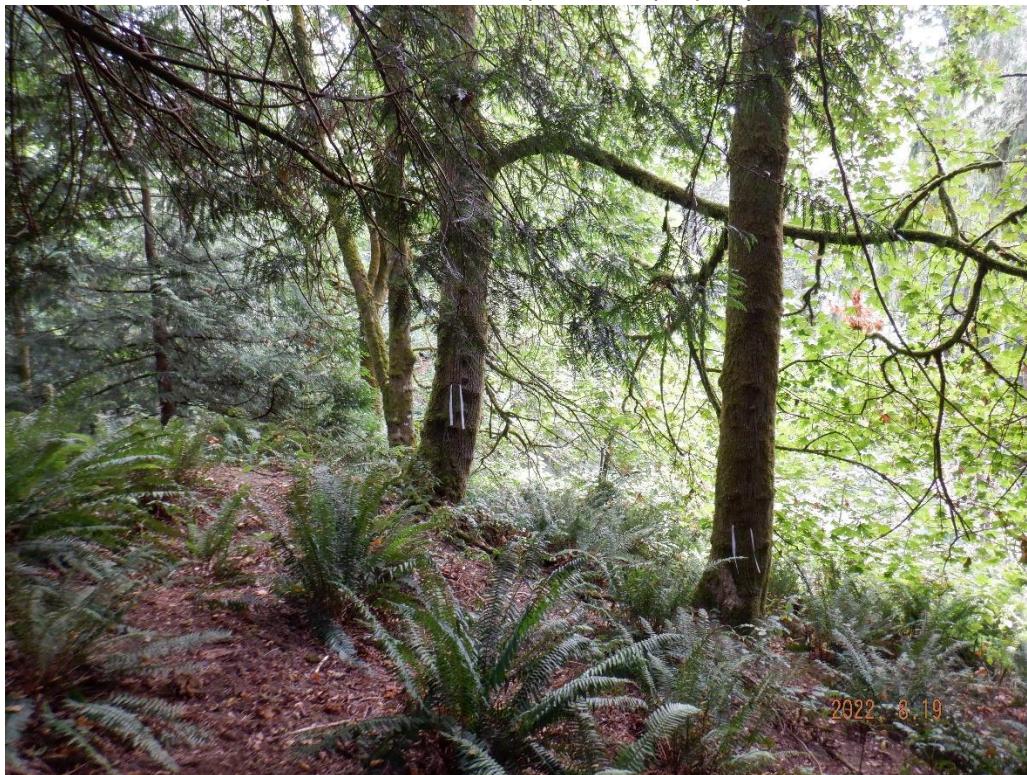
Trees Y and Z near slope break in northeast portion of property

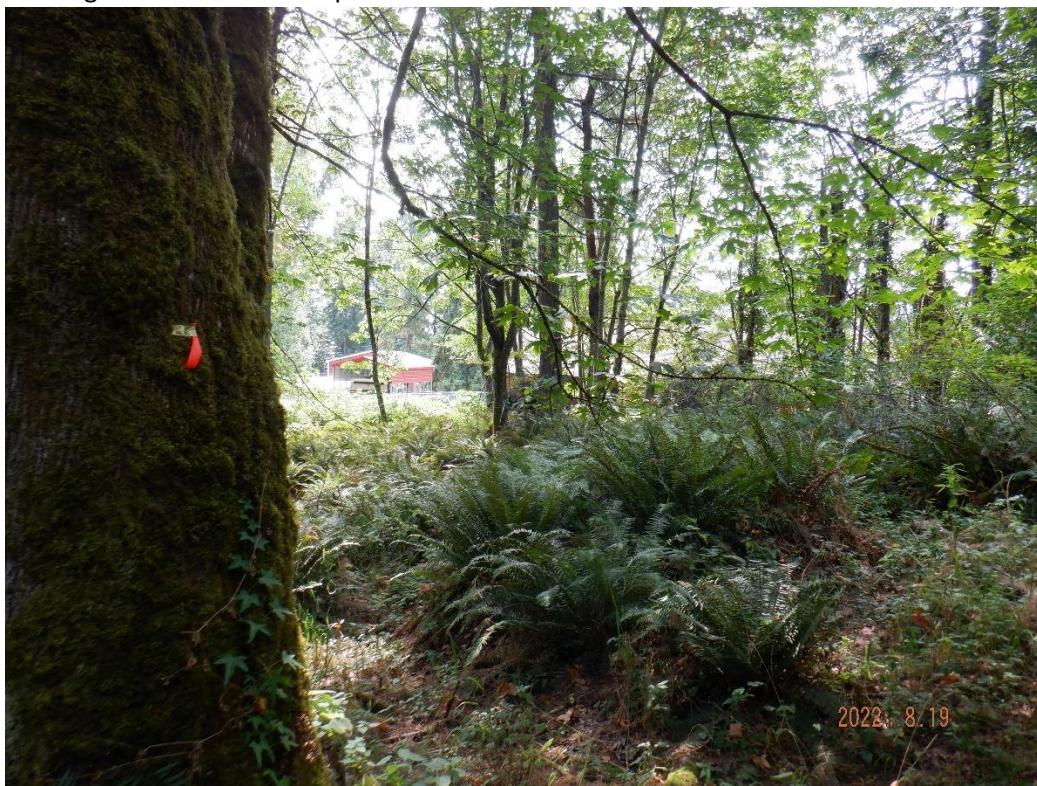
Looking south to southeast portion of buildable area

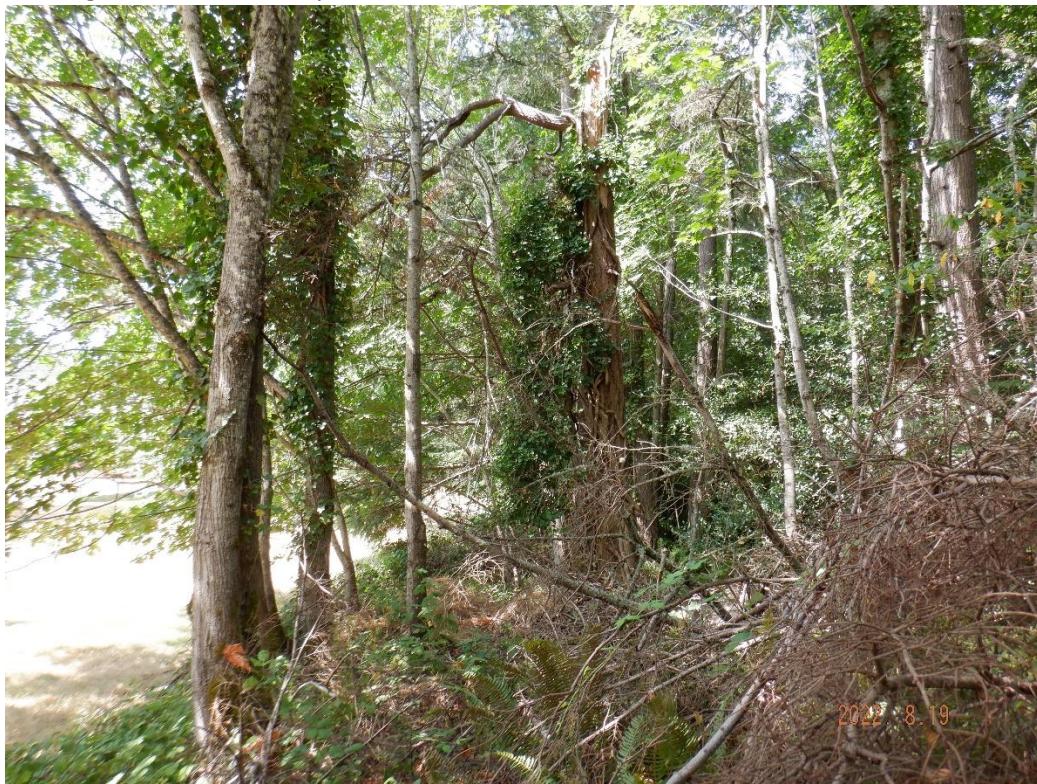
Looking west down south perimeter, Tree #164 in center

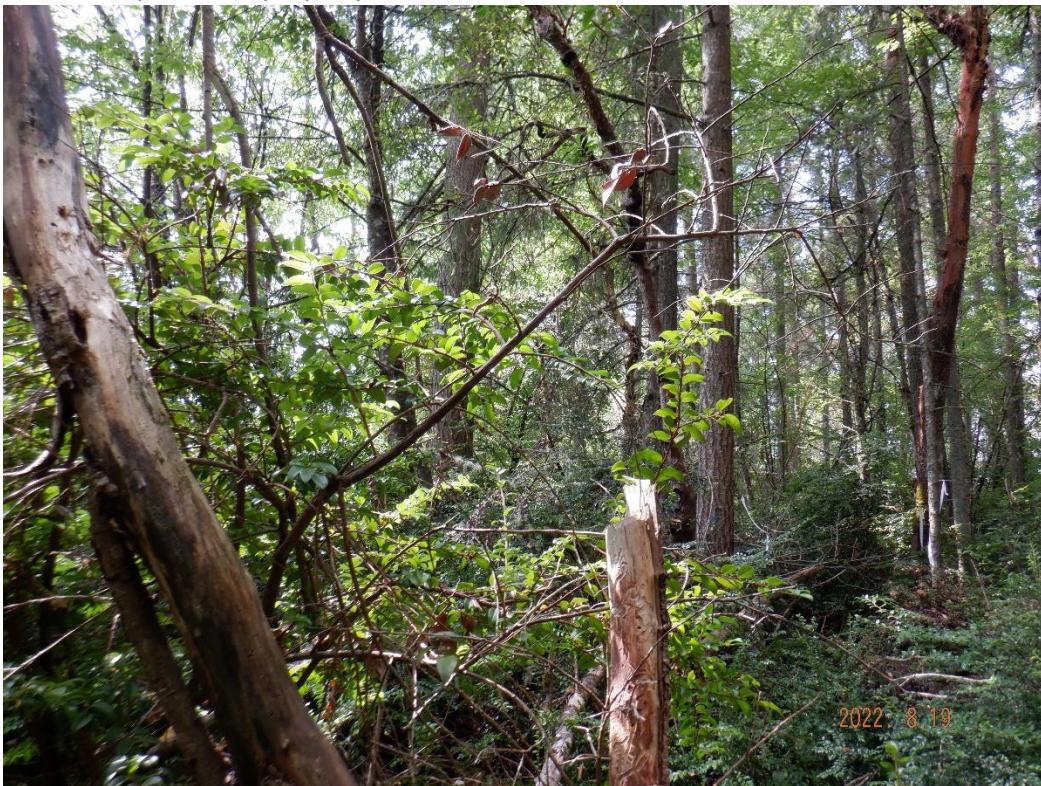
Southwest portion of property

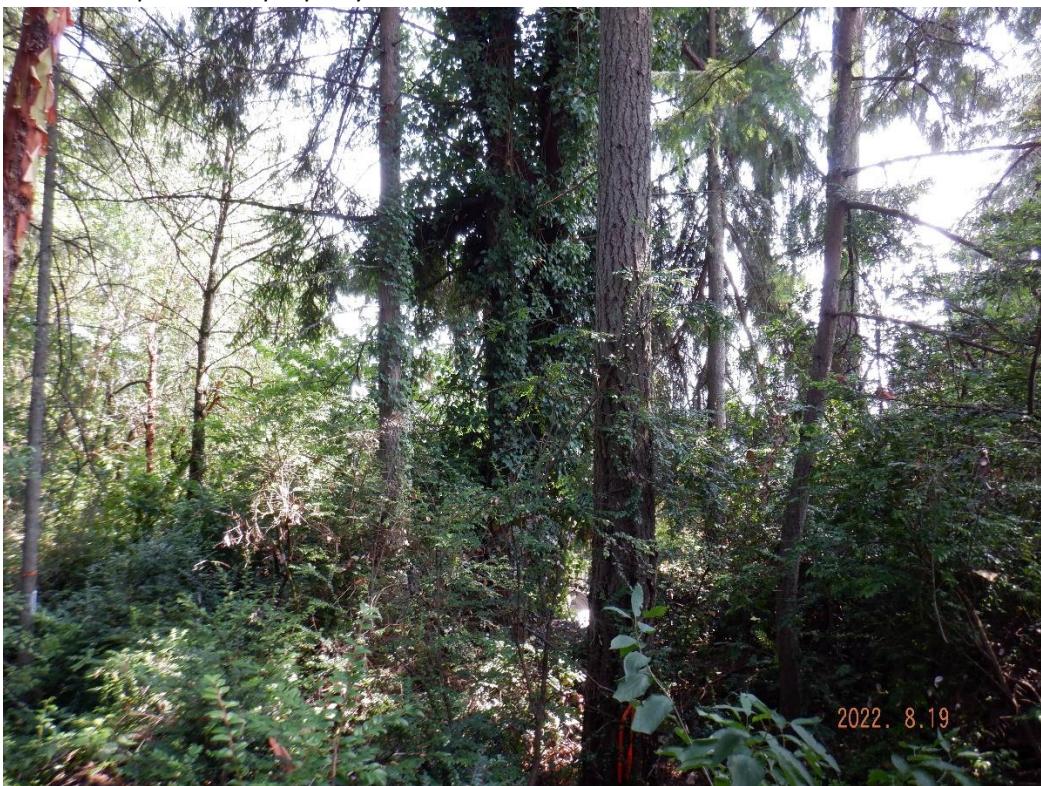
Southwest portion of property
