MASTER PLAN & PHASING PLAN

Final Master Plan

ARCHITECTURAL MEMO

Re: Masonic Lodge

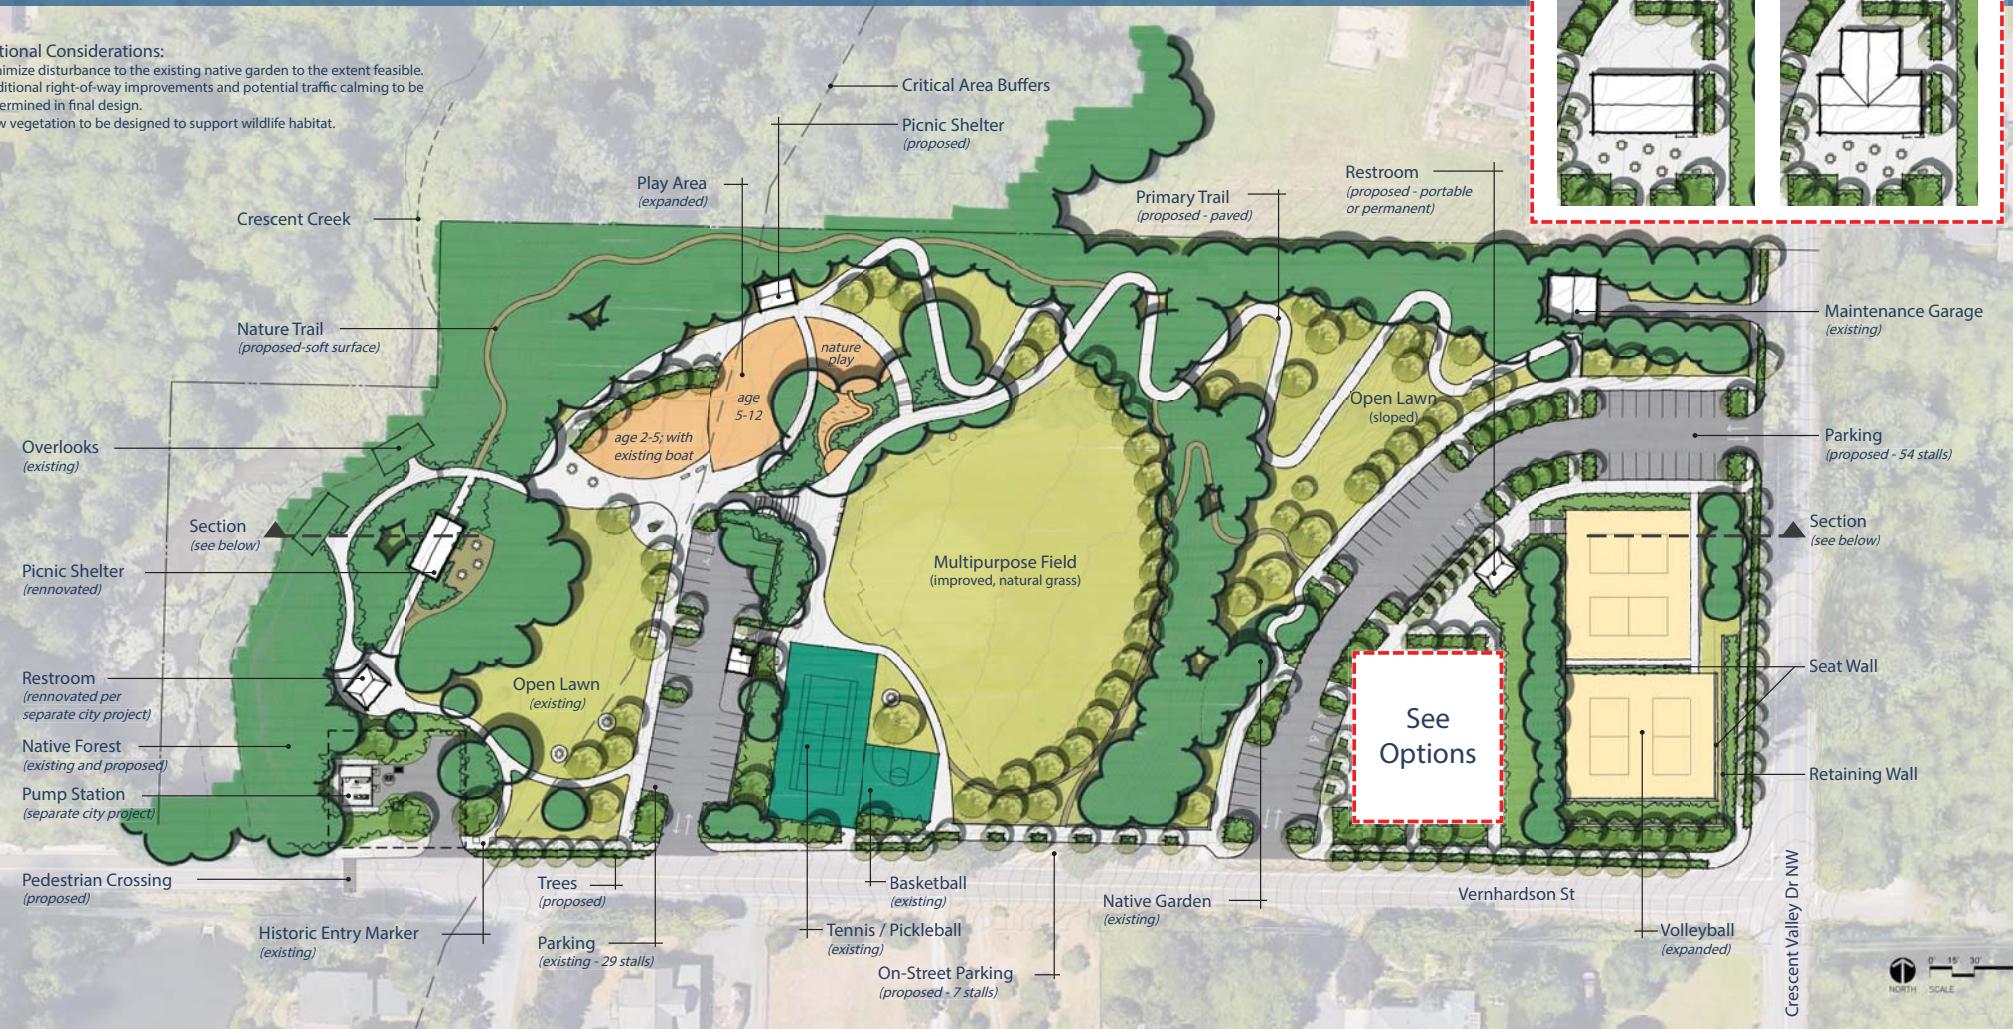
- Minimize disturbance to the existing native garden to the extent feasible.
- Additional right-of-way improvements and potential traffic calming to be determined in final design.
- New vegetation to be designed to support wildlife habitat.

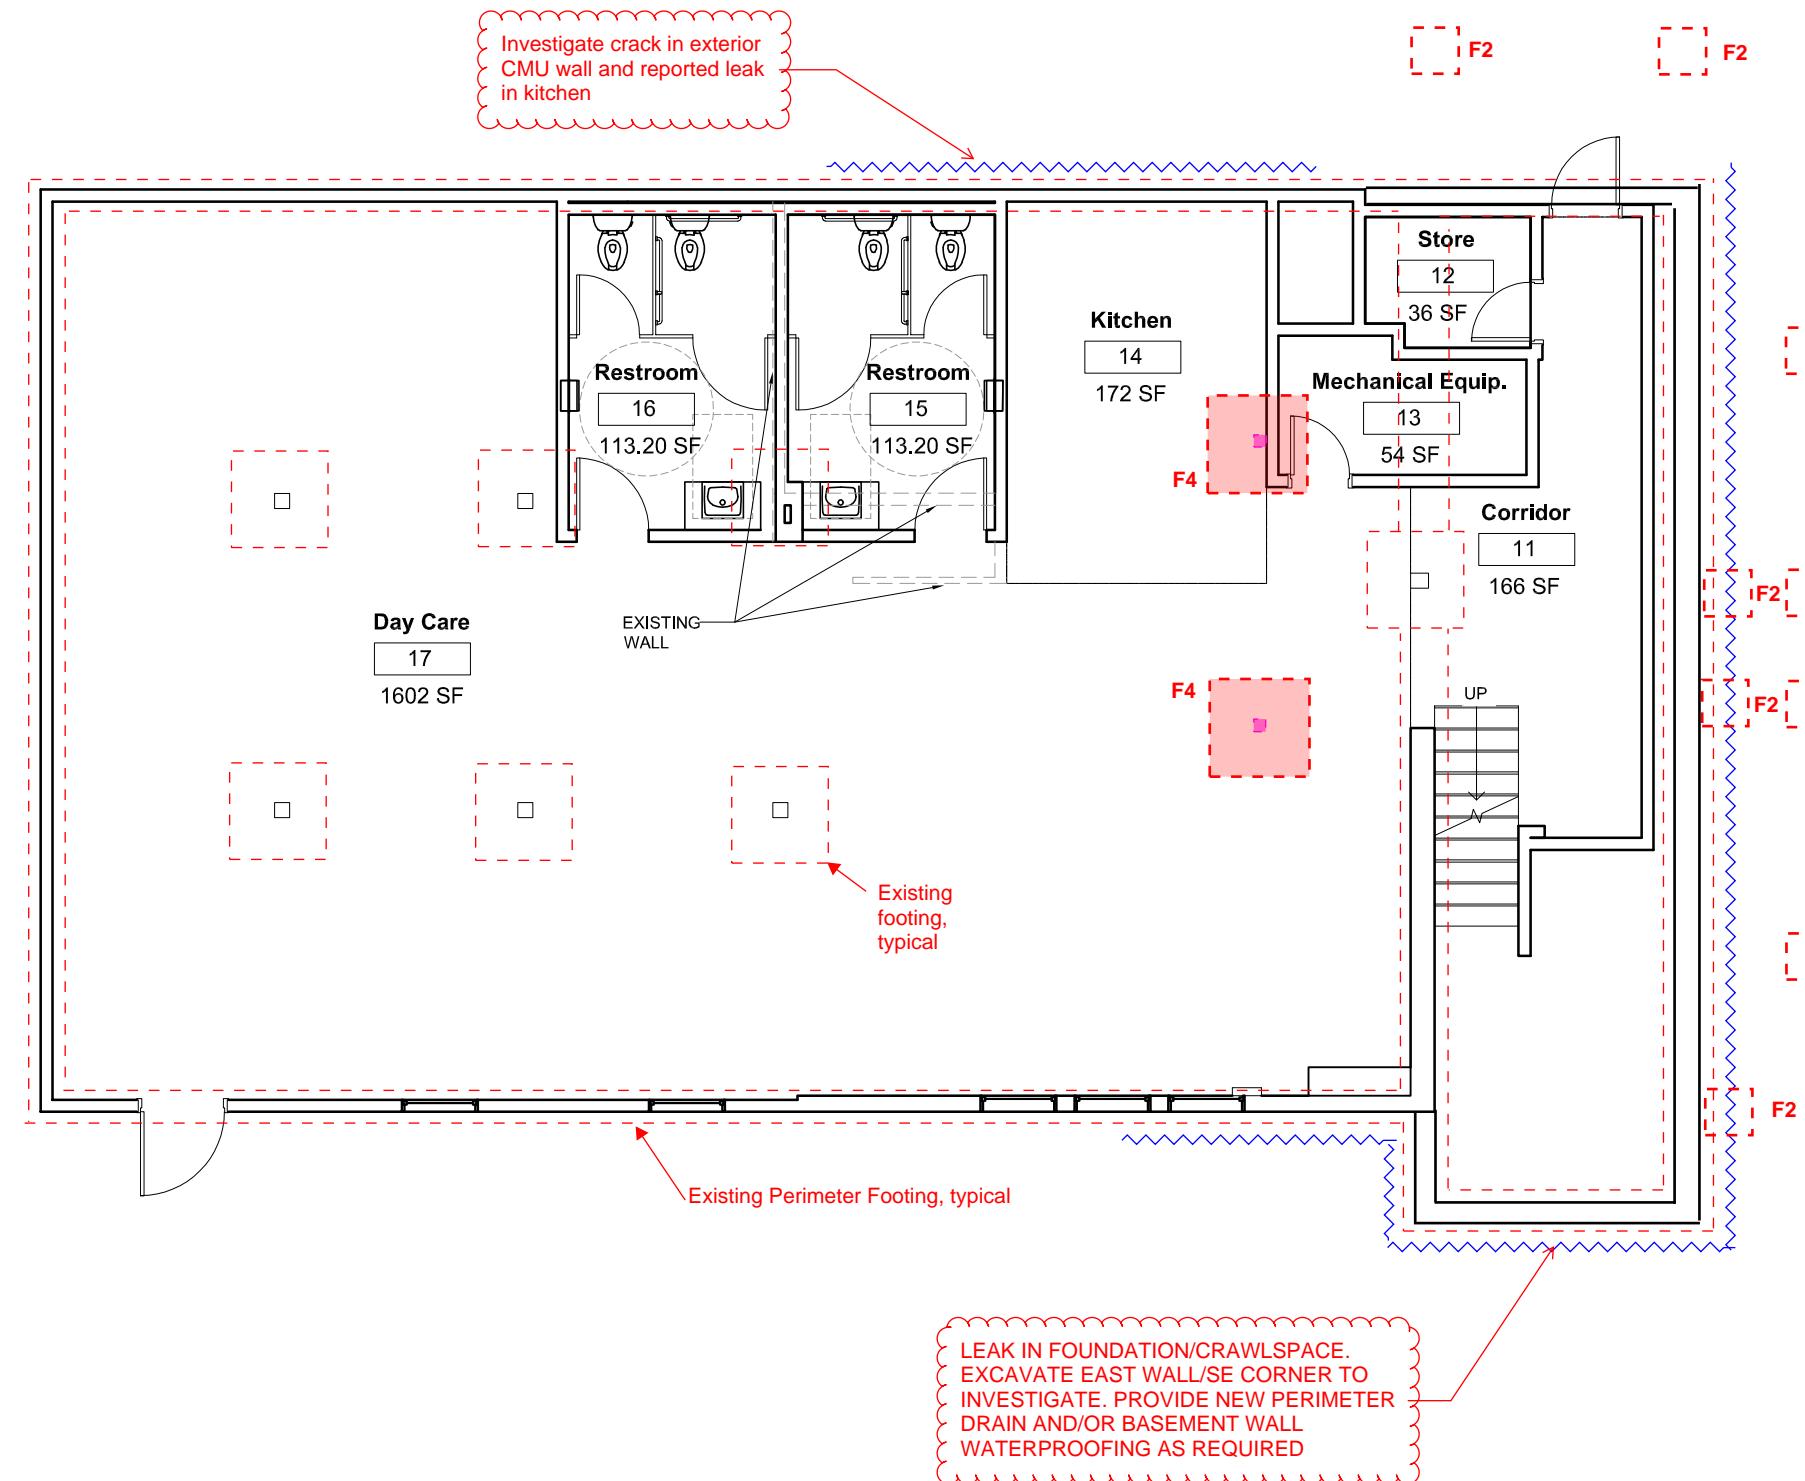
FOUNDATION PLAN

Existing structural framing components to remain, unless noted otherwise.

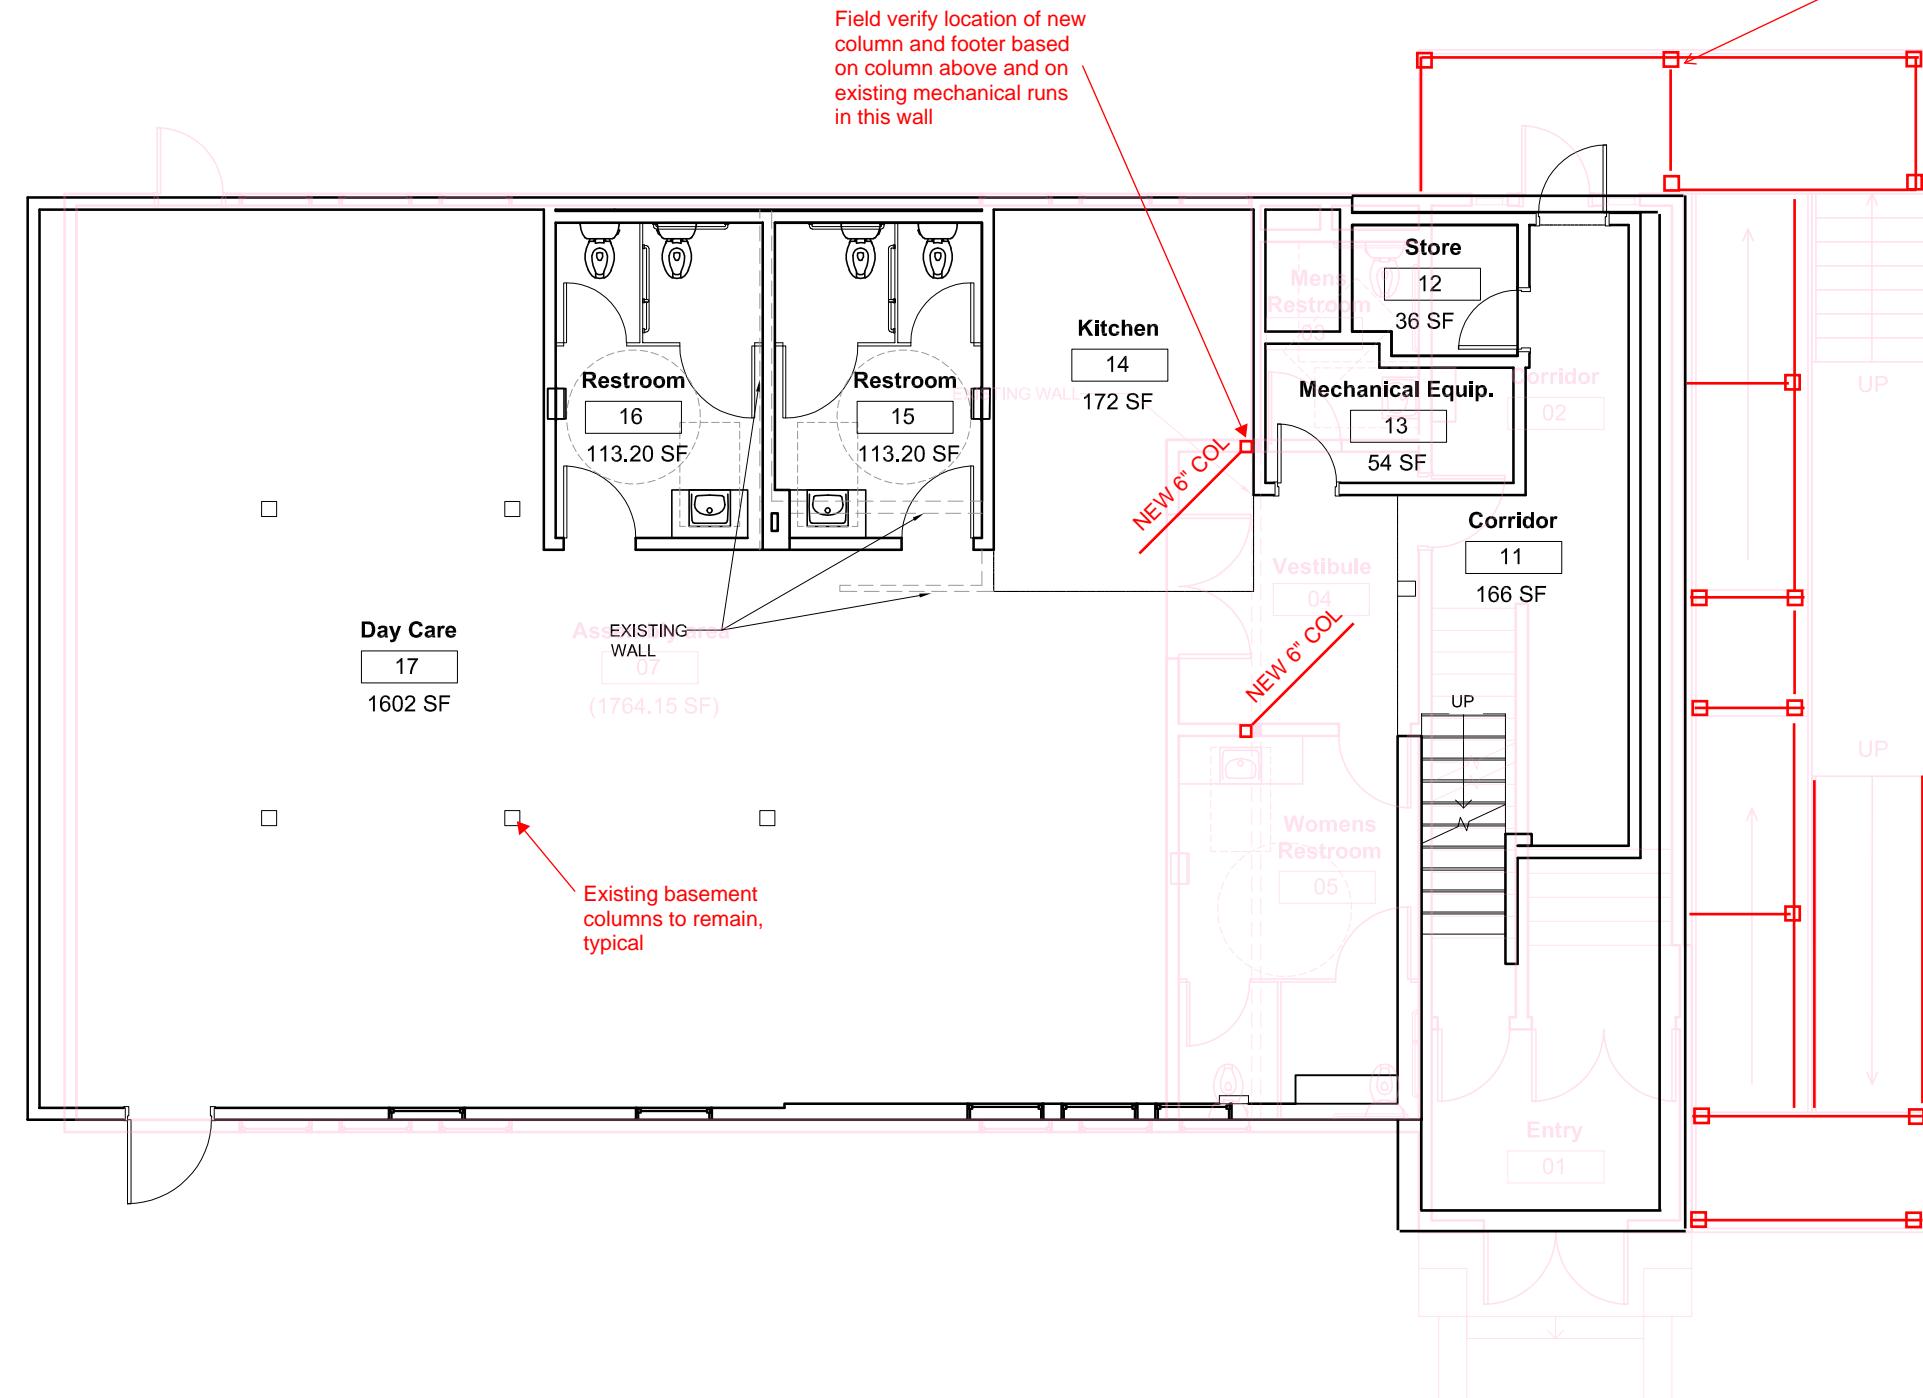
MAIN FLOOR FRAMING PLAN

Existing structural framing components to remain, unless noted otherwise.

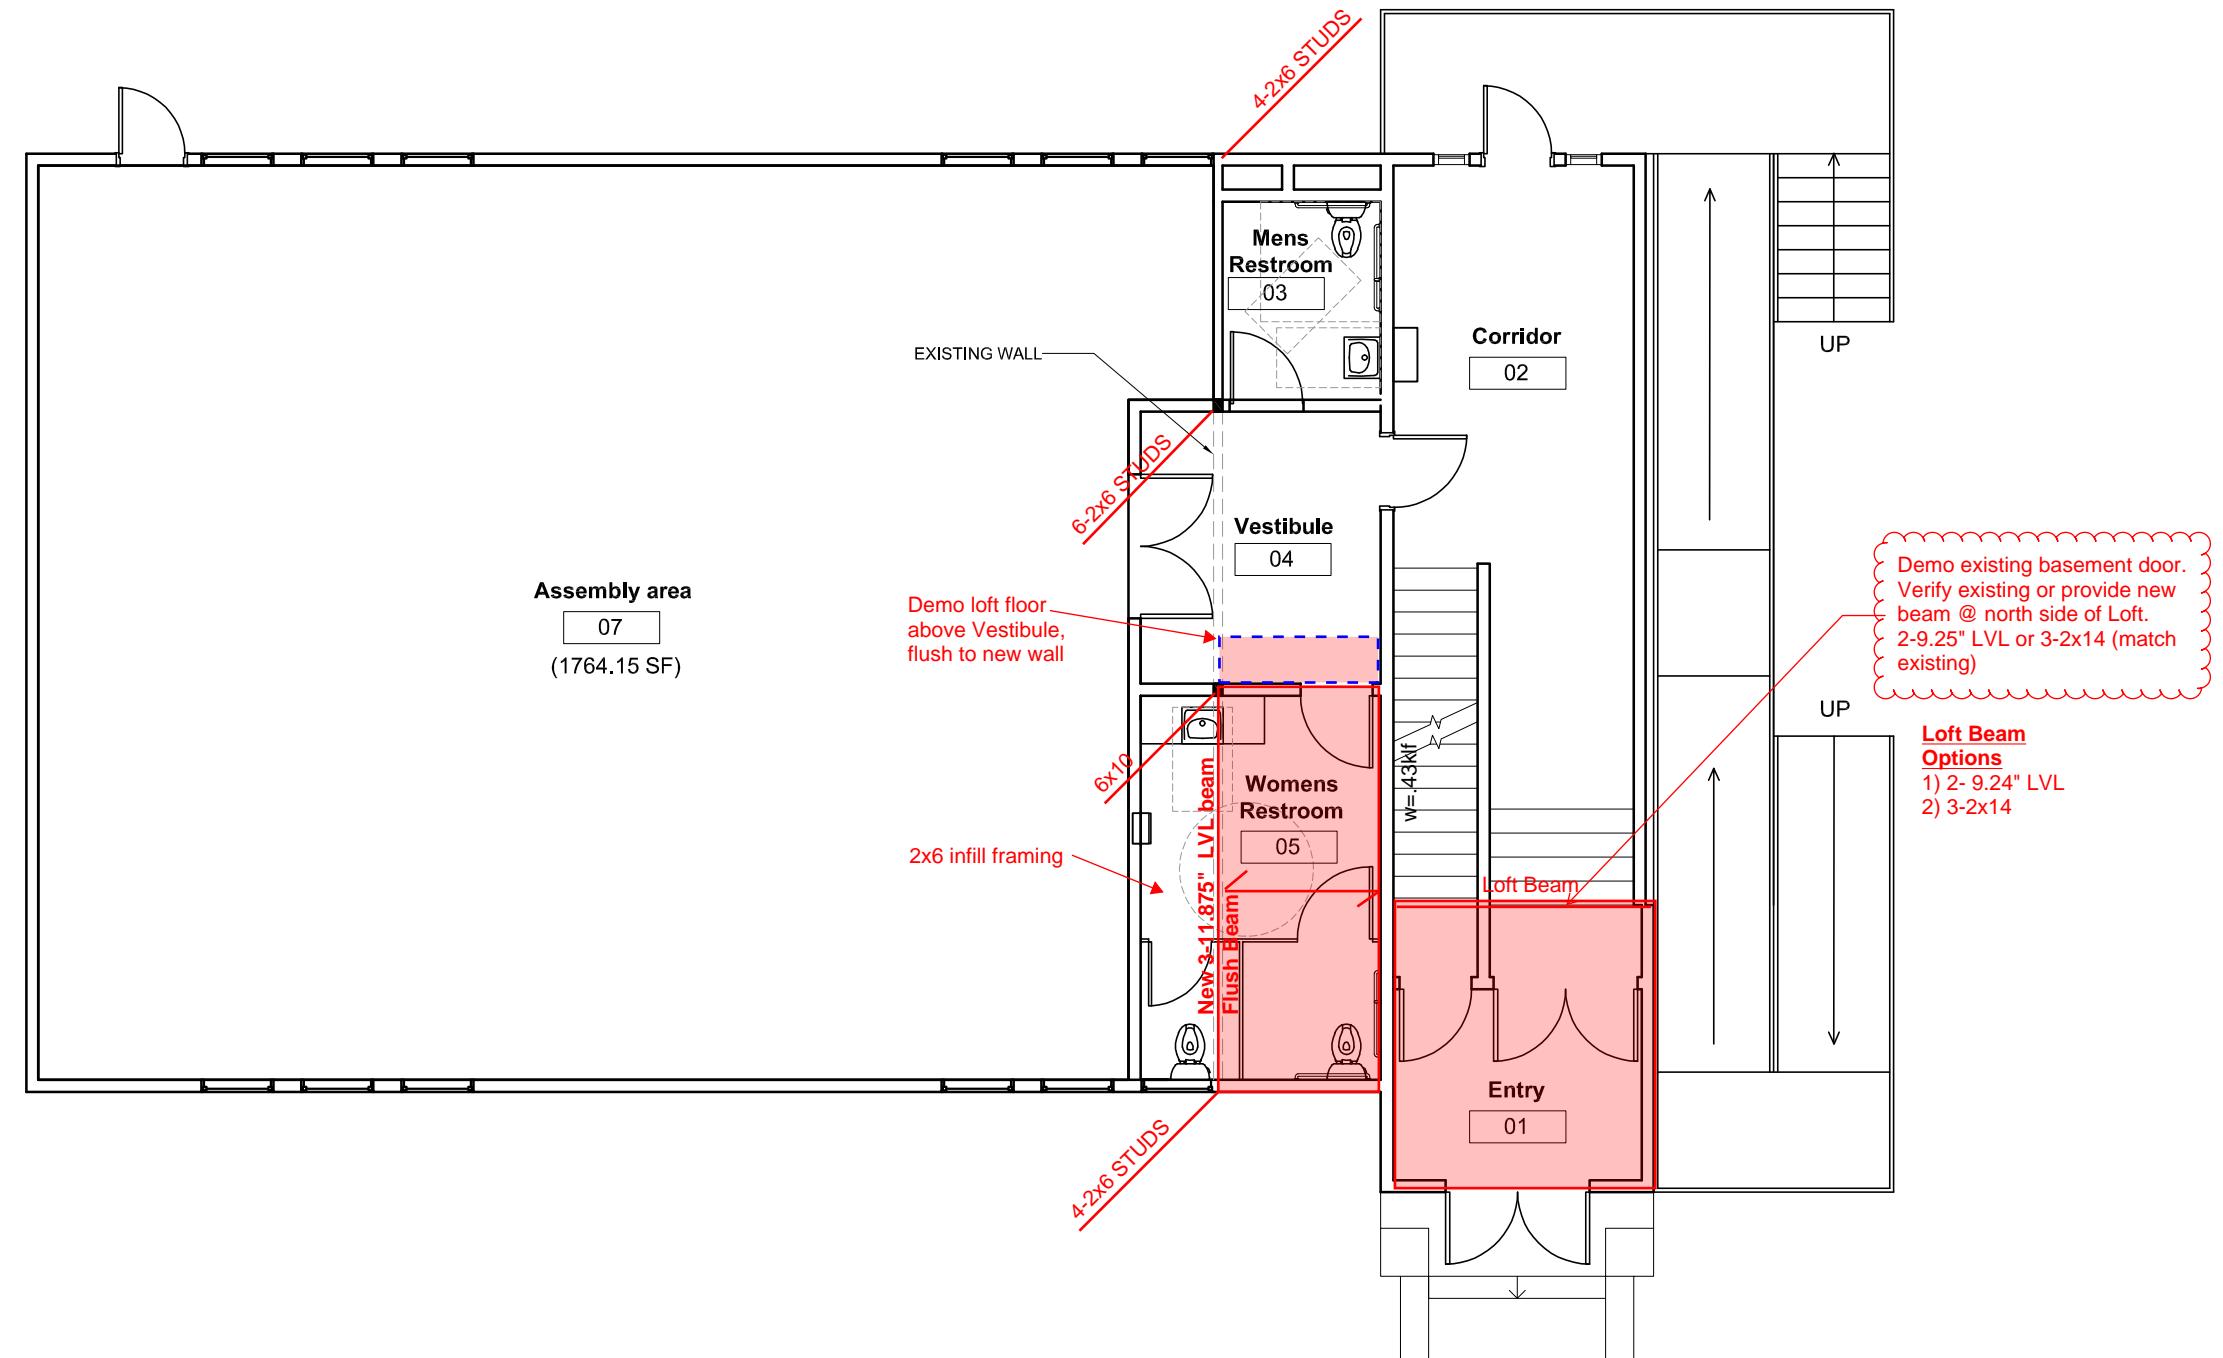
LOFT FLOOR FRAMING PLAN

Existing structural framing components to remain, unless noted otherwise.

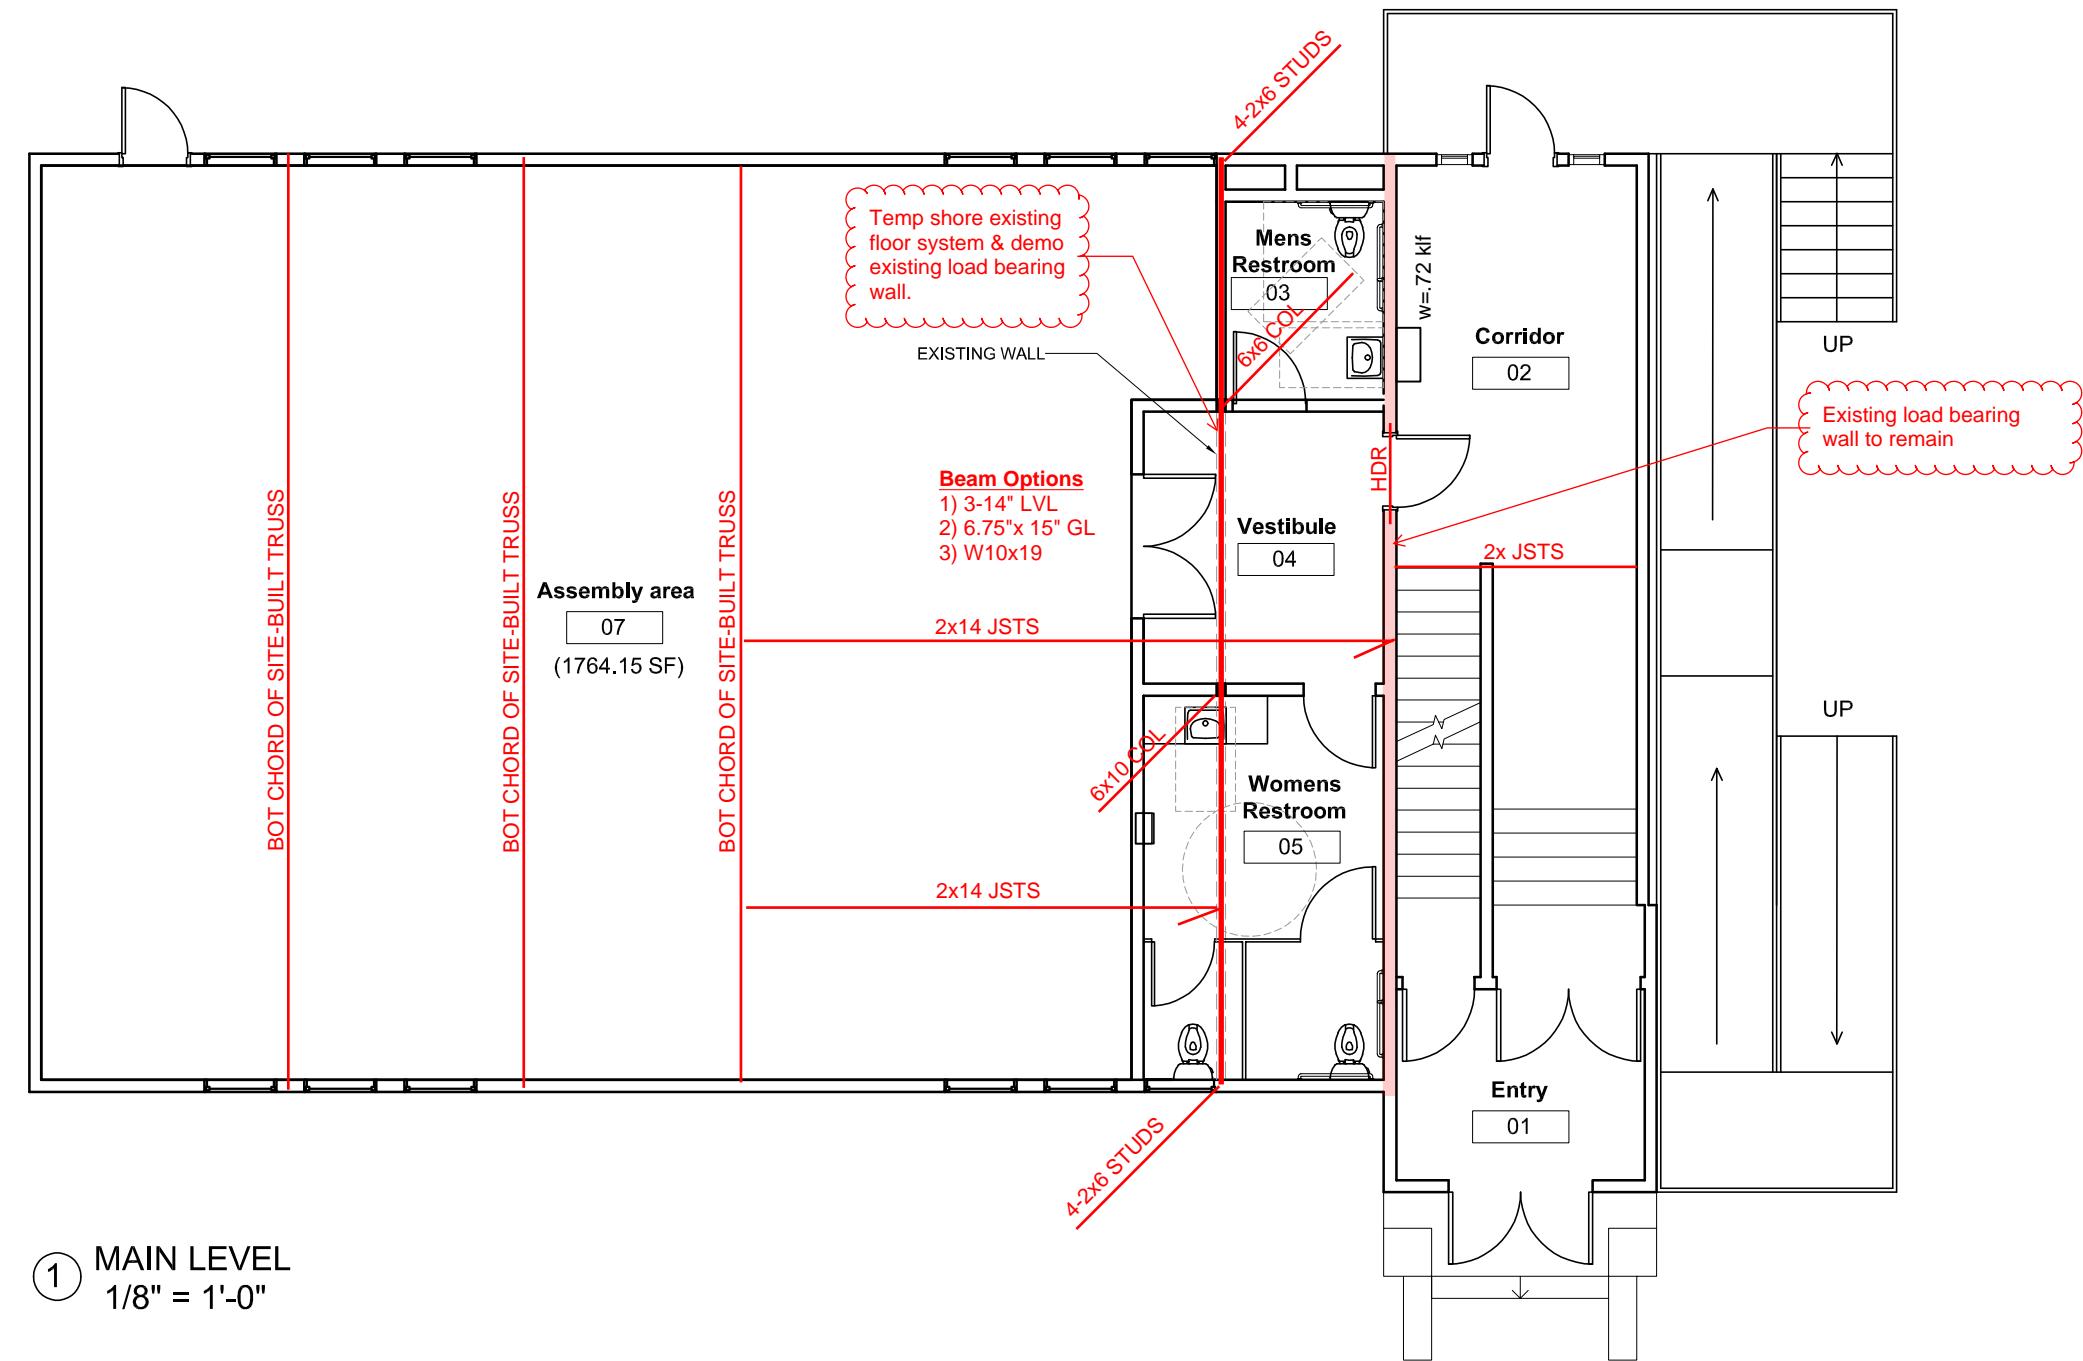
SECOND FLOOR FRAMING PLAN

Existing structural framing components to remain, unless noted otherwise.

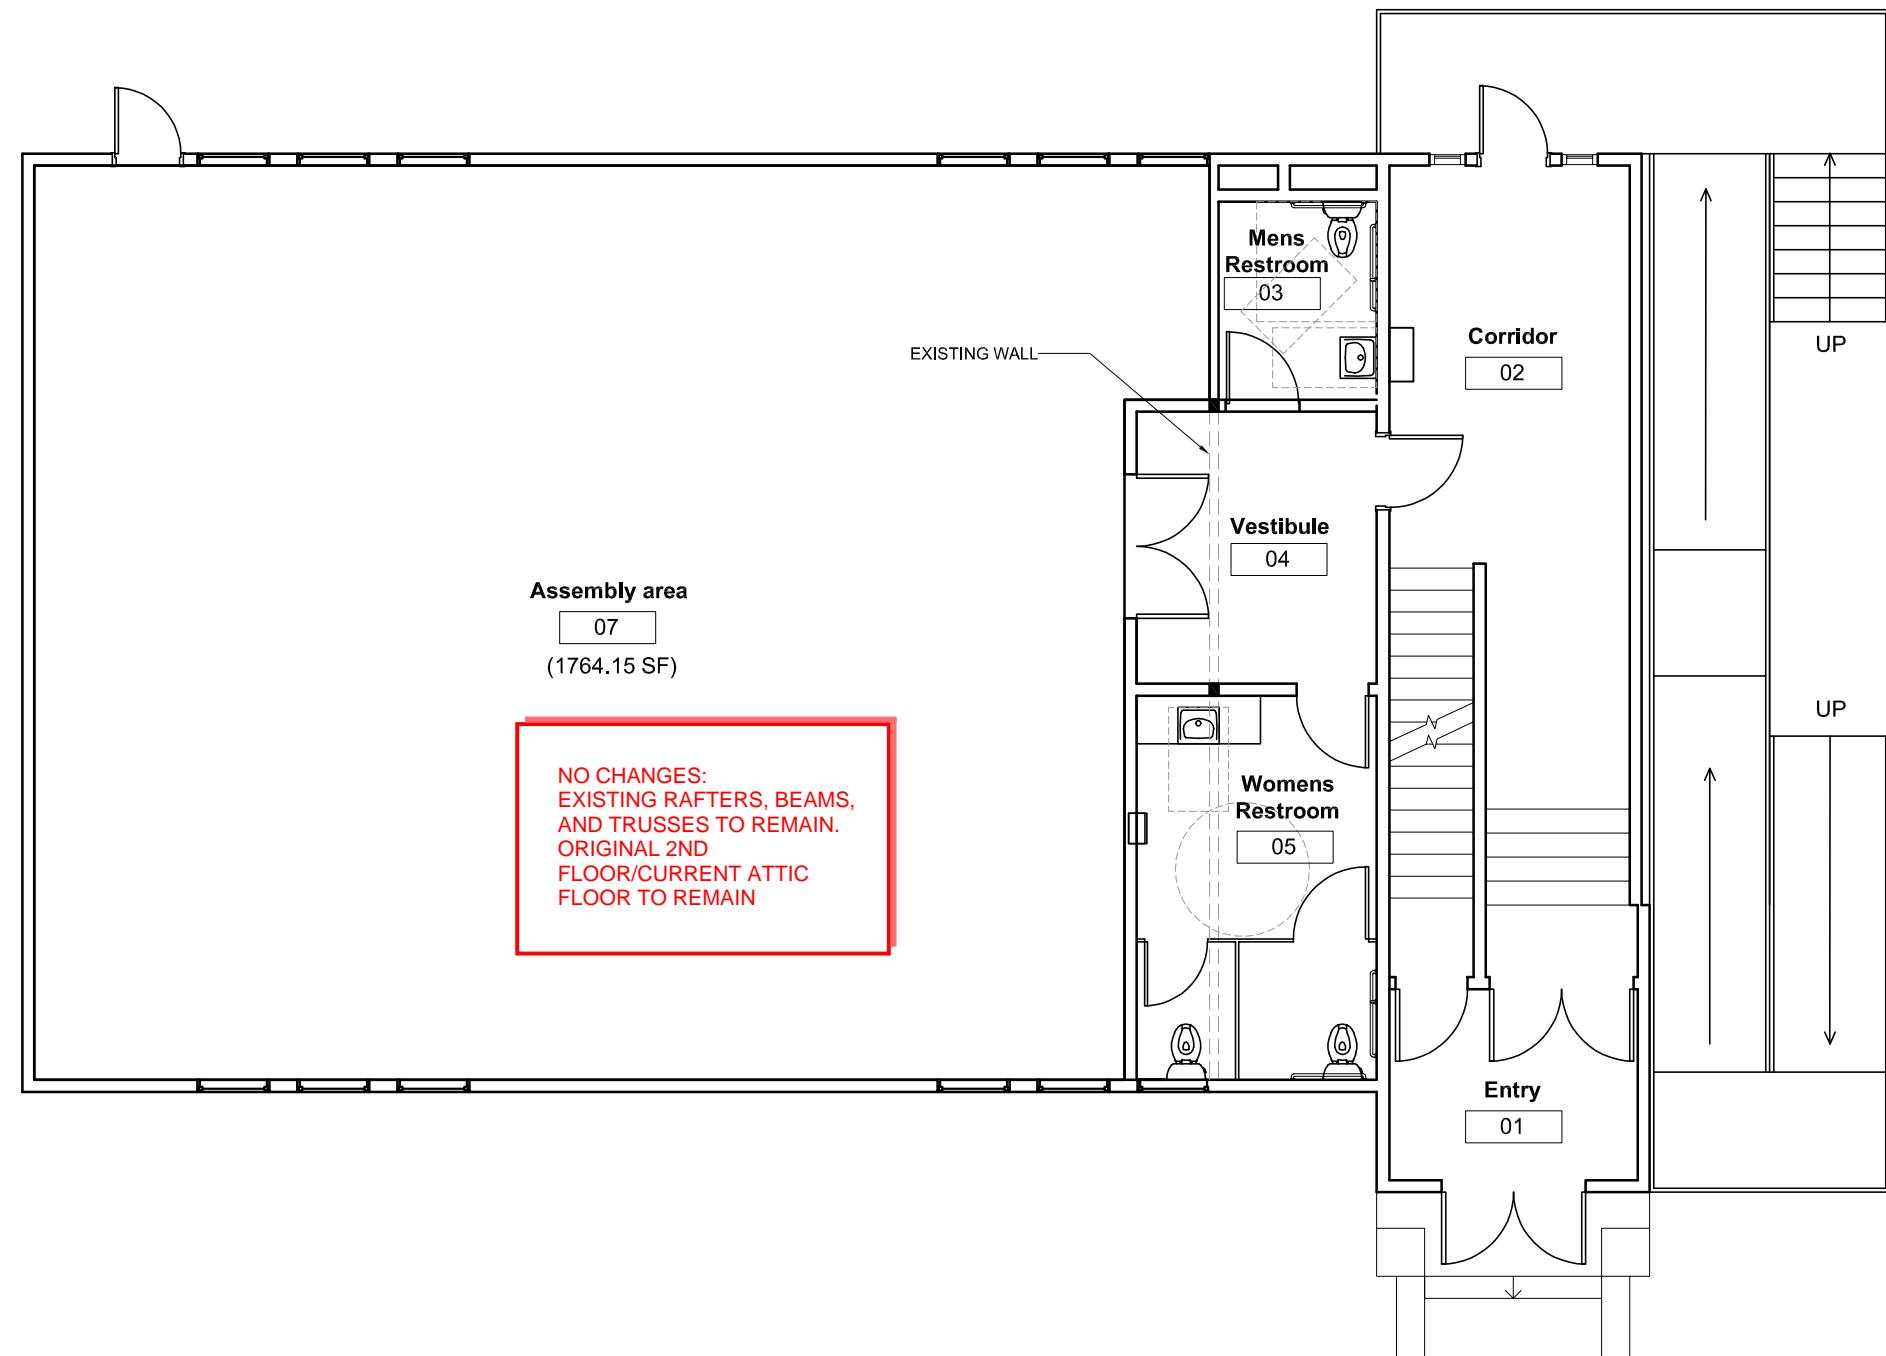
ROOF FRAMING PLAN

Existing structural framing components to remain, unless noted otherwise.

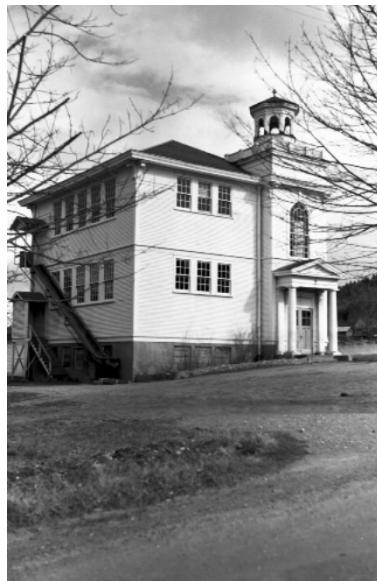
Photograph 2-1. Crescent Valley School Building – South and West Exterior prior to MTA remodel (Circa 1948). Photograph from Harbor History Museum website (www.harborhistorymuseum.org)

As noted in the "Phase 1 Environmental Site Assessment – Masonic Lodge Property" (Aspect 2017), the original Crescent Valley School building was constructed in 1915 and was operated as a school until 1941. The property was then purchased in 1949 by the Masonic Temple Association of Gig Harbor (MTA), after which the building underwent significant remodeling which included an addition to the west side of the building, and removal existing second floor of the school building, see photograph 2.1 and 2.2.

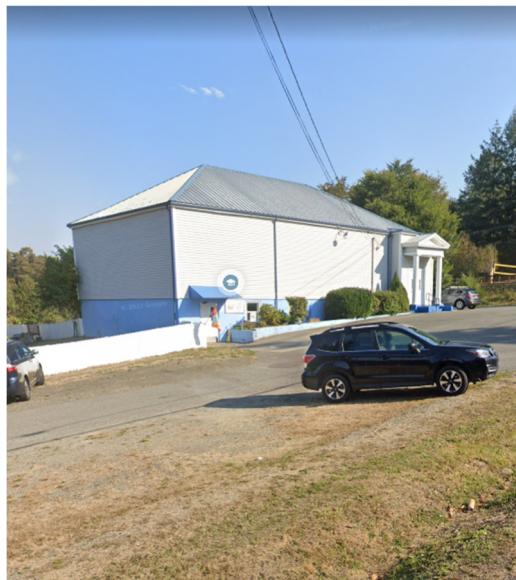
Photograph 2-2. Masonic Lodge – South and West Exterior current condition, post MTA remodel (2023).
Photograph from google maps street view (maps.google.com)

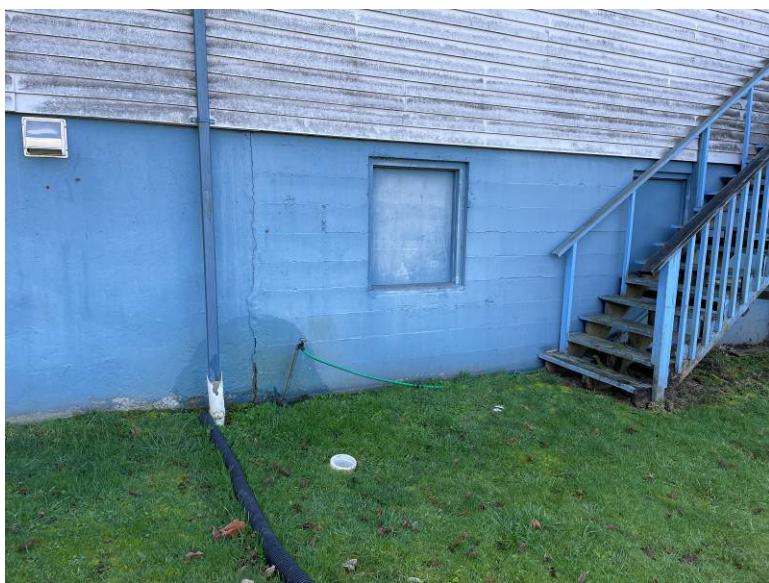
Photograph No. 1

Exterior, north wall, looking south.

Wall with historic (left) and addition (right). Crack developed at block/concrete interface.

The historic structure exterior wall is built with diagonal 2x planking on 2x studs @ 16" oc. (Photo No. 18) The exterior wall of the addition was not immediately available but appeared to be similar. The historic foundation is built with poured concrete walls, the addition is built with CMU. (Photo No. 1) The concrete has various cracks and chips. There is evidence of a leak in the southeast corner, as observed in the crawlspace. The CMU foundation has several cracks; reinforcement is undetermined. (Photo No. 8)

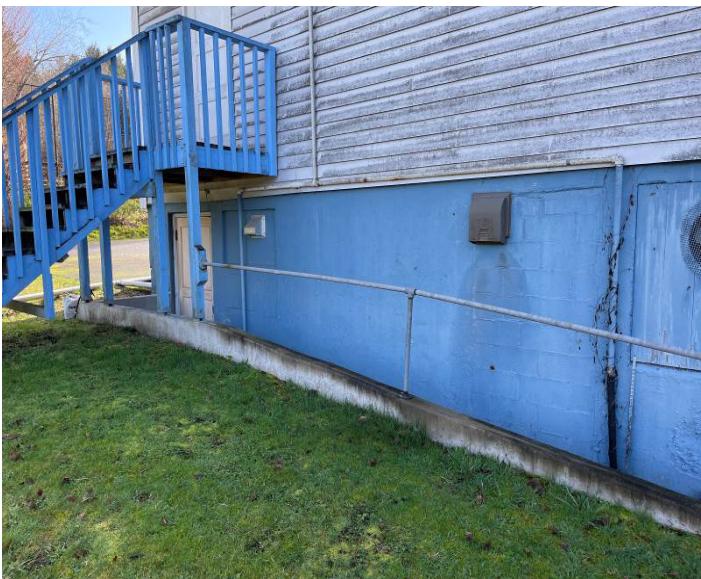
Photograph No. 2

Exterior, north wall, looking east

Typical condition of historic foundation. Block infill at existing opening.

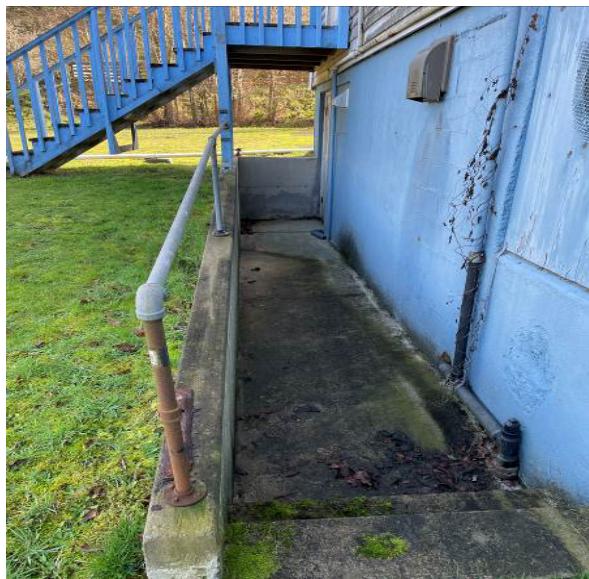
Photograph No. 3

Exterior, north wall, looking east

Basement access in historic foundation.

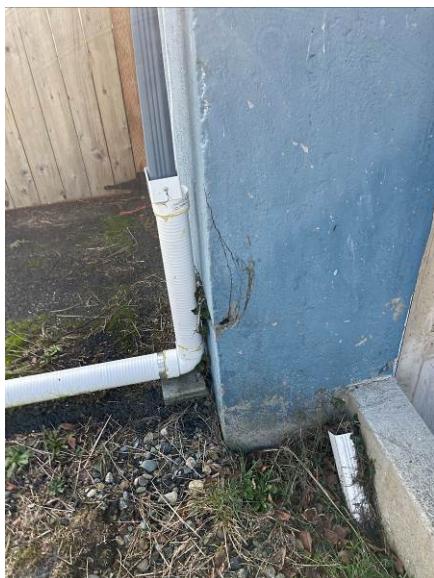
**Photograph No. 4**

Exterior, northeast corner, looking south.

Concrete damage. Possible rebar exposure.

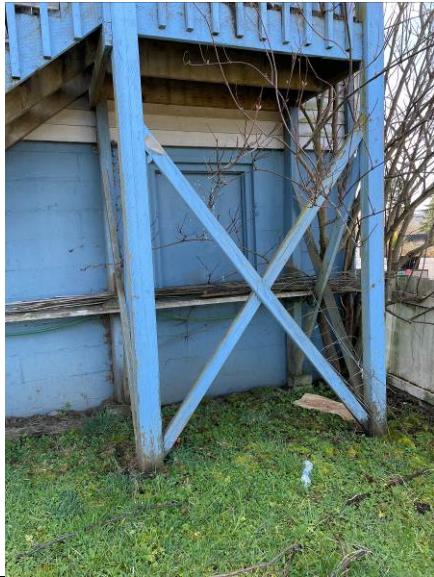
**Photograph No. 5**

Exterior, north wall, looking south.

Exterior exist & stairway from main floor

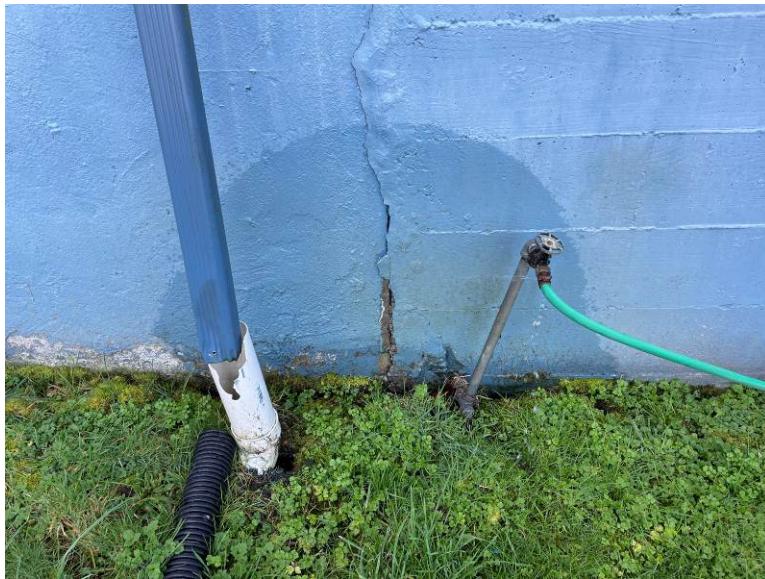
**Photograph No. 6**

Exterior, north wall, looking south.

Water infiltration risk at interface of historic foundation and addition.

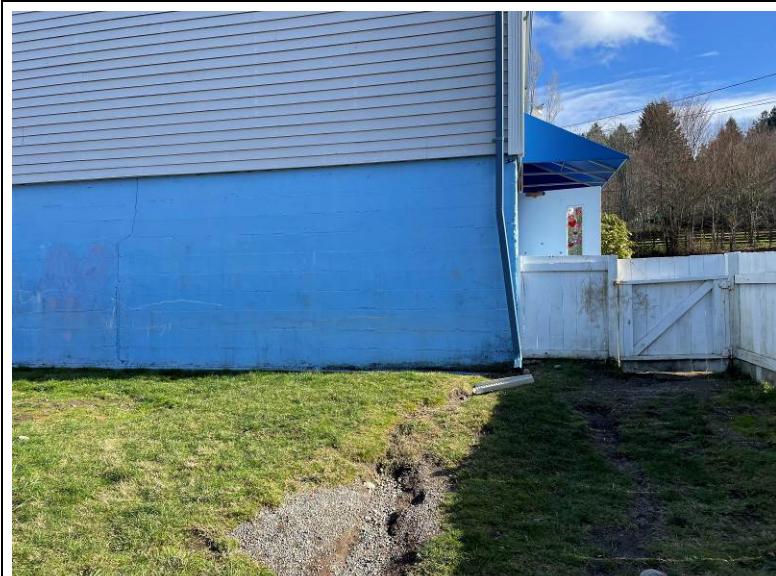
Photograph No. 7

Exterior, west wall, looking east

Overview of south end of west addition basement wall

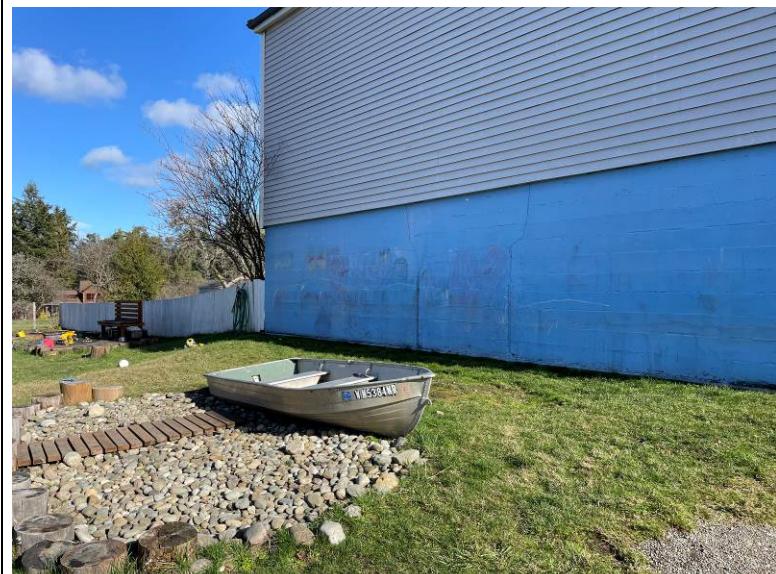
Photograph No. 8

Exterior, west wall, looking east

Overview of south end of west addition basement wall.
Note cracks near center

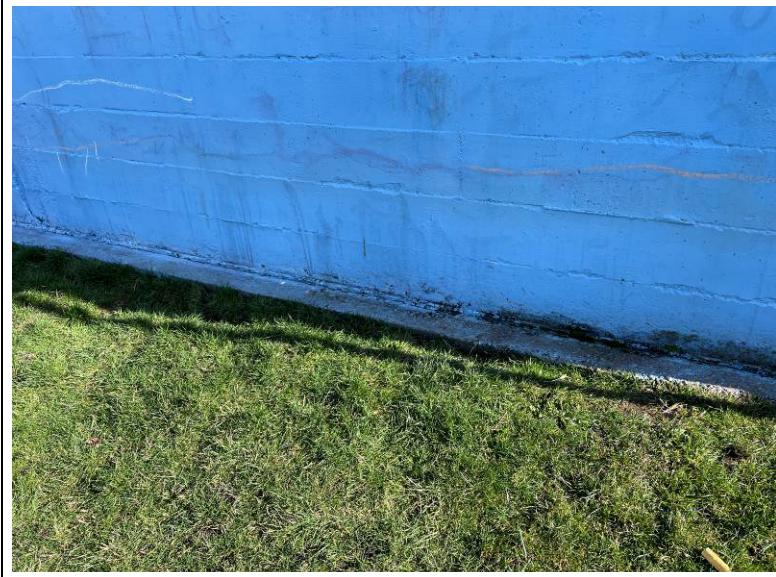
Photograph No. 9

Exterior, west wall, looking east

Top of concrete footing visible, depth undetermined.

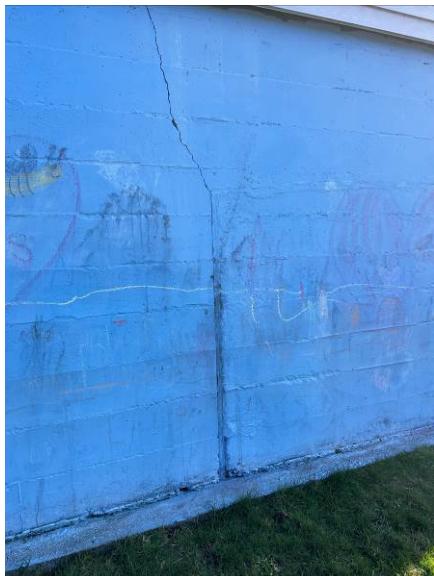
**Photograph No. 10**

Exterior, west wall, looking east

A close up of one of the cracks. The crap begins at the top of a 2x buck that has remained within the CMU wall.

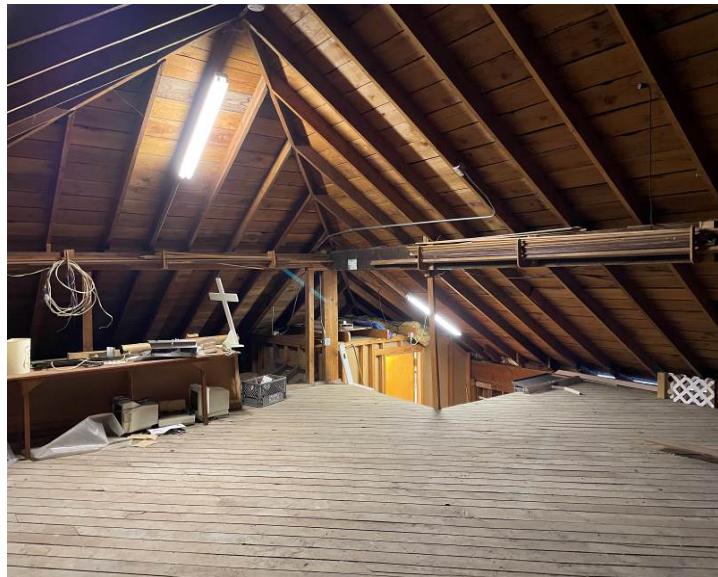
**Photograph No. 11**

Interior, attic, looking SE

Overview of 2x rafters, beam, and historic 2nd floor

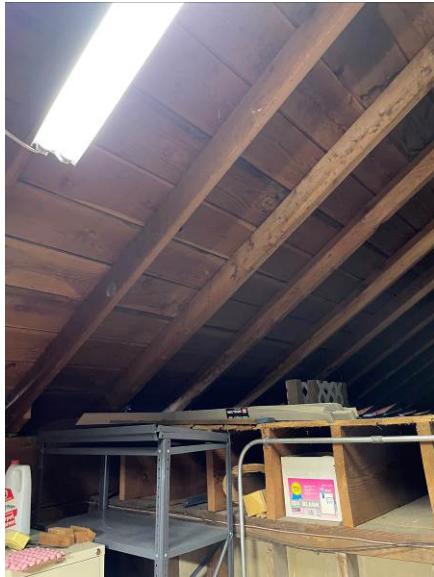
**Photograph No. 12**

Interior, attic, looking SW

Close up of 2x rafters bearing on exterior wall.

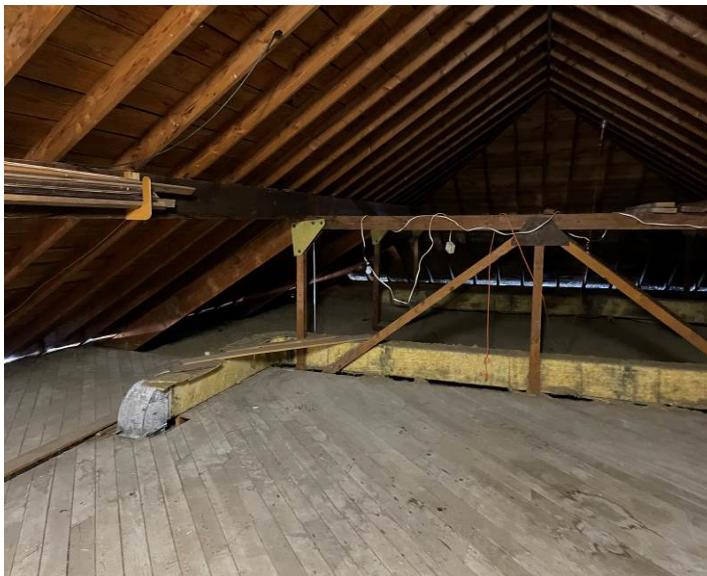
**Photograph No. 13**

Interior, attic, looking west

Site built truss. 4x members, stitch plates, and rafter beam visible

A hip roof is constructed with T&G planking on 2x rafters, hip and ridge boards to cover the entirety of the building. (Photo No. 13) Site-built trusses span north-to-south across the full width of the addition part of the building and support an east-west beam that carries the rafters at mid-span. The roof over the historic portion of the building is constructed over the existing second floor framing, forming an attic space. (Photo No. 11) The rafters, trusses and beams appeared generally to be sized appropriately and in acceptable condition.

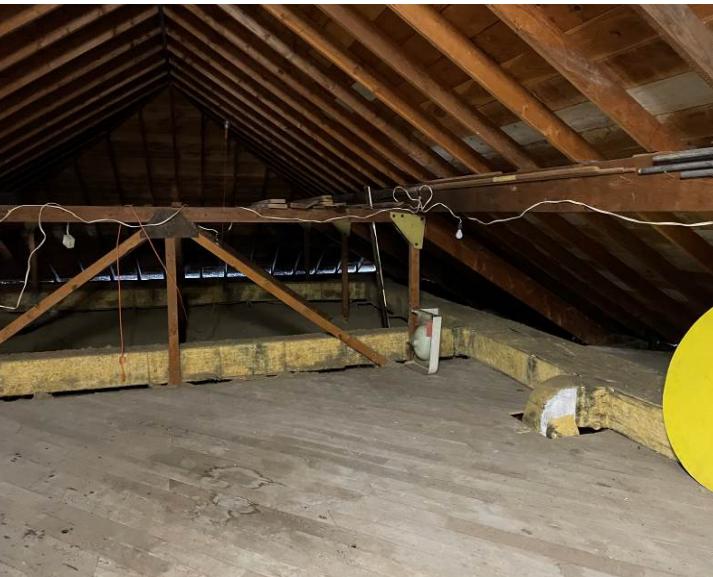
**Photograph No. 14**

Interior, attic, looking west

Site built truss. 4x members, stitch plates, and rafter beam visible. Note possible water on floor.

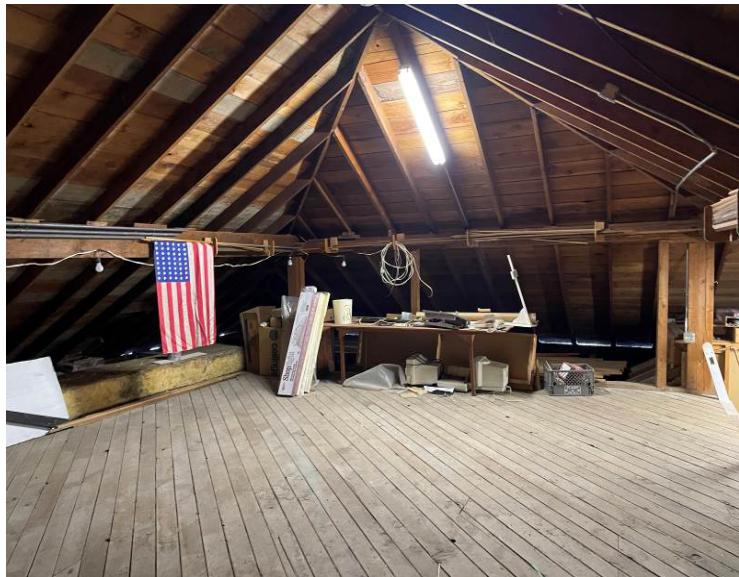
**Photograph No. 15**

Interior, attic, looking east

General condition of roof and 2nd floor over historic portion of structure.
