MASTER PLAN & PHASING PLAN

Final Master Plan

ARCHITECTURAL MEMO

Re: Masonic Lodge

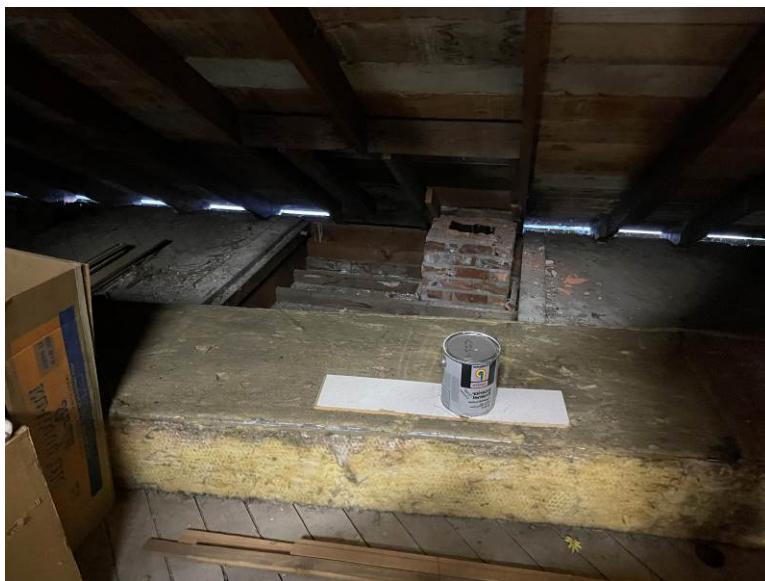
**Photograph No. 16**

Interior, attic, looking north

Existing brick chimney

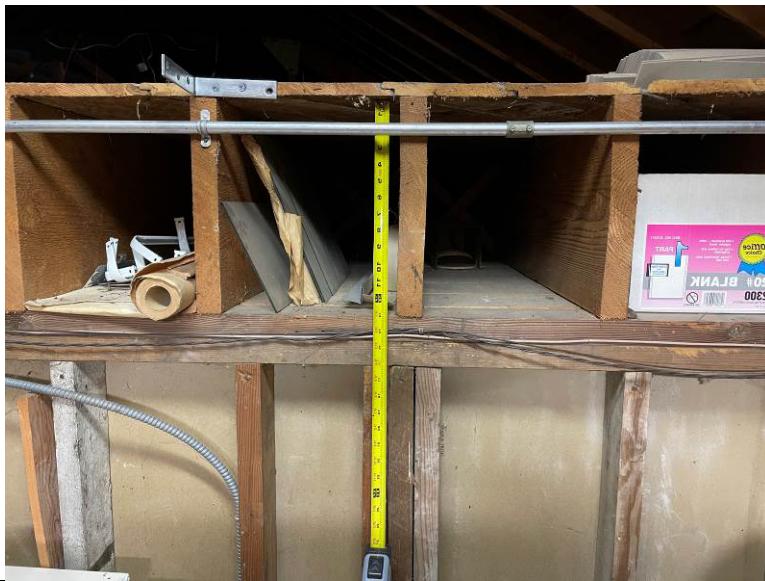
**Photograph No. 17**

Interior, attic, looking west

Typical 1x T&G decking on 2x14 2x14 floor joists at 12" oc. Interior 2x bearing wall below.

The 2nd floor framing of the historic structure is comprised of 2x14 joists @ 12" oc, generally in good condition. (Photo No. 17) The floor sheathing and joists did not extend to the exterior walls of the historic structure. At the historic side, the area between the 2nd floor and the exterior wall is generally built with smaller 2x ceiling joists above the entry area. On the new side, no floor exists, and the ceiling below is supported by the site-built trusses.

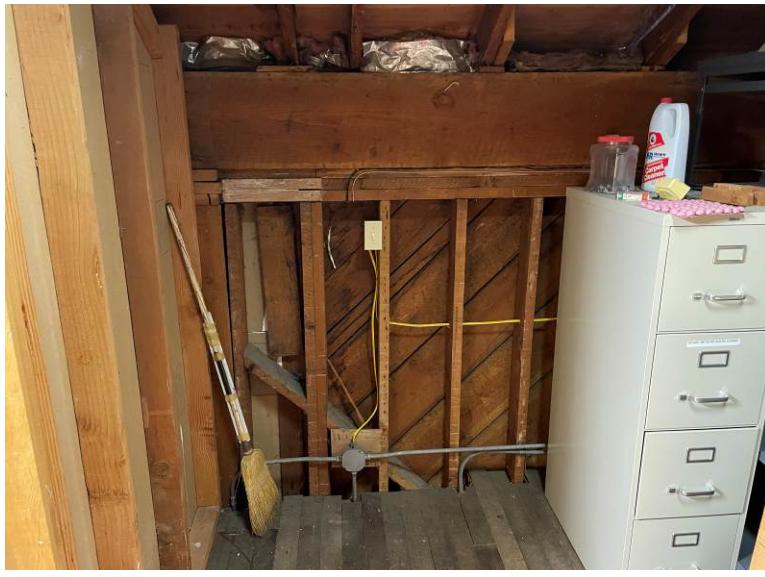
**Photograph No. 18**

Interior, attic, looking south

Rafters bearing on 14" continuous rim beam. Exterior diagonal sheathing visible on typical 2x studs. 14" x continuous rim.

The historic structure exterior wall is built with diagonal 2x planking on 2x studs @ 16" oc. (Photo No. 18) The exterior wall of the addition was not immediately available but appeared to be similar. The historic foundation is built with poured concrete walls, the addition is built with CMU. (Photo No. 1) The concrete has various cracks and chips. There is evidence of a leak in the southeast corner, as observed in the crawlspace. The CMU foundation has several cracks; reinforcement is undetermined. (Photo No. 8)

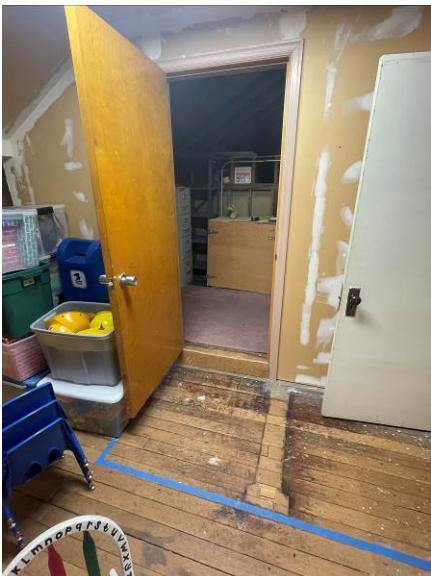
**Photograph No. 18**

Interior, entrance to attic, looking west

Typical interior condition

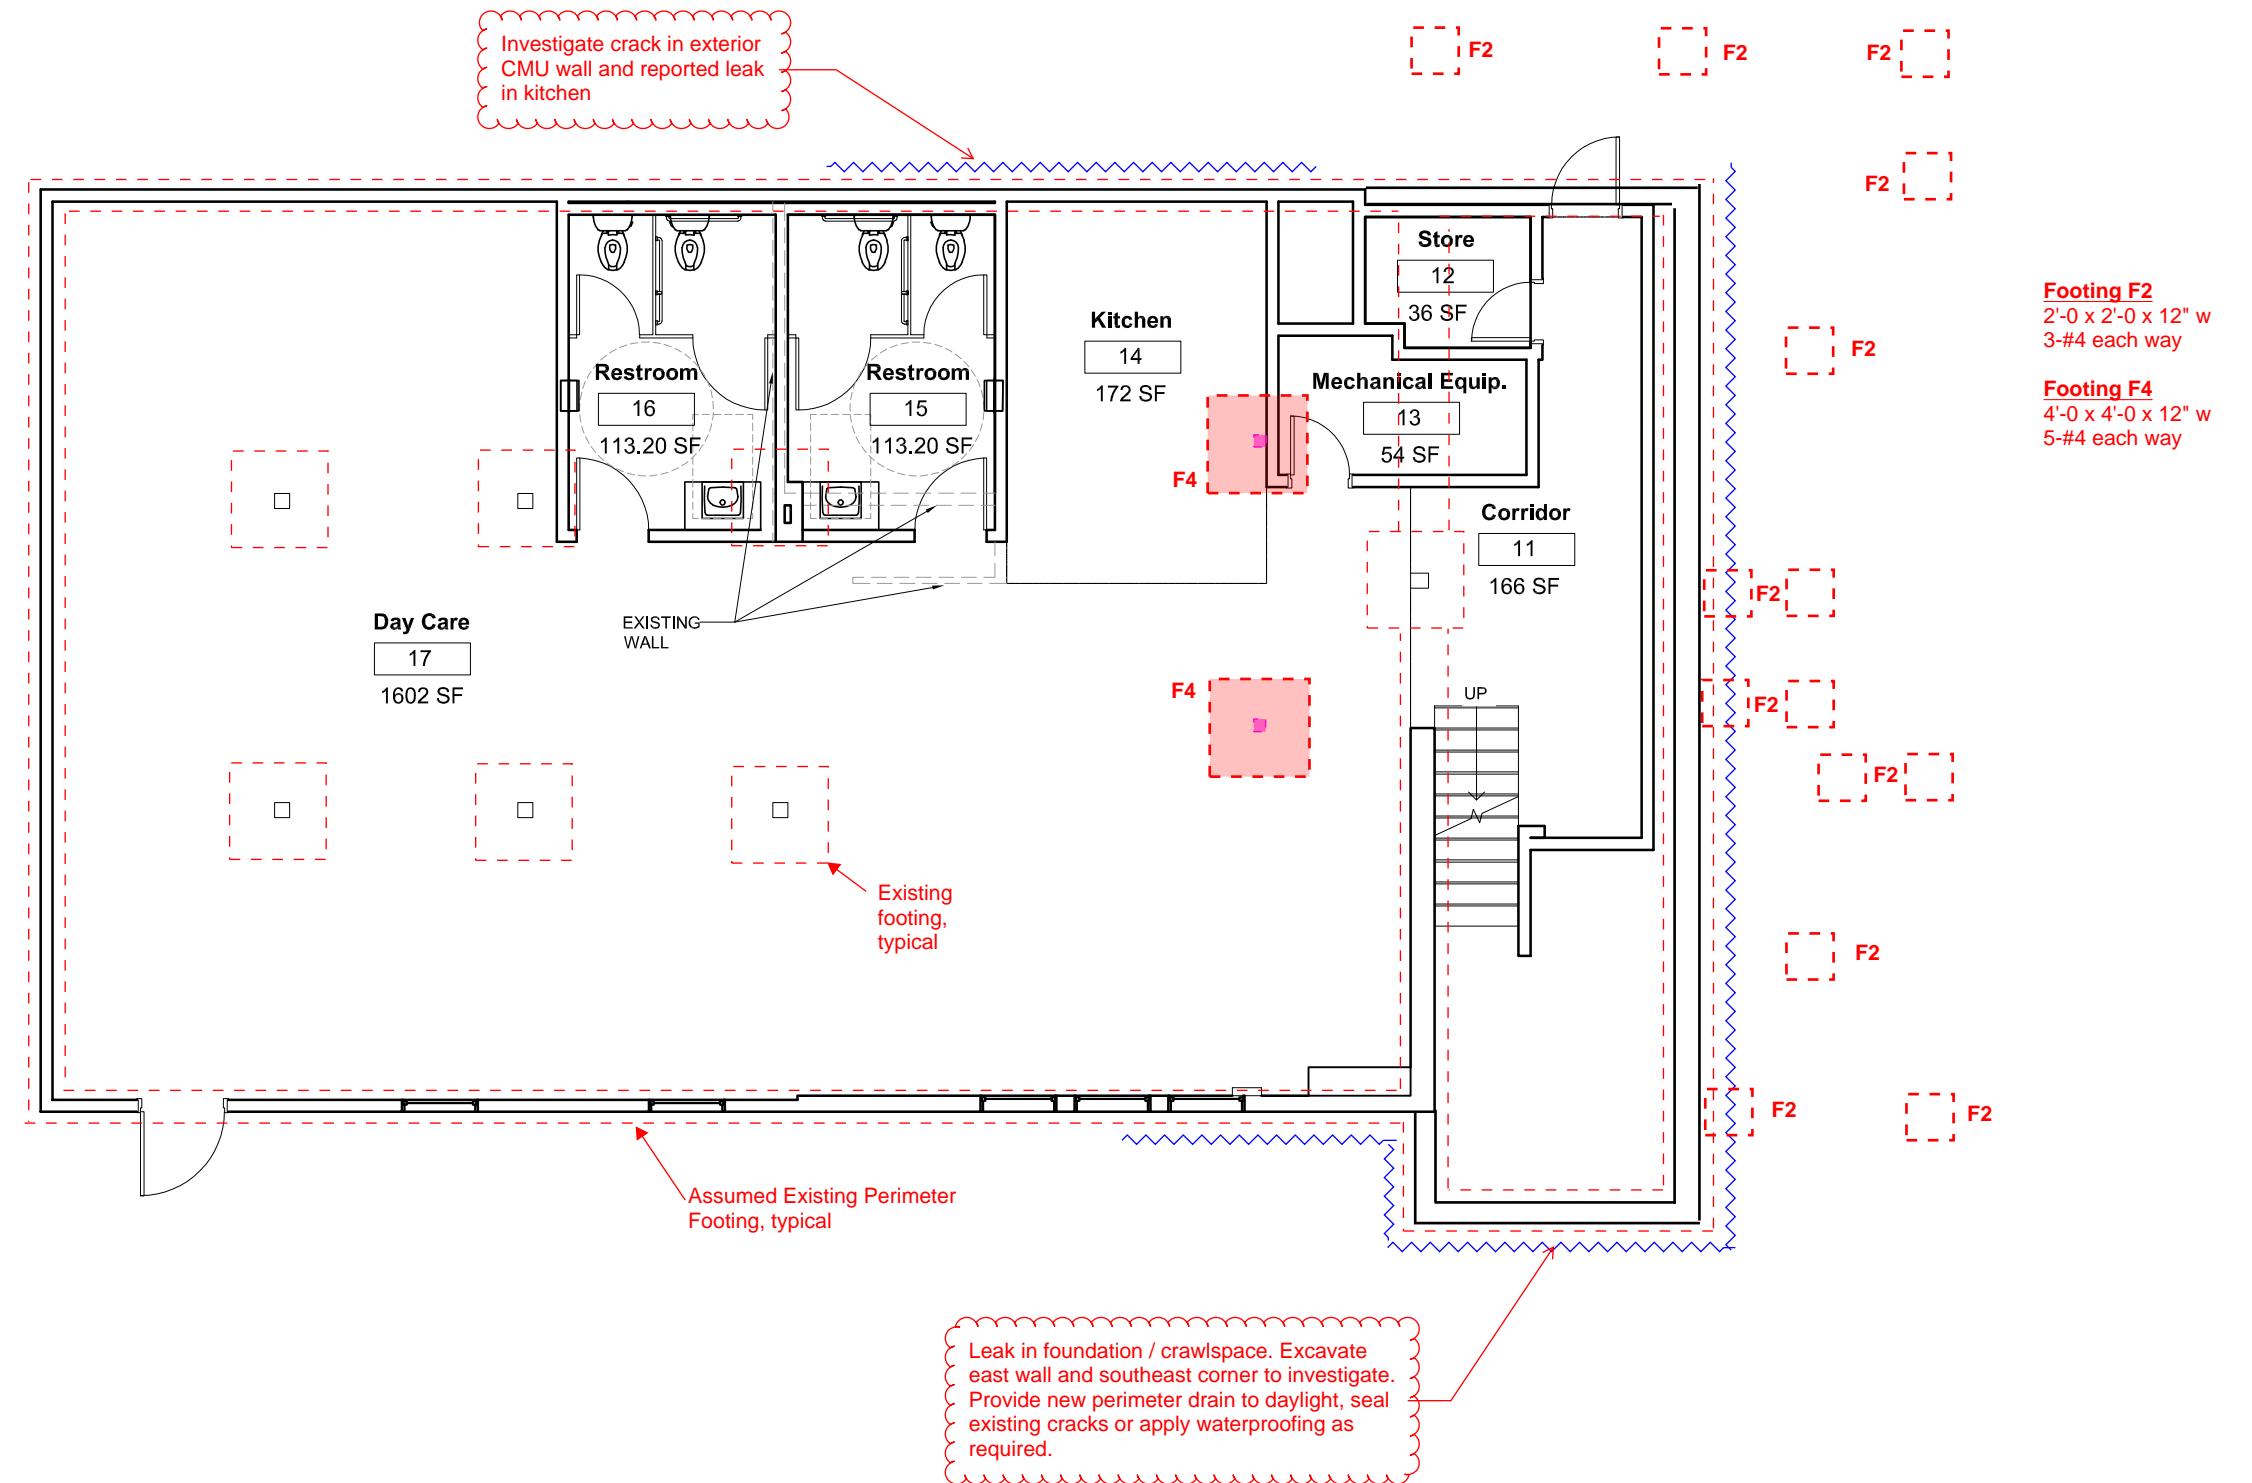
FOUNDATION PLAN

Existing structural framing components to remain, unless noted otherwise

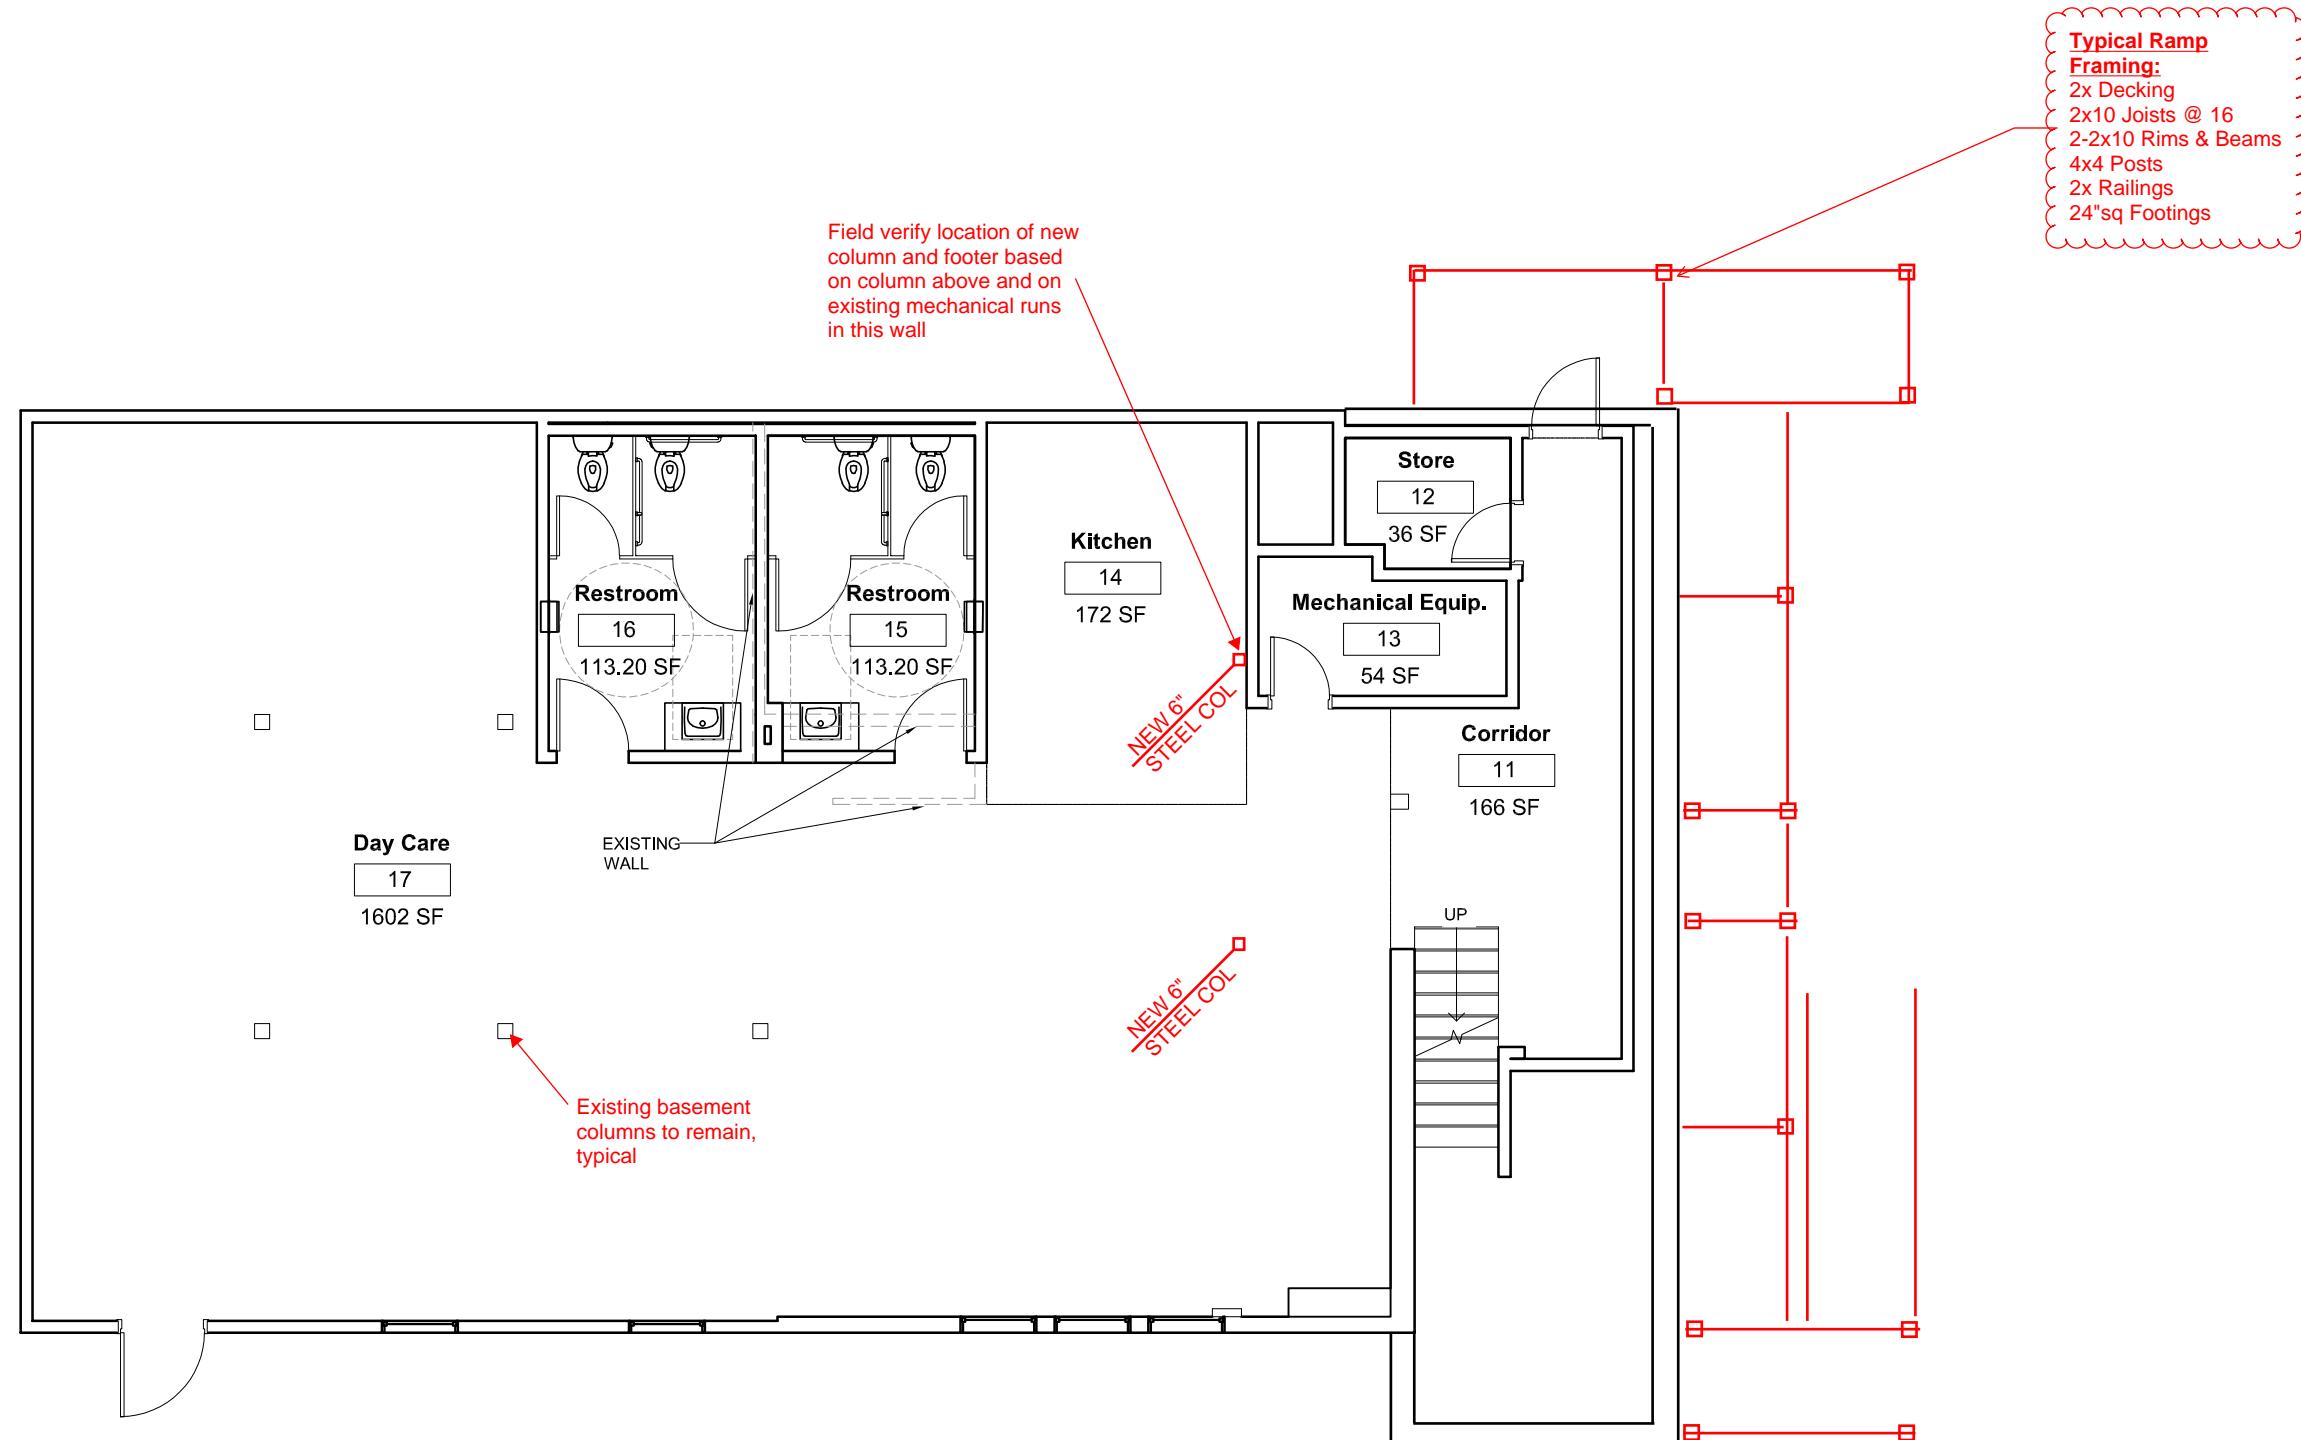
MAIN FLOOR FRAMING PLAN

Existing structural framing components to remain, unless noted otherwise.

The first floor, both the historic portion and the added portion, were not exposed, but appeared to be similarly sized to the 2nd floor. (Photo No. 18) The joists spanned between beams, which were in turn supported on posts. The floor appeared sturdy, with no apparent sags, bounce, or soft spots. The floor plan in Appendix A outlines the location and sizes of the posts and beams.

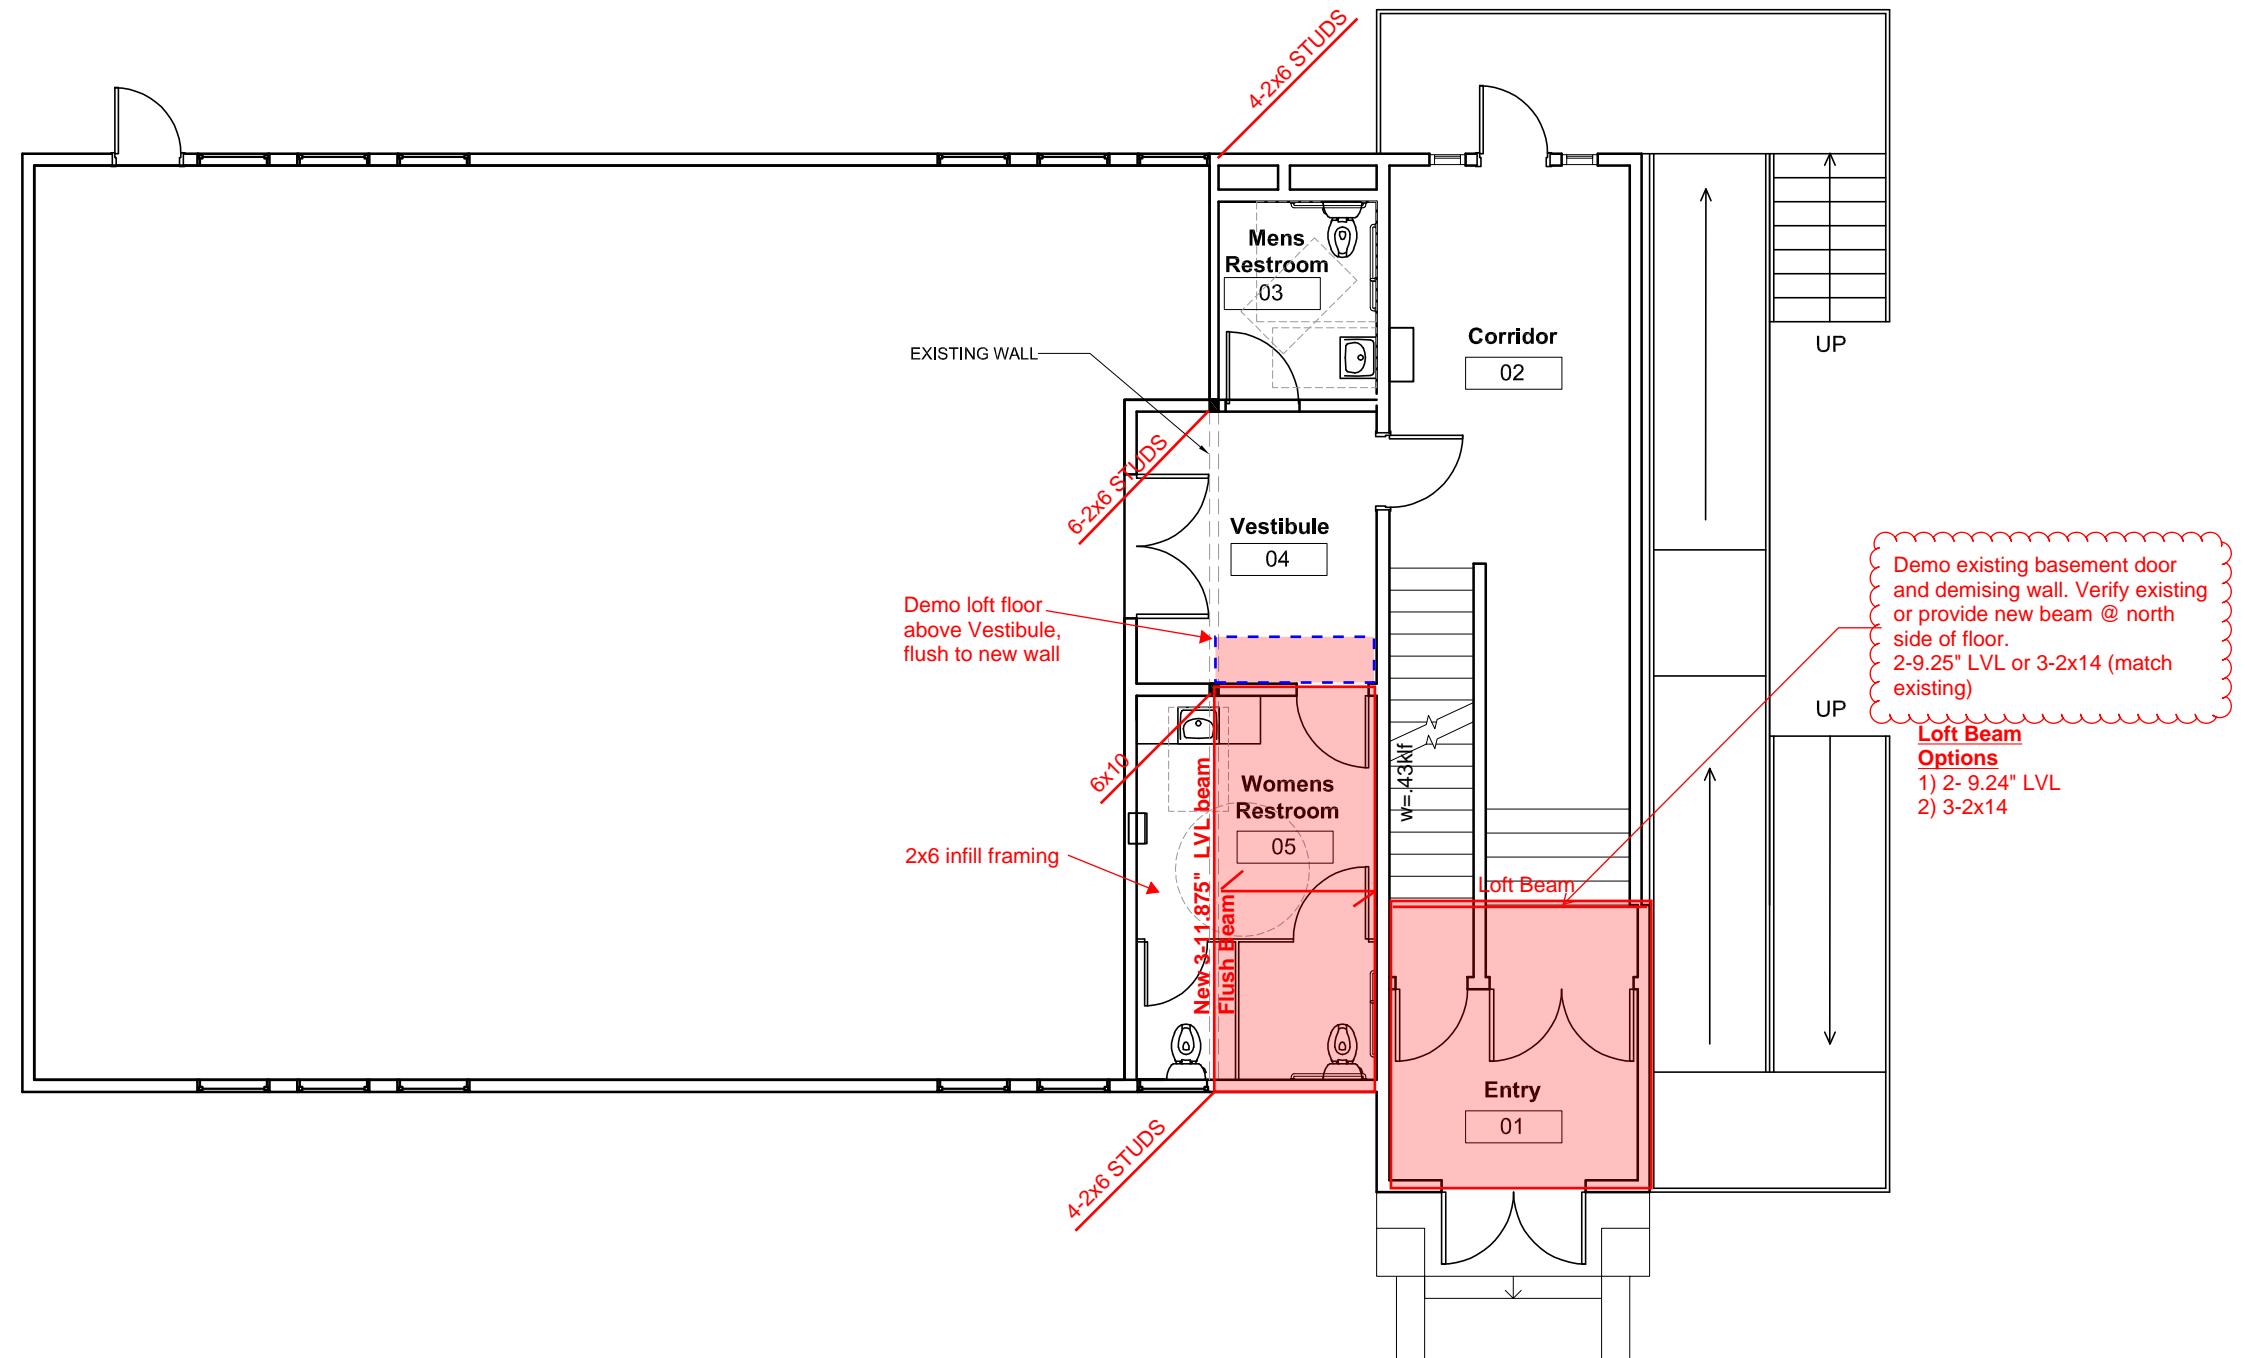
SECOND FLOOR FRAMING PLAN (INSET)

Existing structural framing components to remain, unless noted otherwise.

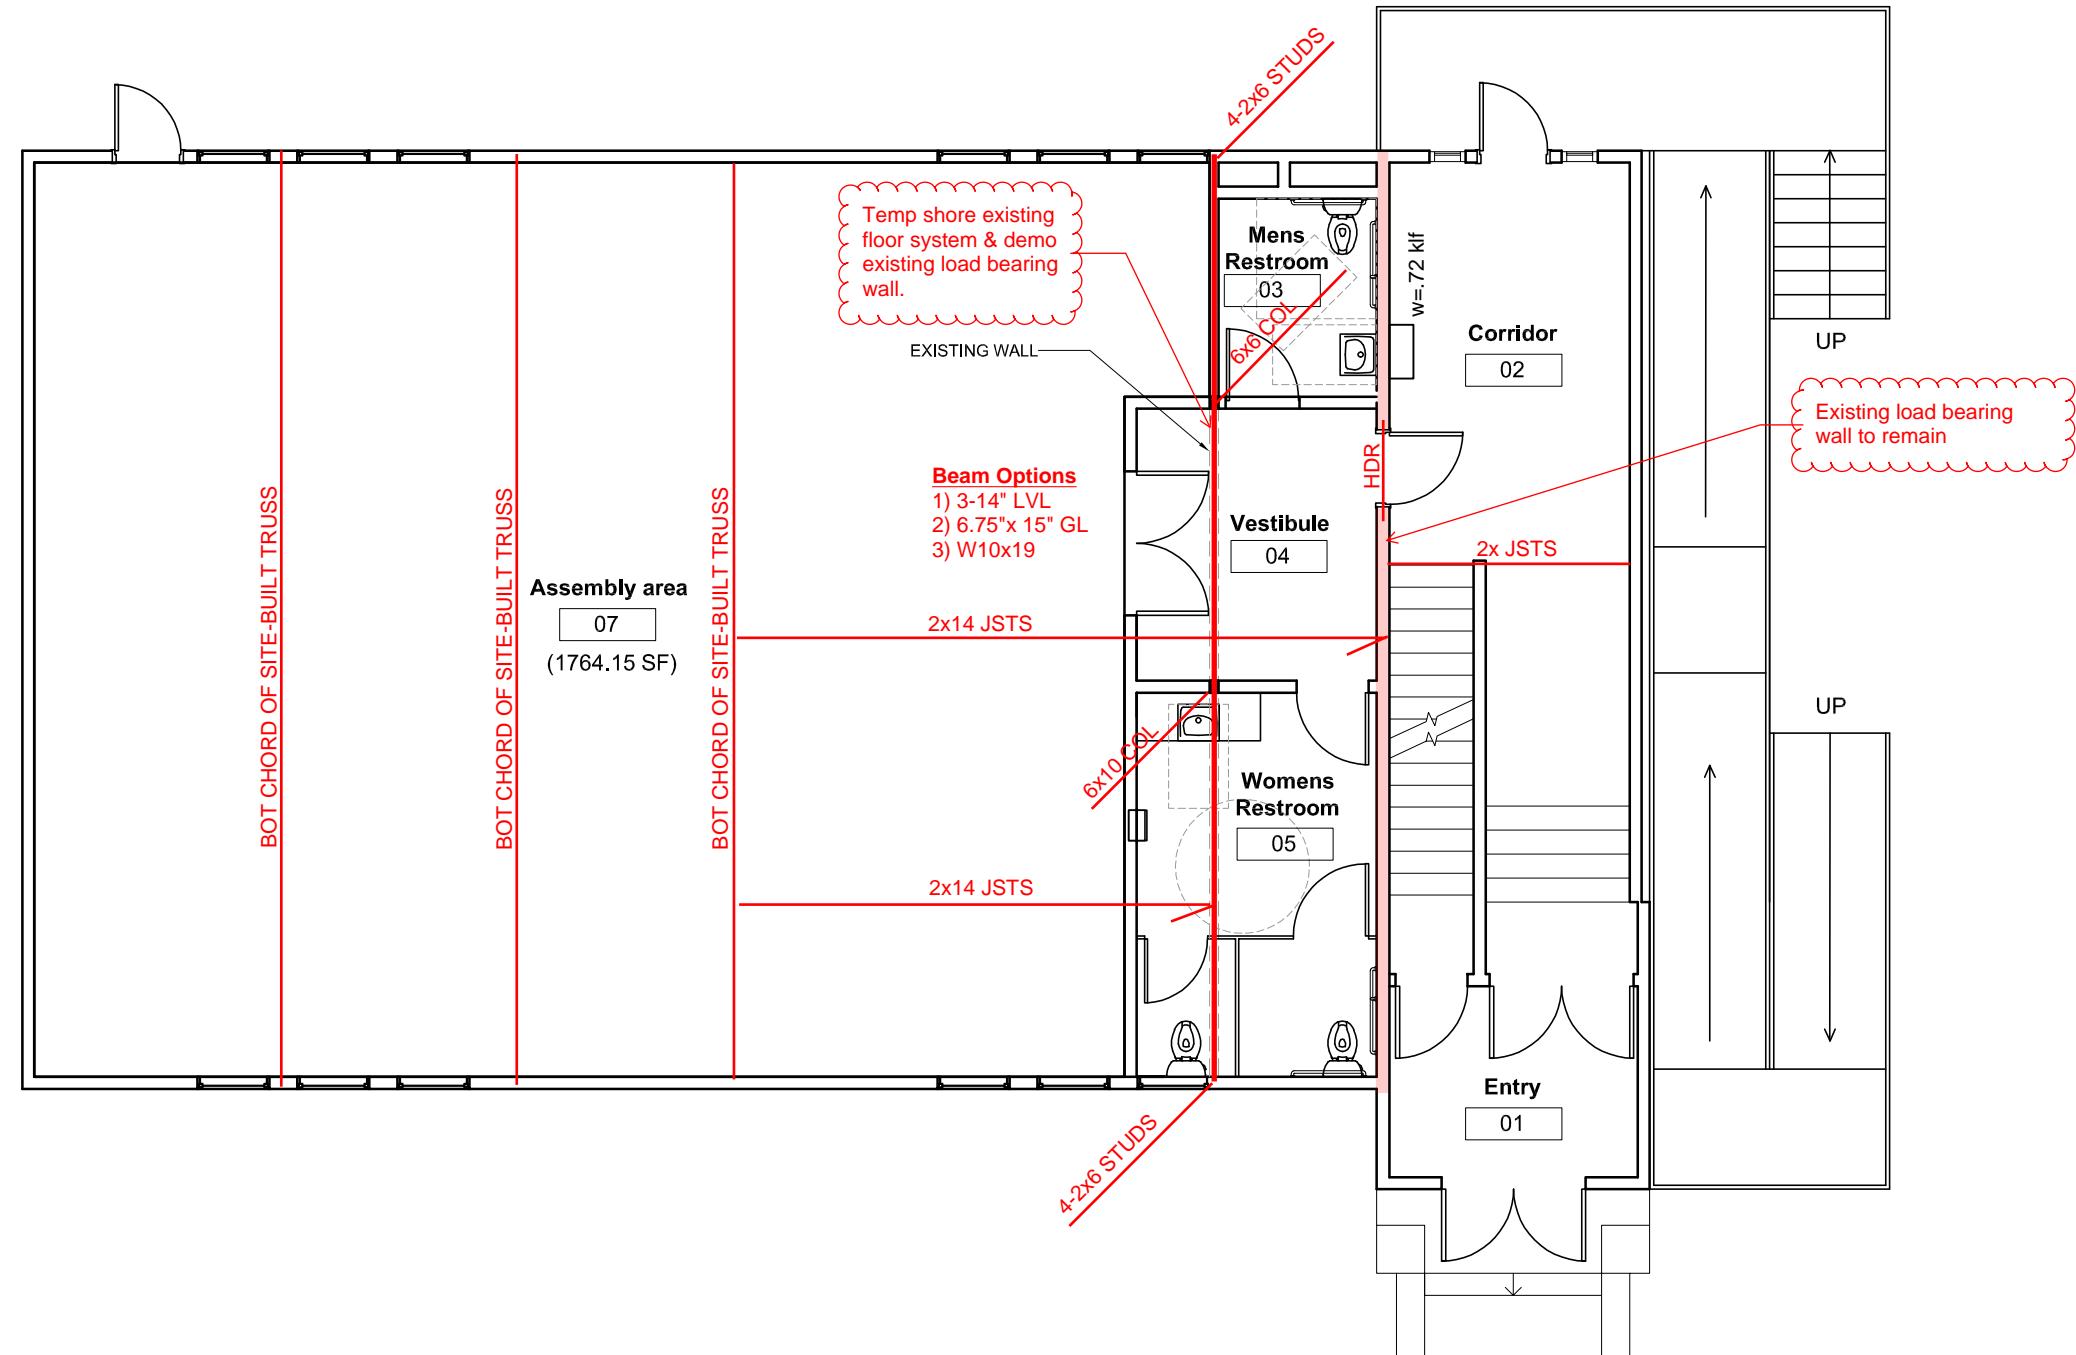
SECOND FLOOR FRAMING PLAN

Existing structural framing components to remain, unless noted otherwise.

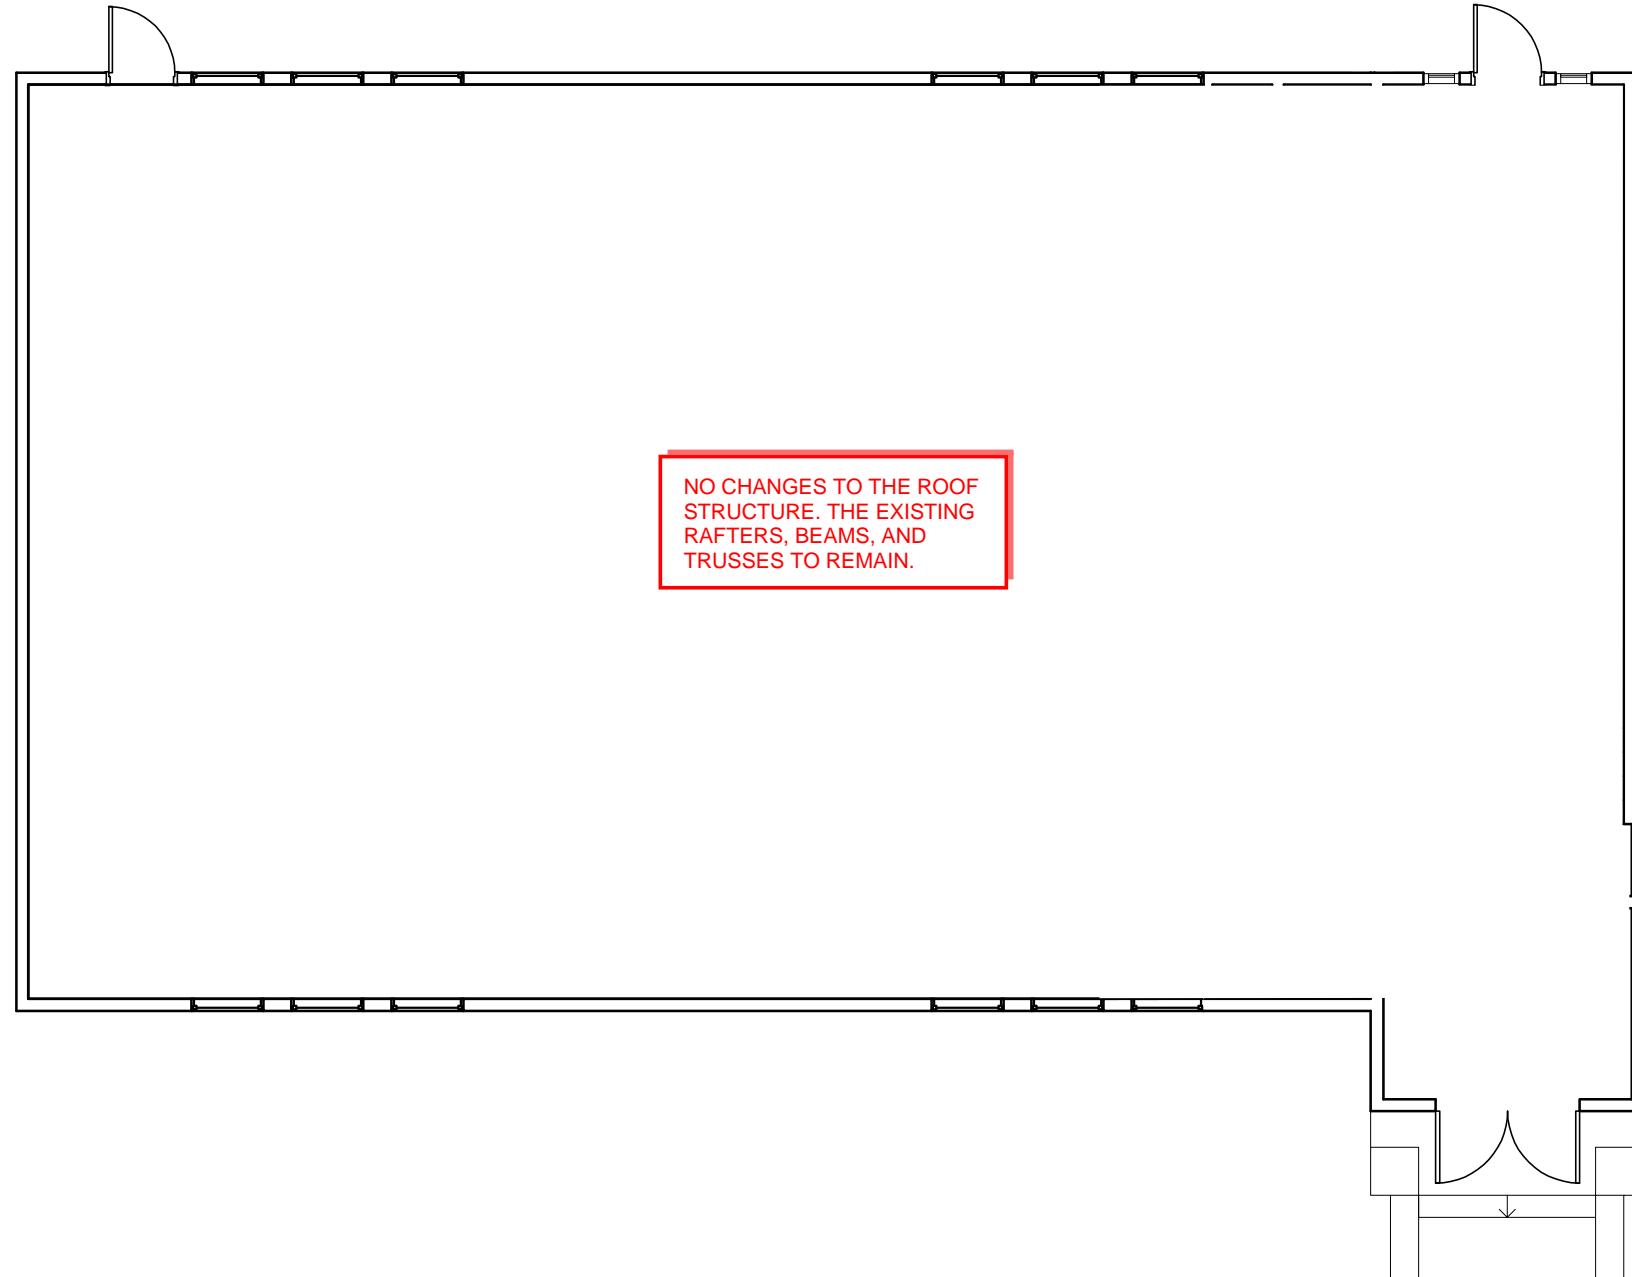
ROOF FRAMING PLAN

Existing structural framing components to
remain, unless noted otherwise.

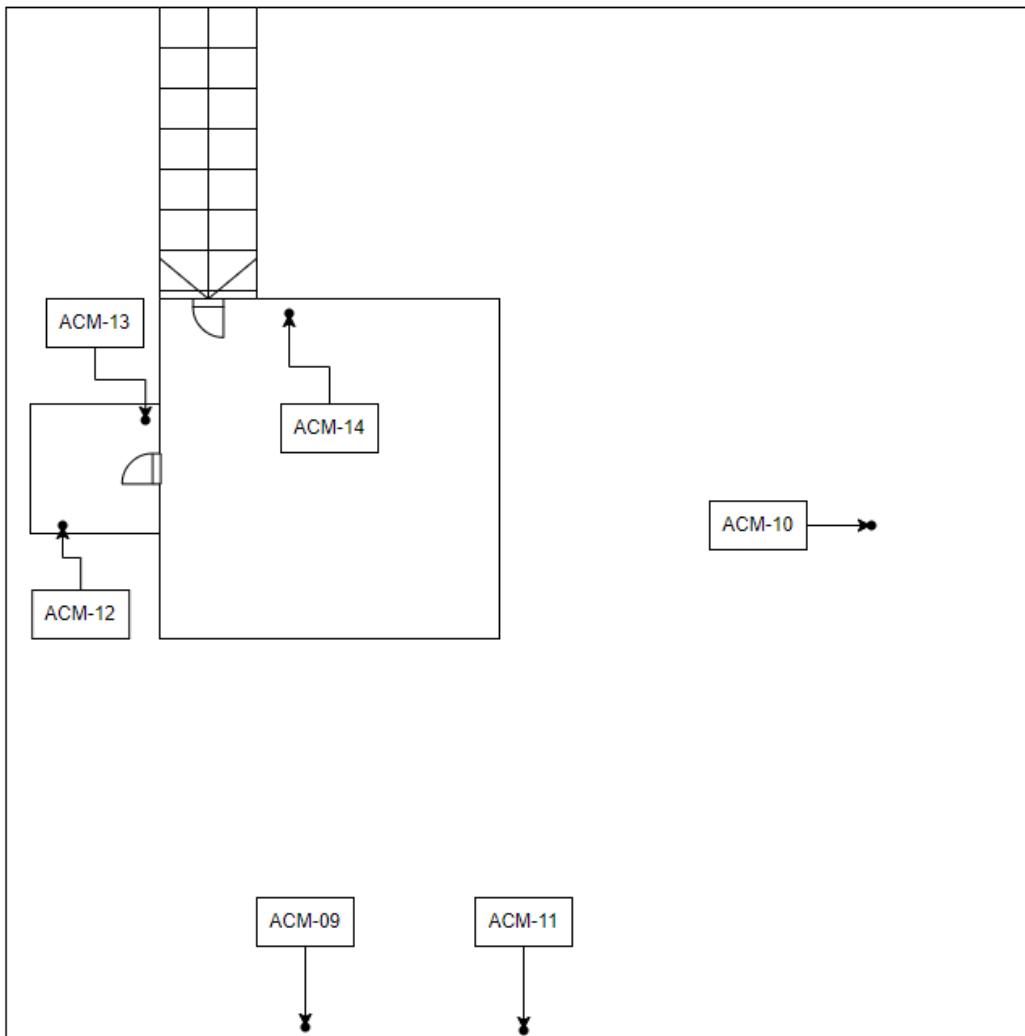
Figure 3 Sample Locations: Attic Lead Paint & Asbestos Assessment

Asbestos Assessment Attic	Figure 3 Sample Locations	Key: <ul style="list-style-type: none"> • Sample Locations Red = Positive Test Result <p>*Not to scale</p>
By: Brian Johnson AHERA Building Inspector	Site Address: 3025 96 th Street Gig Harbor, WA 98332

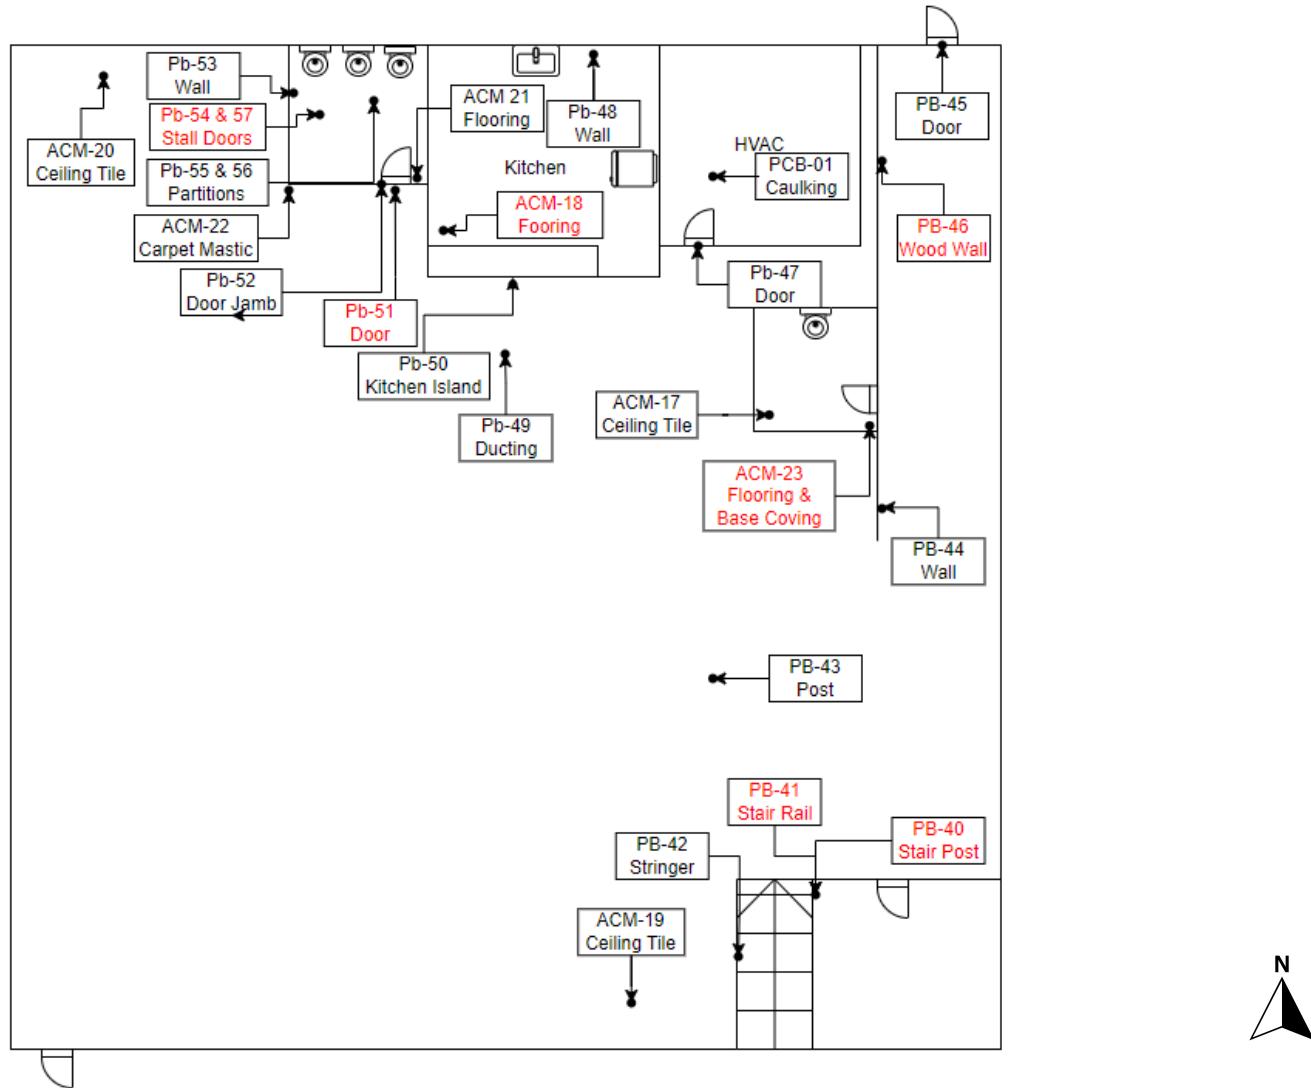
Figure 4 Sample Locations: Basement Lead Paint & Asbestos Assessment

Lead Paint & Asbestos Assessment Basement	Figure 4 Sample Locations	Key: • Sample Locations Red = Positive Test Result *Not to scale
By: Brian Johnson AHERA Building Inspector	Site Address: 3025 96 th Street Gig Harbor, WA 98332

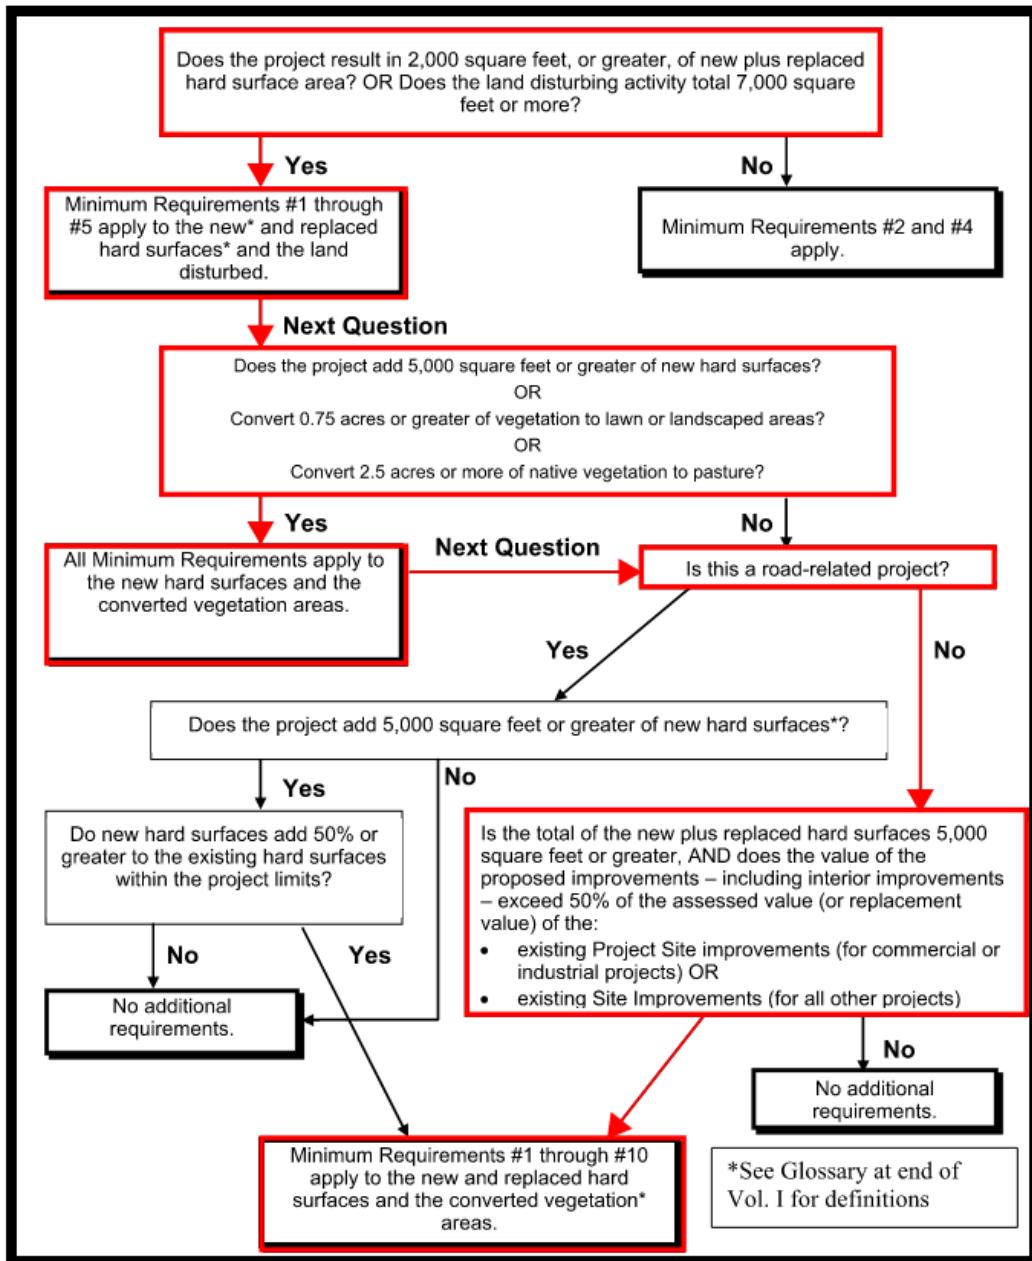
Figure 3-1 GHSWMM Minimum Requirement Flow Chart

Figure 2.2. Flow Chart for Determining Requirements for Redevelopment.

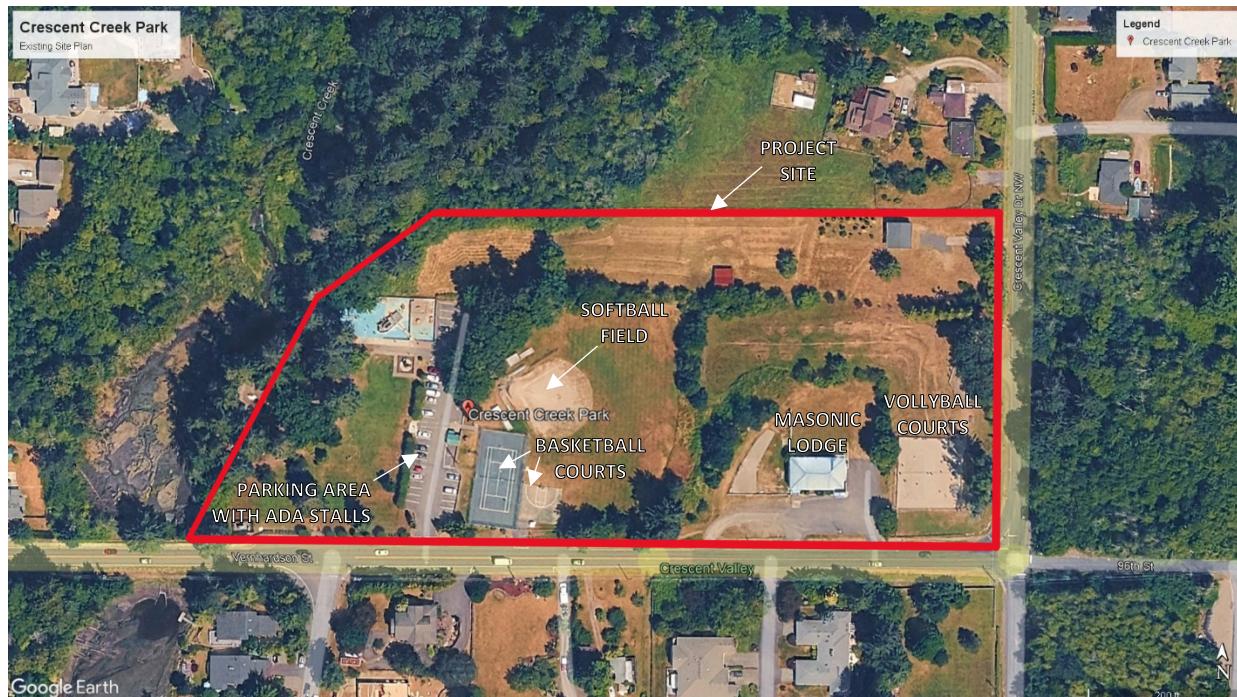
Figure 1: Existing Site Plan

The Park is situated between Crescent Valley Drive and Vernhardson Street in Gig Harbor, WA. The existing park contains a few amenities and buildings including volleyball courts, a basketball and tennis court, the Masonic Lodge, a small restroom building, some park shelters, and a small playground. See Figure 1 below showing the existing site.

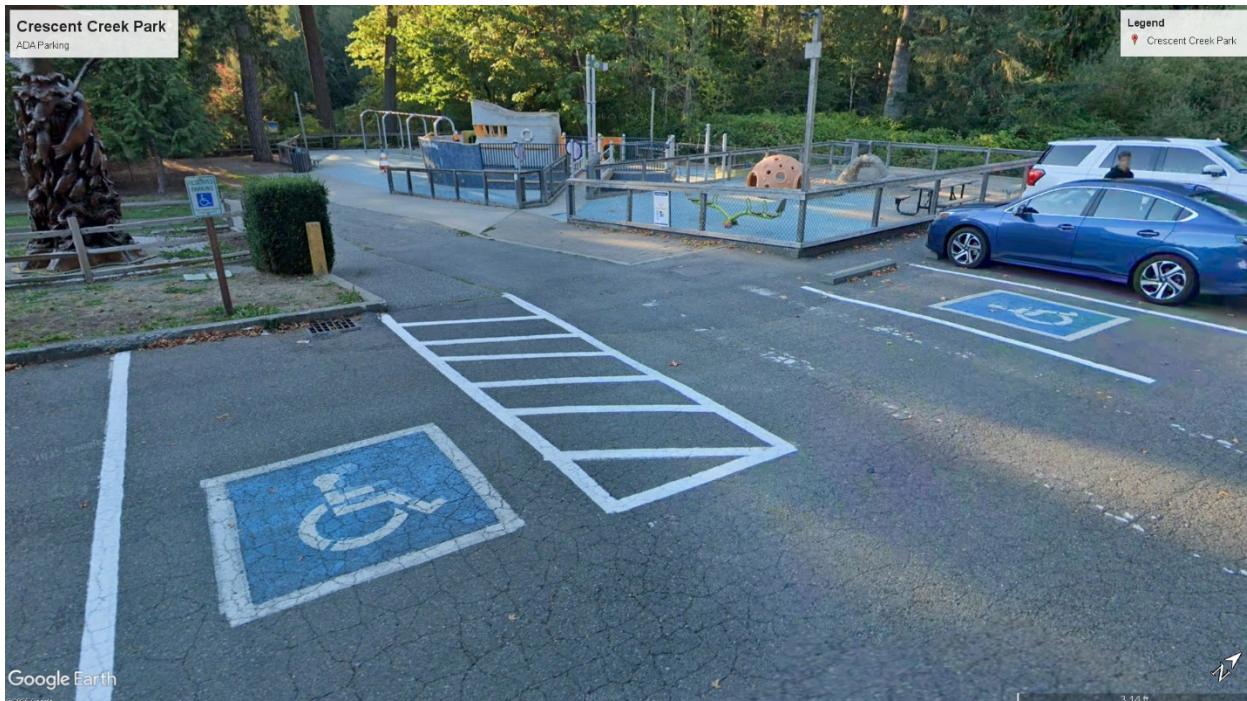
Figure 2: ADA Parking Stalls

The existing parking lot on the western side of the park includes two marked ADA parking stalls; however, neither stall is designated as van-accessible. An access aisle is provided only adjacent to the southernmost ADA stall, while the northernmost ADA stall lacks a required access aisle. At least one of the ADA stalls should be designated as van-accessible to meet accessibility standards. Figure 2 illustrates the existing ADA parking configuration within this parking lot.
