MASTER PLAN & PHASING PLAN

Final Master Plan

ARCHITECTURAL MEMO

Re: Masonic Lodge

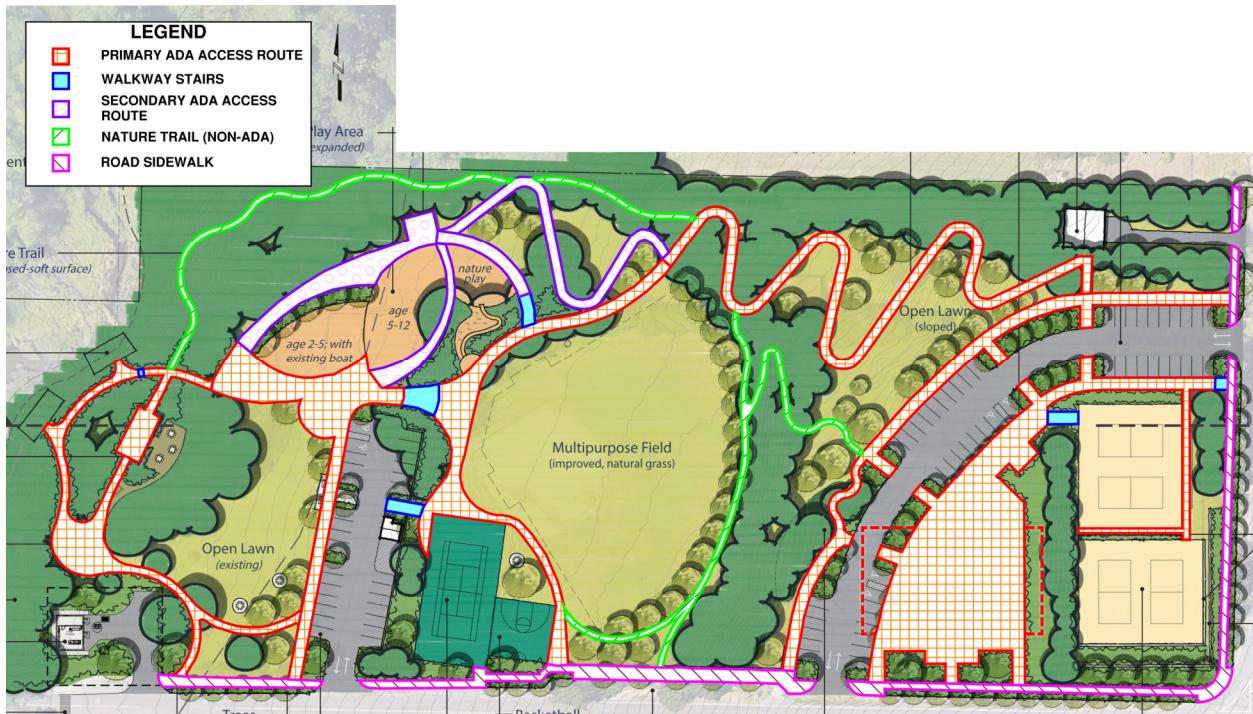
Figure 6: Proposed Site Walkways

A network of new sidewalks and trails is proposed throughout the site. The Primary Trail is located along the northern edge of the park and follows a gently sloping alignment that traverses the existing topography. This alignment was selected to minimize grading and the need for extensive ramping while maintaining ADA-compliant slopes. The Primary Trail provides accessible connections from the eastern parking lot to the multipurpose field, basketball courts, tennis and pickleball courts, play areas, and the western parking lot. See figure 6 for a summary of the proposed accessible walkways.

Frontage improvements along Verhardson Street and Crescent Valley Drive include new sidewalks and landscaping. Based on analysis of the existing grades along the eastern (Crescent Valley Drive) and southern (Verhardson Street) edges of the park, slopes for the proposed sidewalk would exceed allowable ADA slopes for both ADA compliant sidewalks (5%) and ramps (8.33%). Due to the steep slopes, an ADA variance will be needed to construct the sidewalks along the southern and eastern edges of Crescent Creek Park.

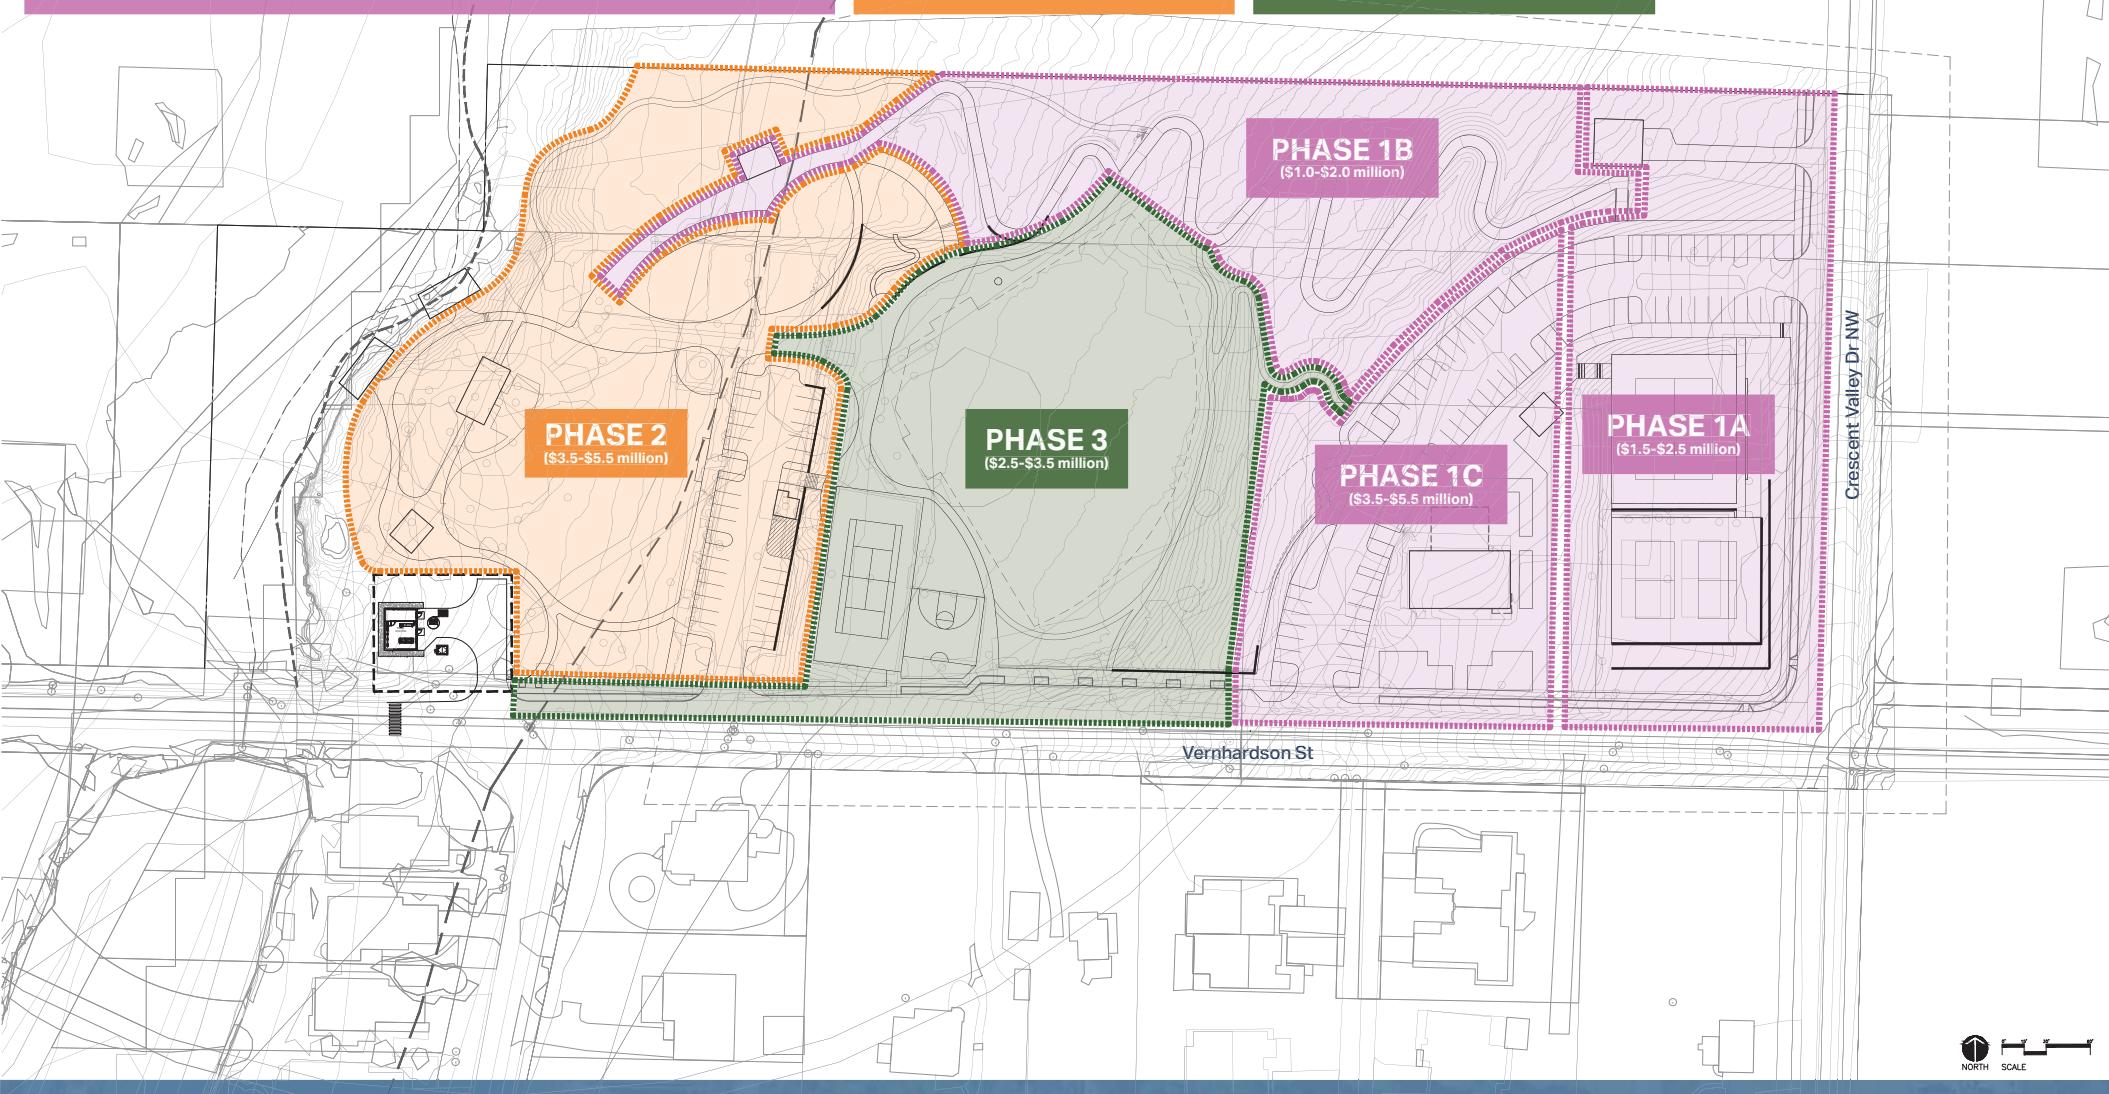
Preliminary Phasing & Construction Budget

Phase 3 includes a renovated multipurpose field, expanded stairs to the lower terrace, nature trail connection to the upper terrace, gathering areas, and remaining required right-of-way improvements.

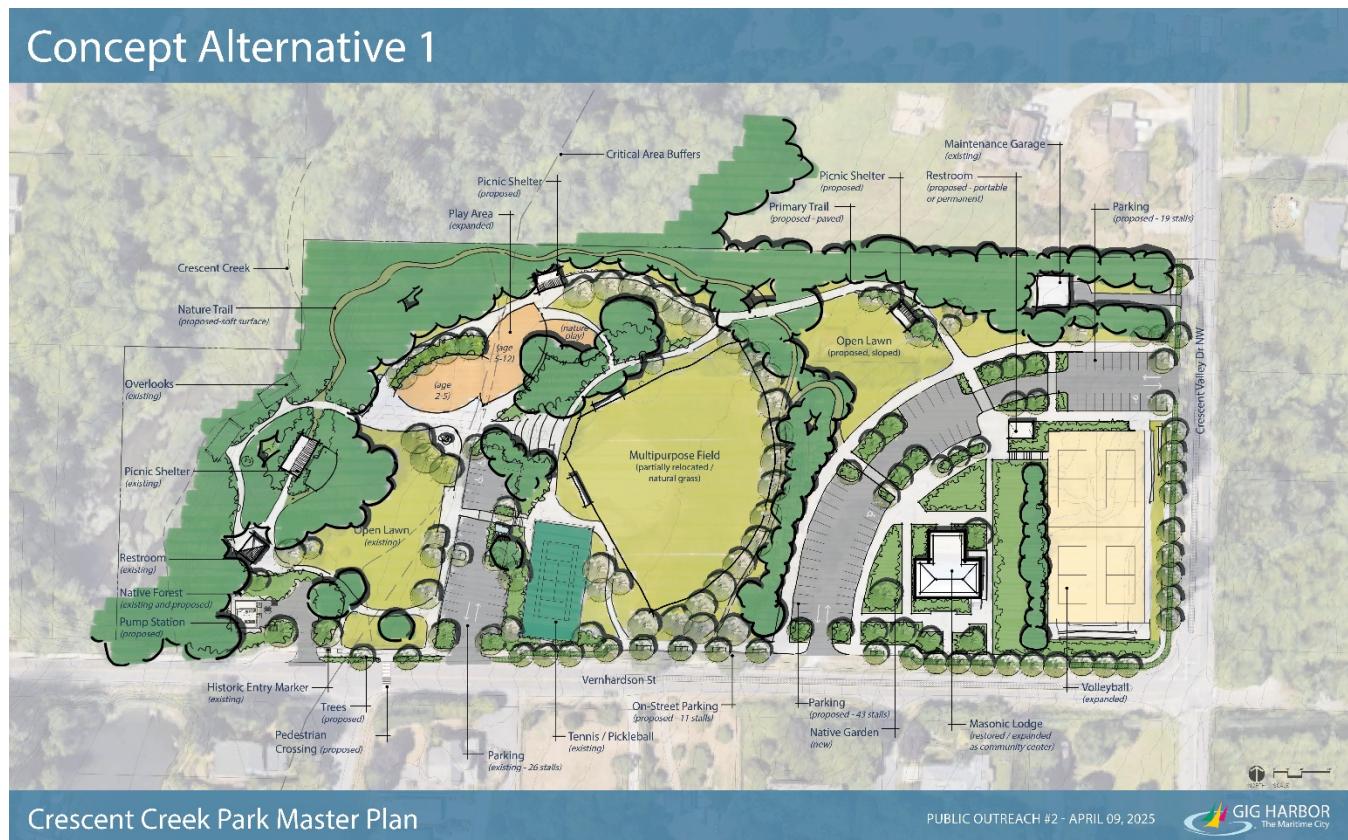
CONCEPT ALTERNATIVE 1

Concept Alternative 1 primarily enhances or expands the existing park features. This concept expands the playground to include nature and hillside play features. A terraced, expanded pedestrian connection is created between the ballfield area and the lower lawn to provide opportunities for community gathering or small events. Concept Alternative 1 has more new parking stalls compared to Concept Alternative 2, but less than Concept Alternative 3. The cost for construction is likely less for this concept as compared to other alternatives.

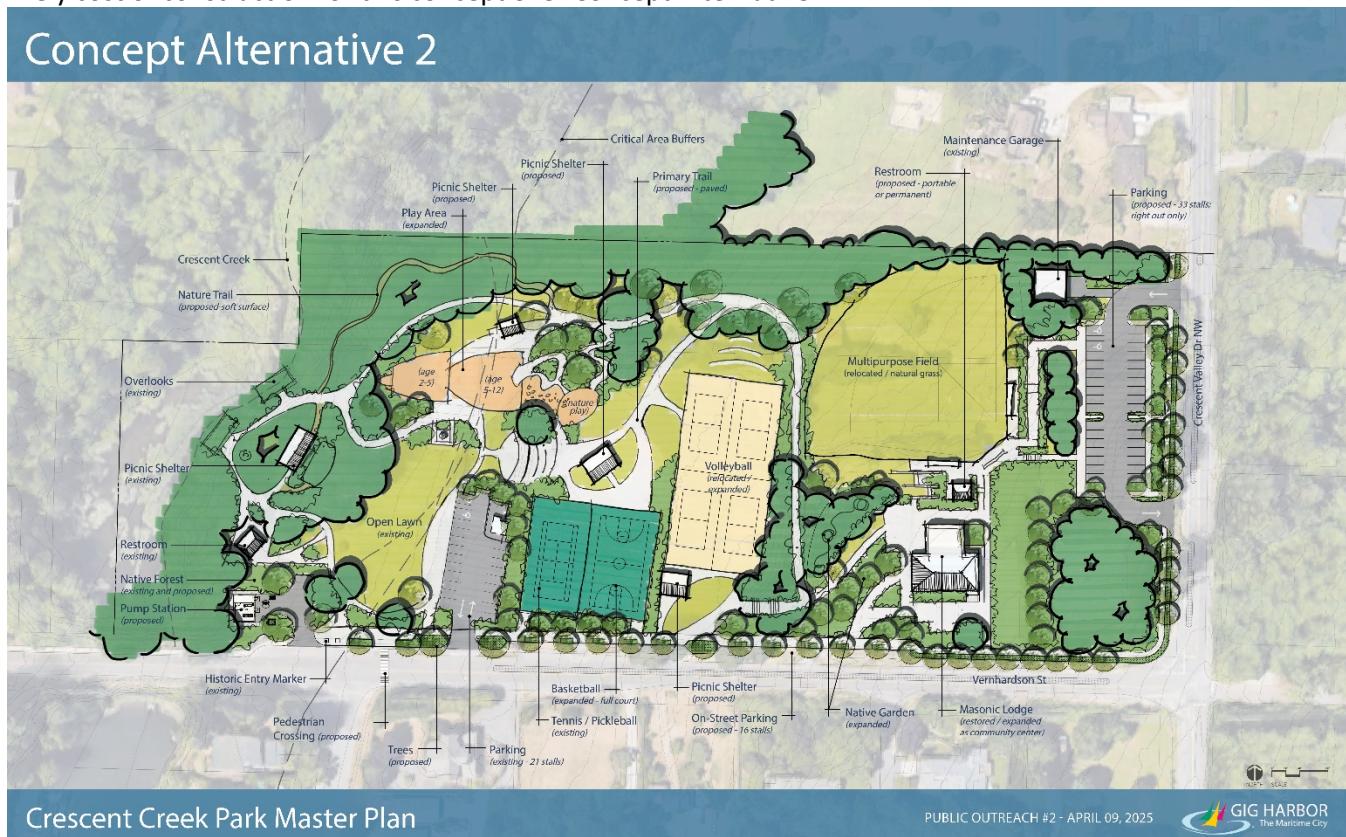
CONCEPT ALTERNATIVE 2

Concept Alternative 2 relocates the existing ballfield to the east and consolidates the tennis court, pickleball courts and a full-size basketball court in the central area of the park. A series of ramps and stairs will be needed to ensure ADA access to all areas of the park. The playground is expanded to include nature and hillside play features with a small gathering space connecting the new court area to the lower lawn, similar to Concept Alternative 1. This concept has the least number of new parking stalls and least number of trails compared to other concepts. Significant grading and new walls would be needed on the east half of the park, increasing the likely cost of construction for this concept over Concept Alternative 1.

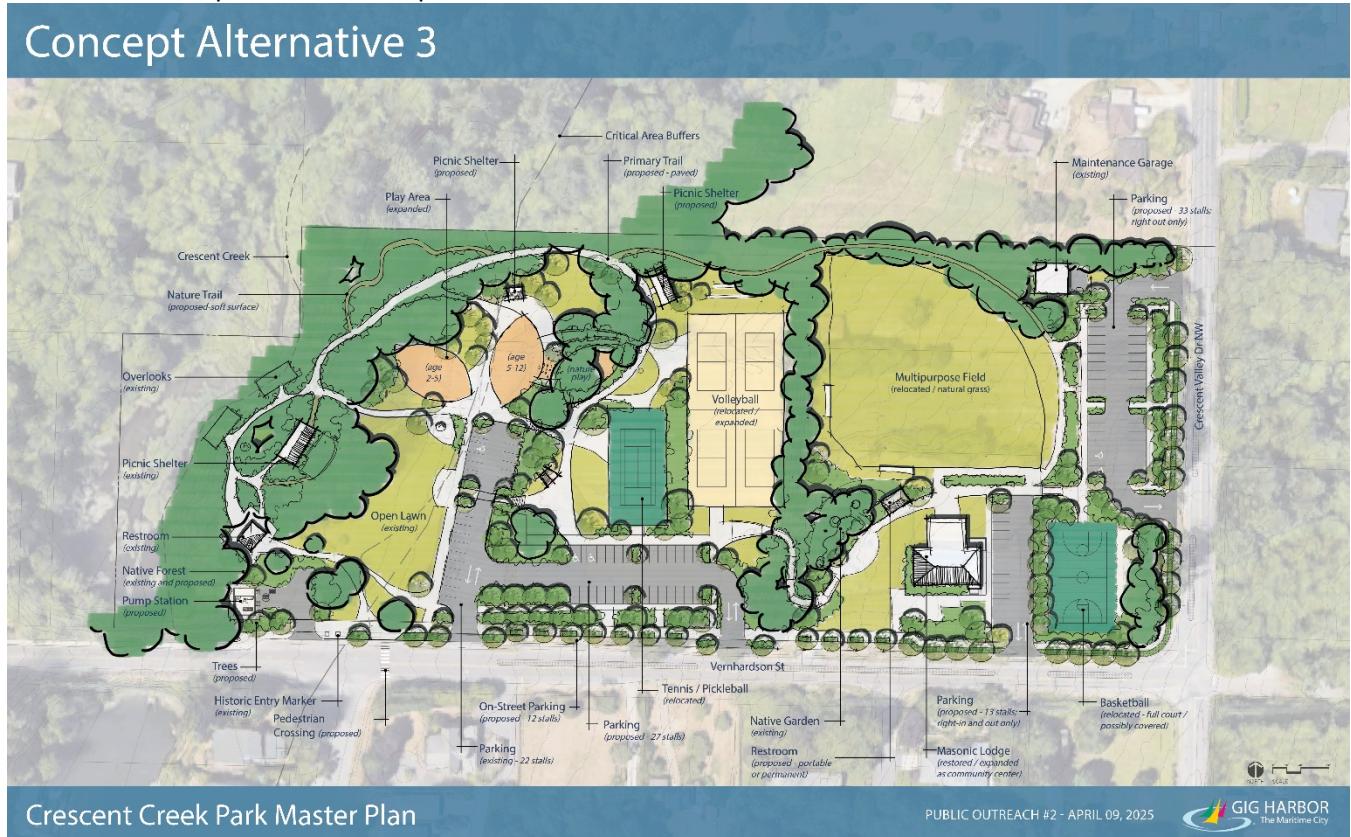
Concept Alternative 3 relocates the existing ballfield to the east. The playground is expanded to include nature and hillside play features. A new covered basketball court is also included. This concept has the most new parking stalls, the most new trails, and the largest playground also adding nature and hillside play features. Significant grading and new walls would be needed on the east half of the park with the likely cost of construction comparable to Concept Alternative 2.

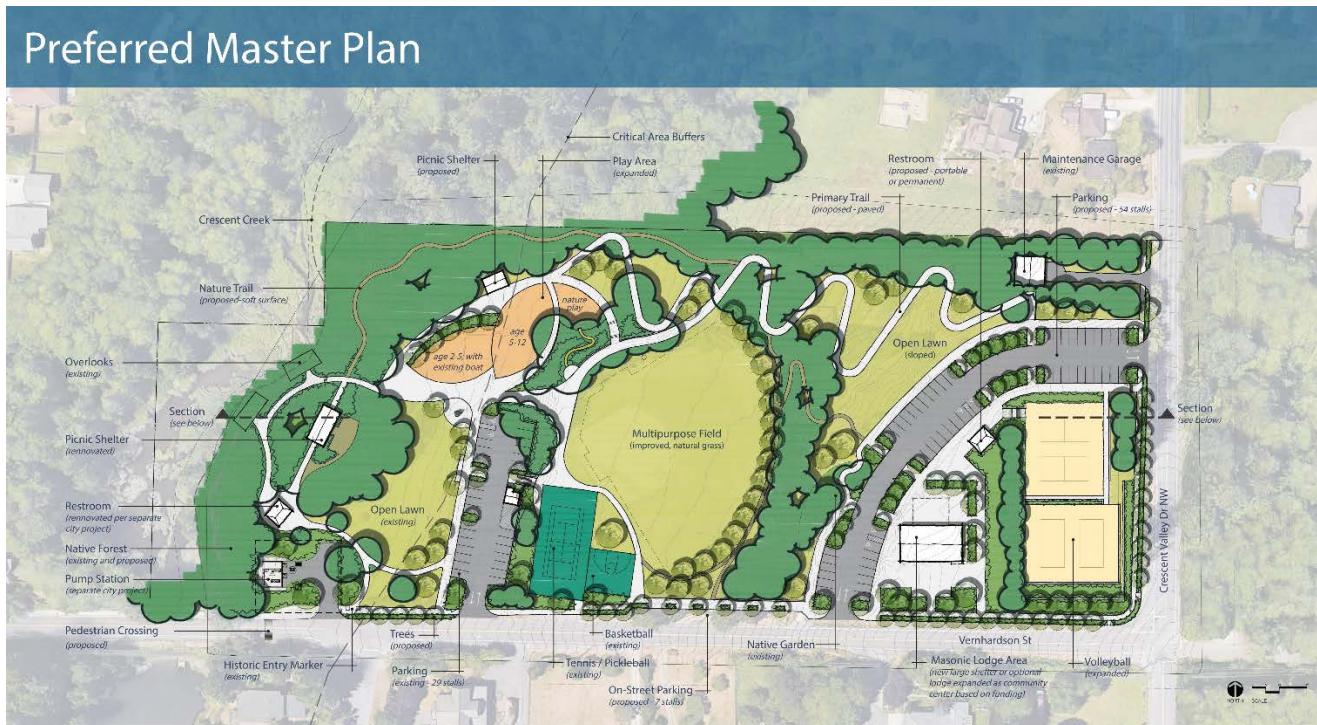
The Preferred Master Plan keeps the existing ballfield and courts in their current location and does not change the existing lower lawn area except to provide ADA access to the existing restroom, overlooks, and picnic shelter. The play area is expanded for all ages and abilities, including a nature play area, with the existing boat play structure to remain. A terraced, expanded pedestrian connection is created between the ballfield area and the lower lawn to provide opportunities for community gathering or small events. The upper terrace is improved with expanded parking, two additional volleyball courts, a second restroom, and an accessible trail connecting through all the various park amenities. Improvements in the Masonic Lodge Area shown in the plan below include removing the Lodge and adding a new open covered shelter in the same footprint as the Masonic Lodge, with interpretive features to convey the unique history of the original structure. If community fundraising efforts are successful, the Masonic Lodge could still be renovated into a community center space instead of the covered shelter. The proposed phasing for park improvements is developed in a way to allow time for community fundraising efforts so this option is not precluded while other park improvements are implemented.

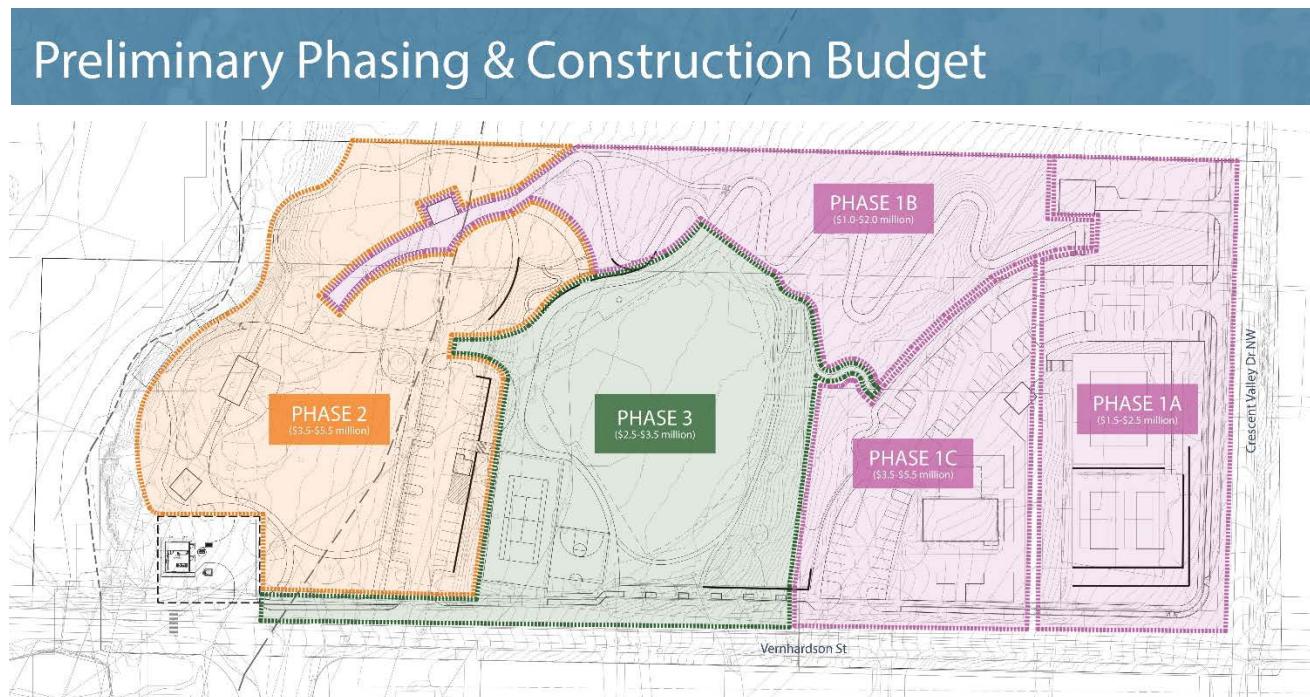
Phase 2 includes an expanded and universally designed play areas, nature trails, picnic shelter, gathering areas, and accessible paths to existing park amenities.

Phase 3 includes a renovated multipurpose field, expanded stairs to the lower terrace, nature trail connection to the upper terrace, gathering areas, and remaining required right-of-way improvements.

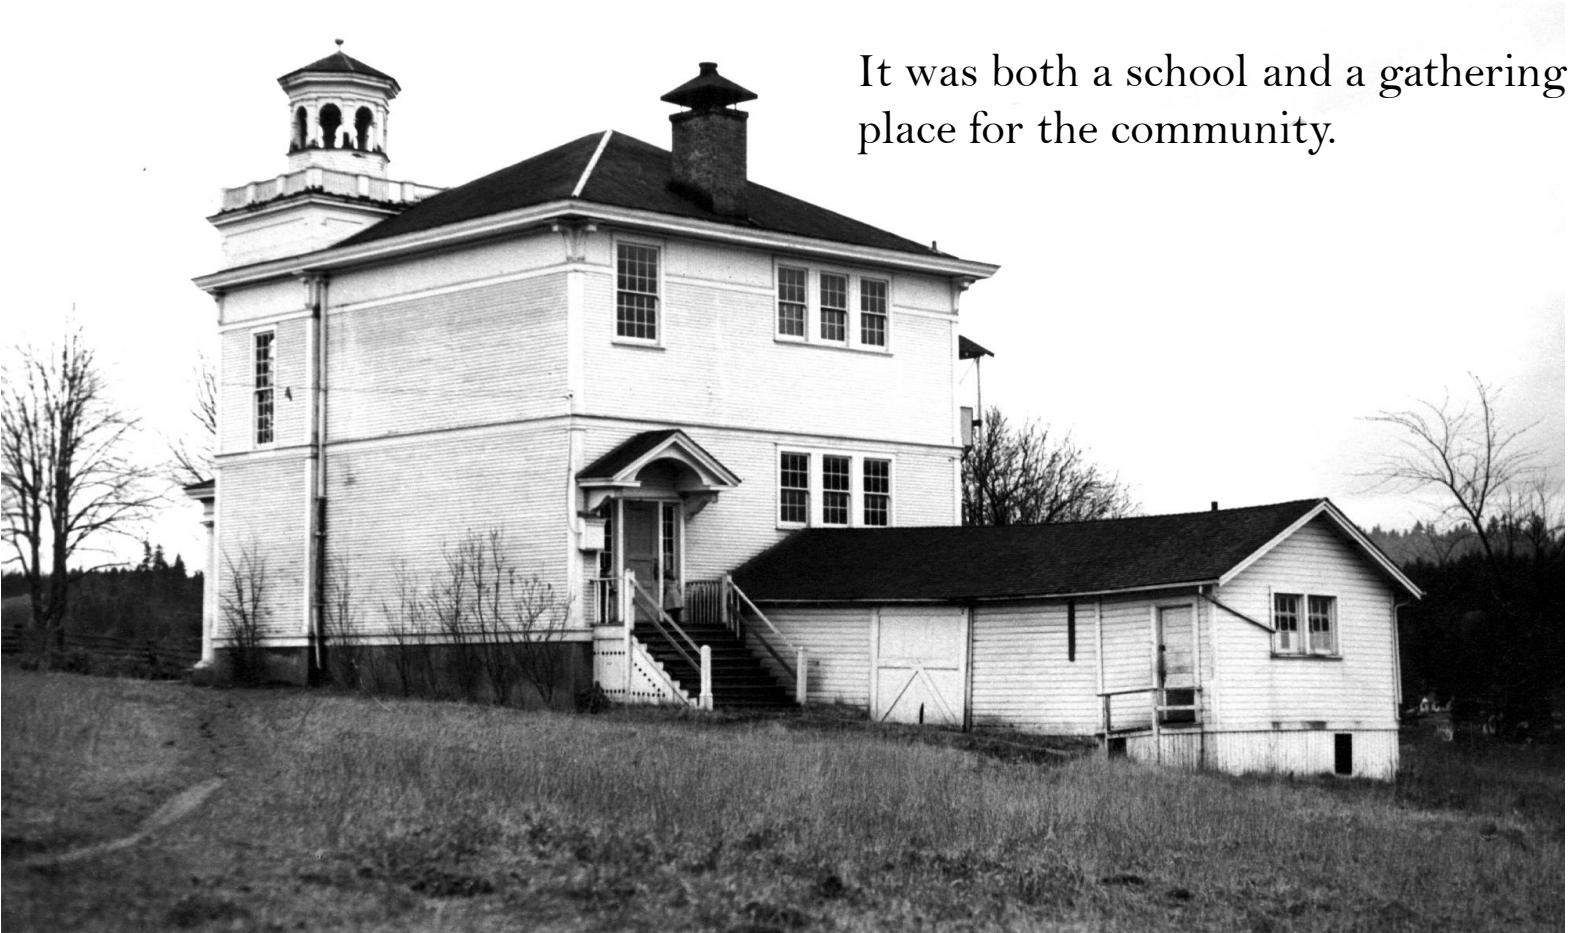
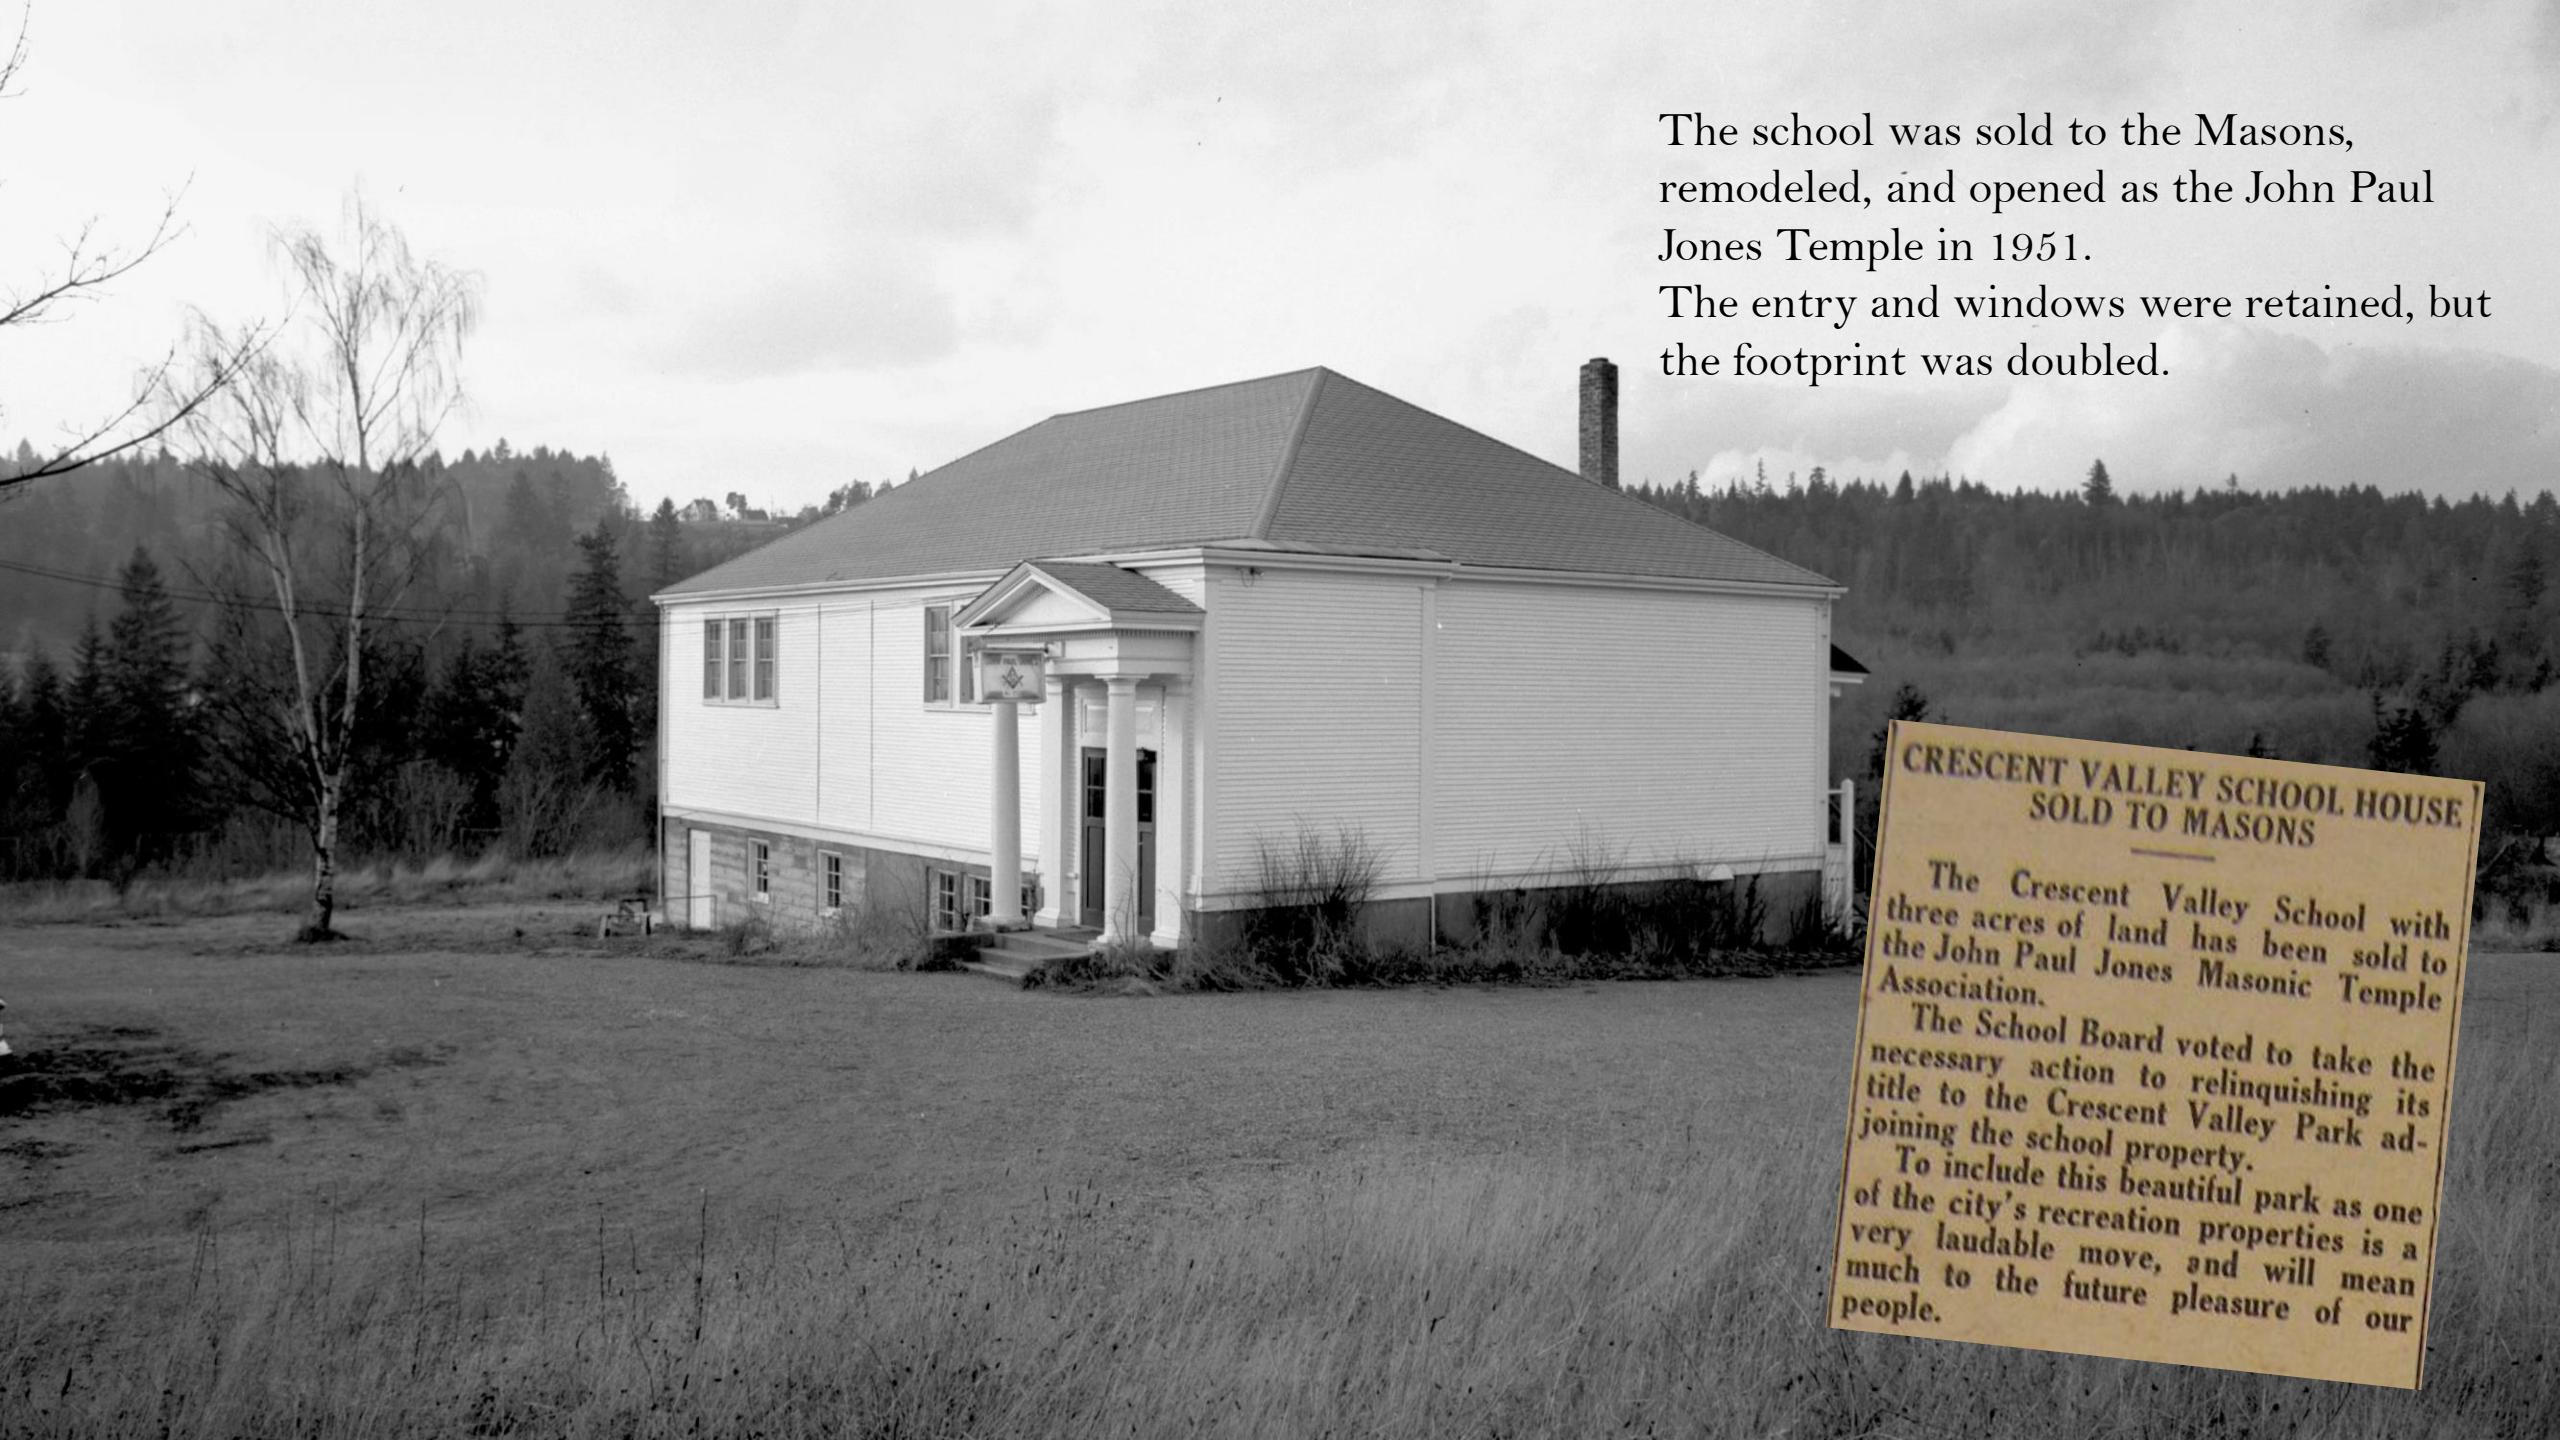
The school was sold to the Masons, remodeled, and opened as the John Paul Jones Temple in 1951.

The entry and windows were retained, but the footprint was doubled.

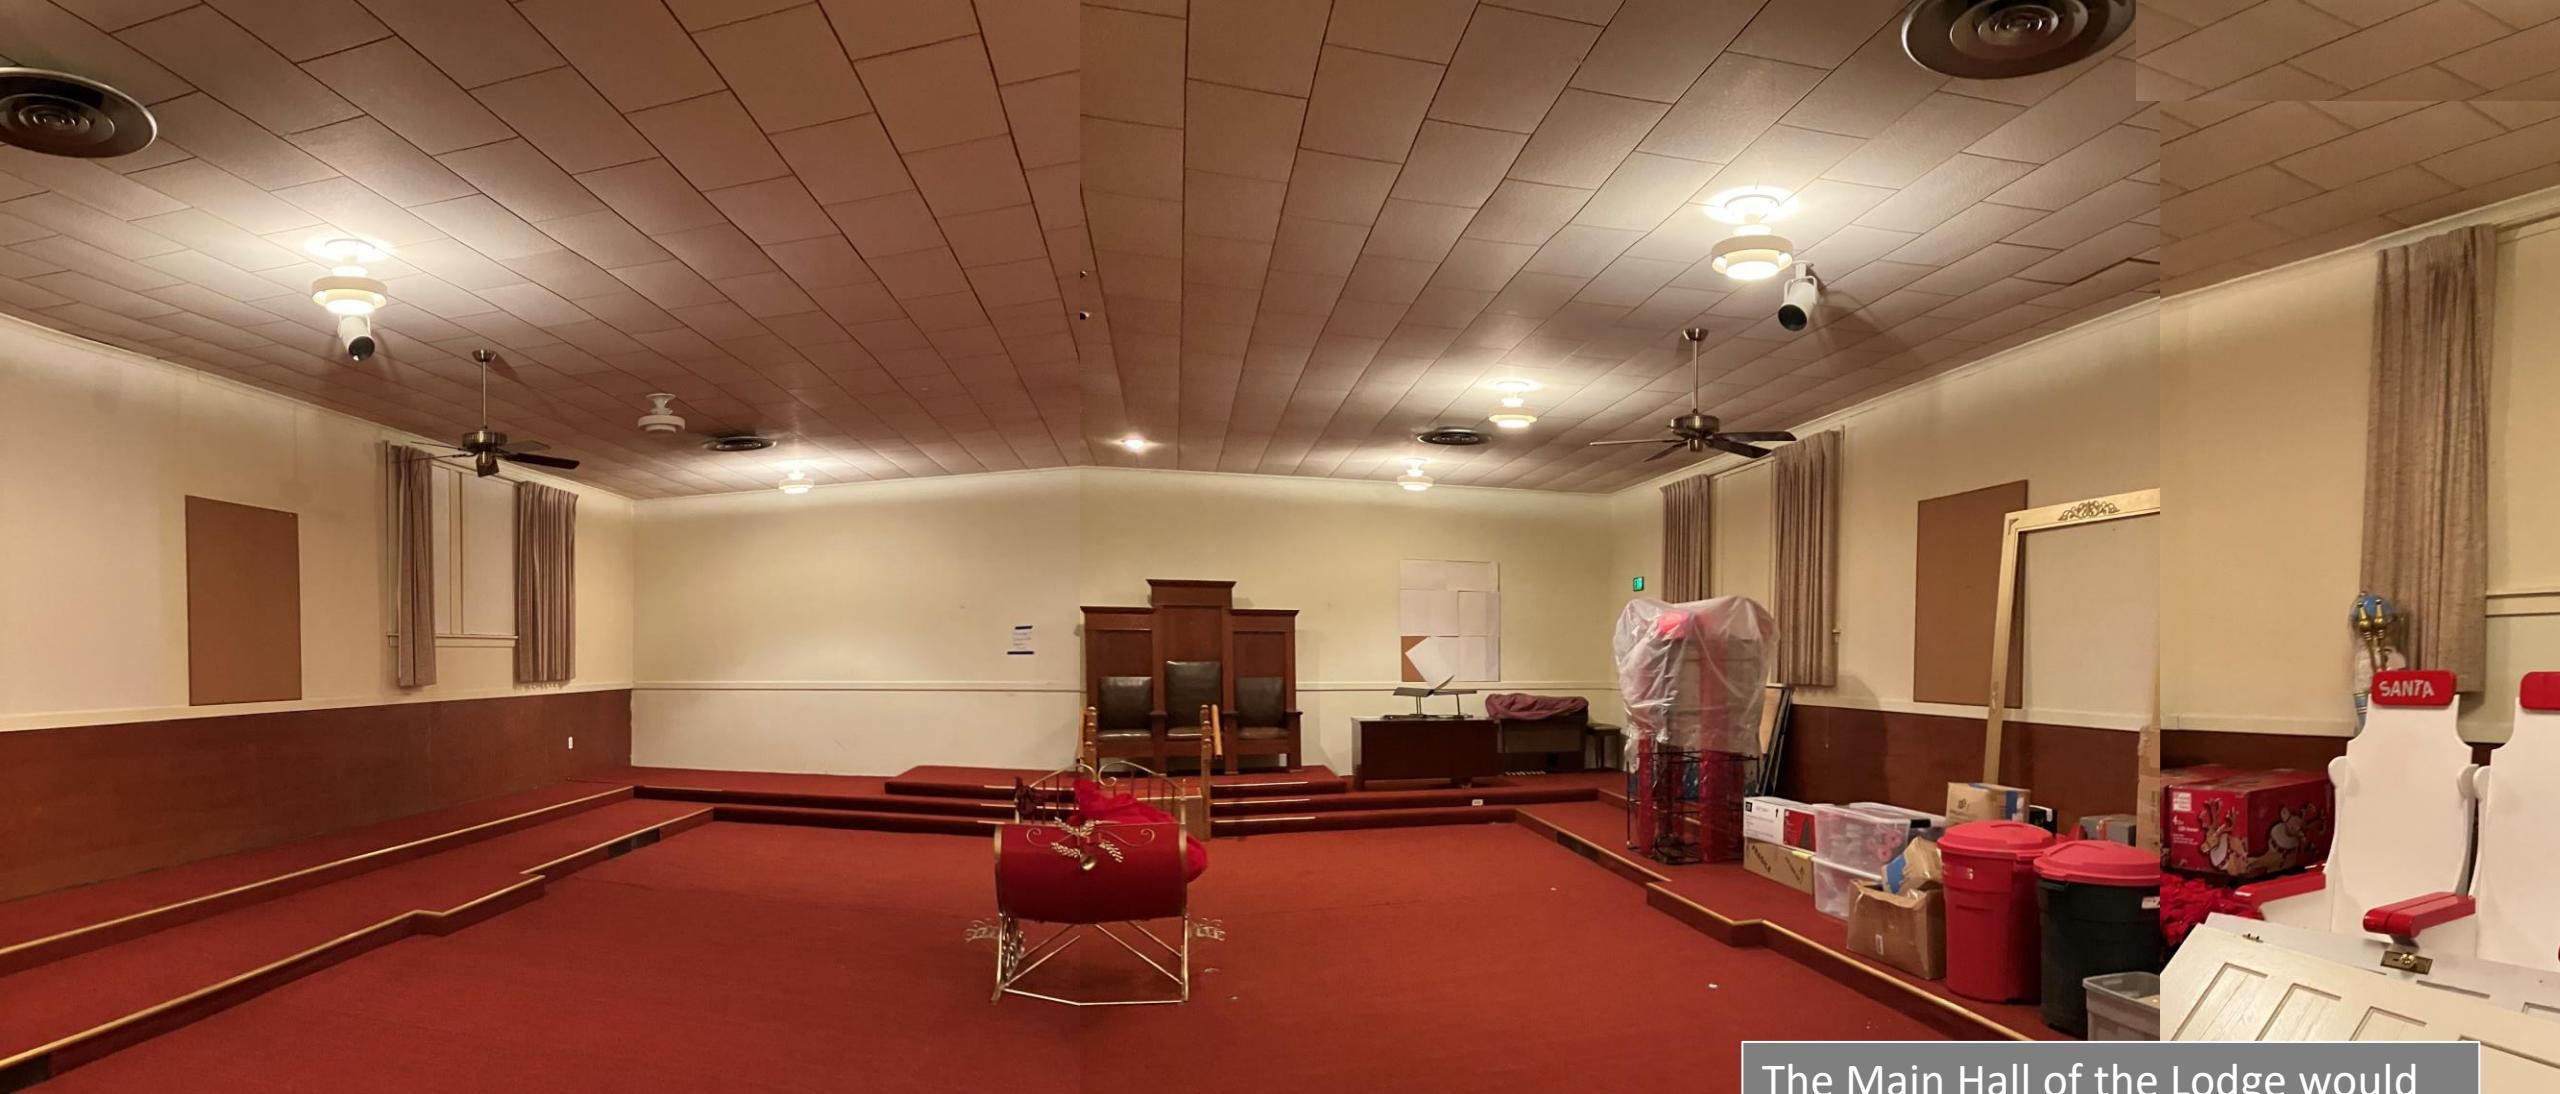
The Main Hall of the Lodge would have the capacity to hold as many as 200 people based on square footage. The space can transform from this to...

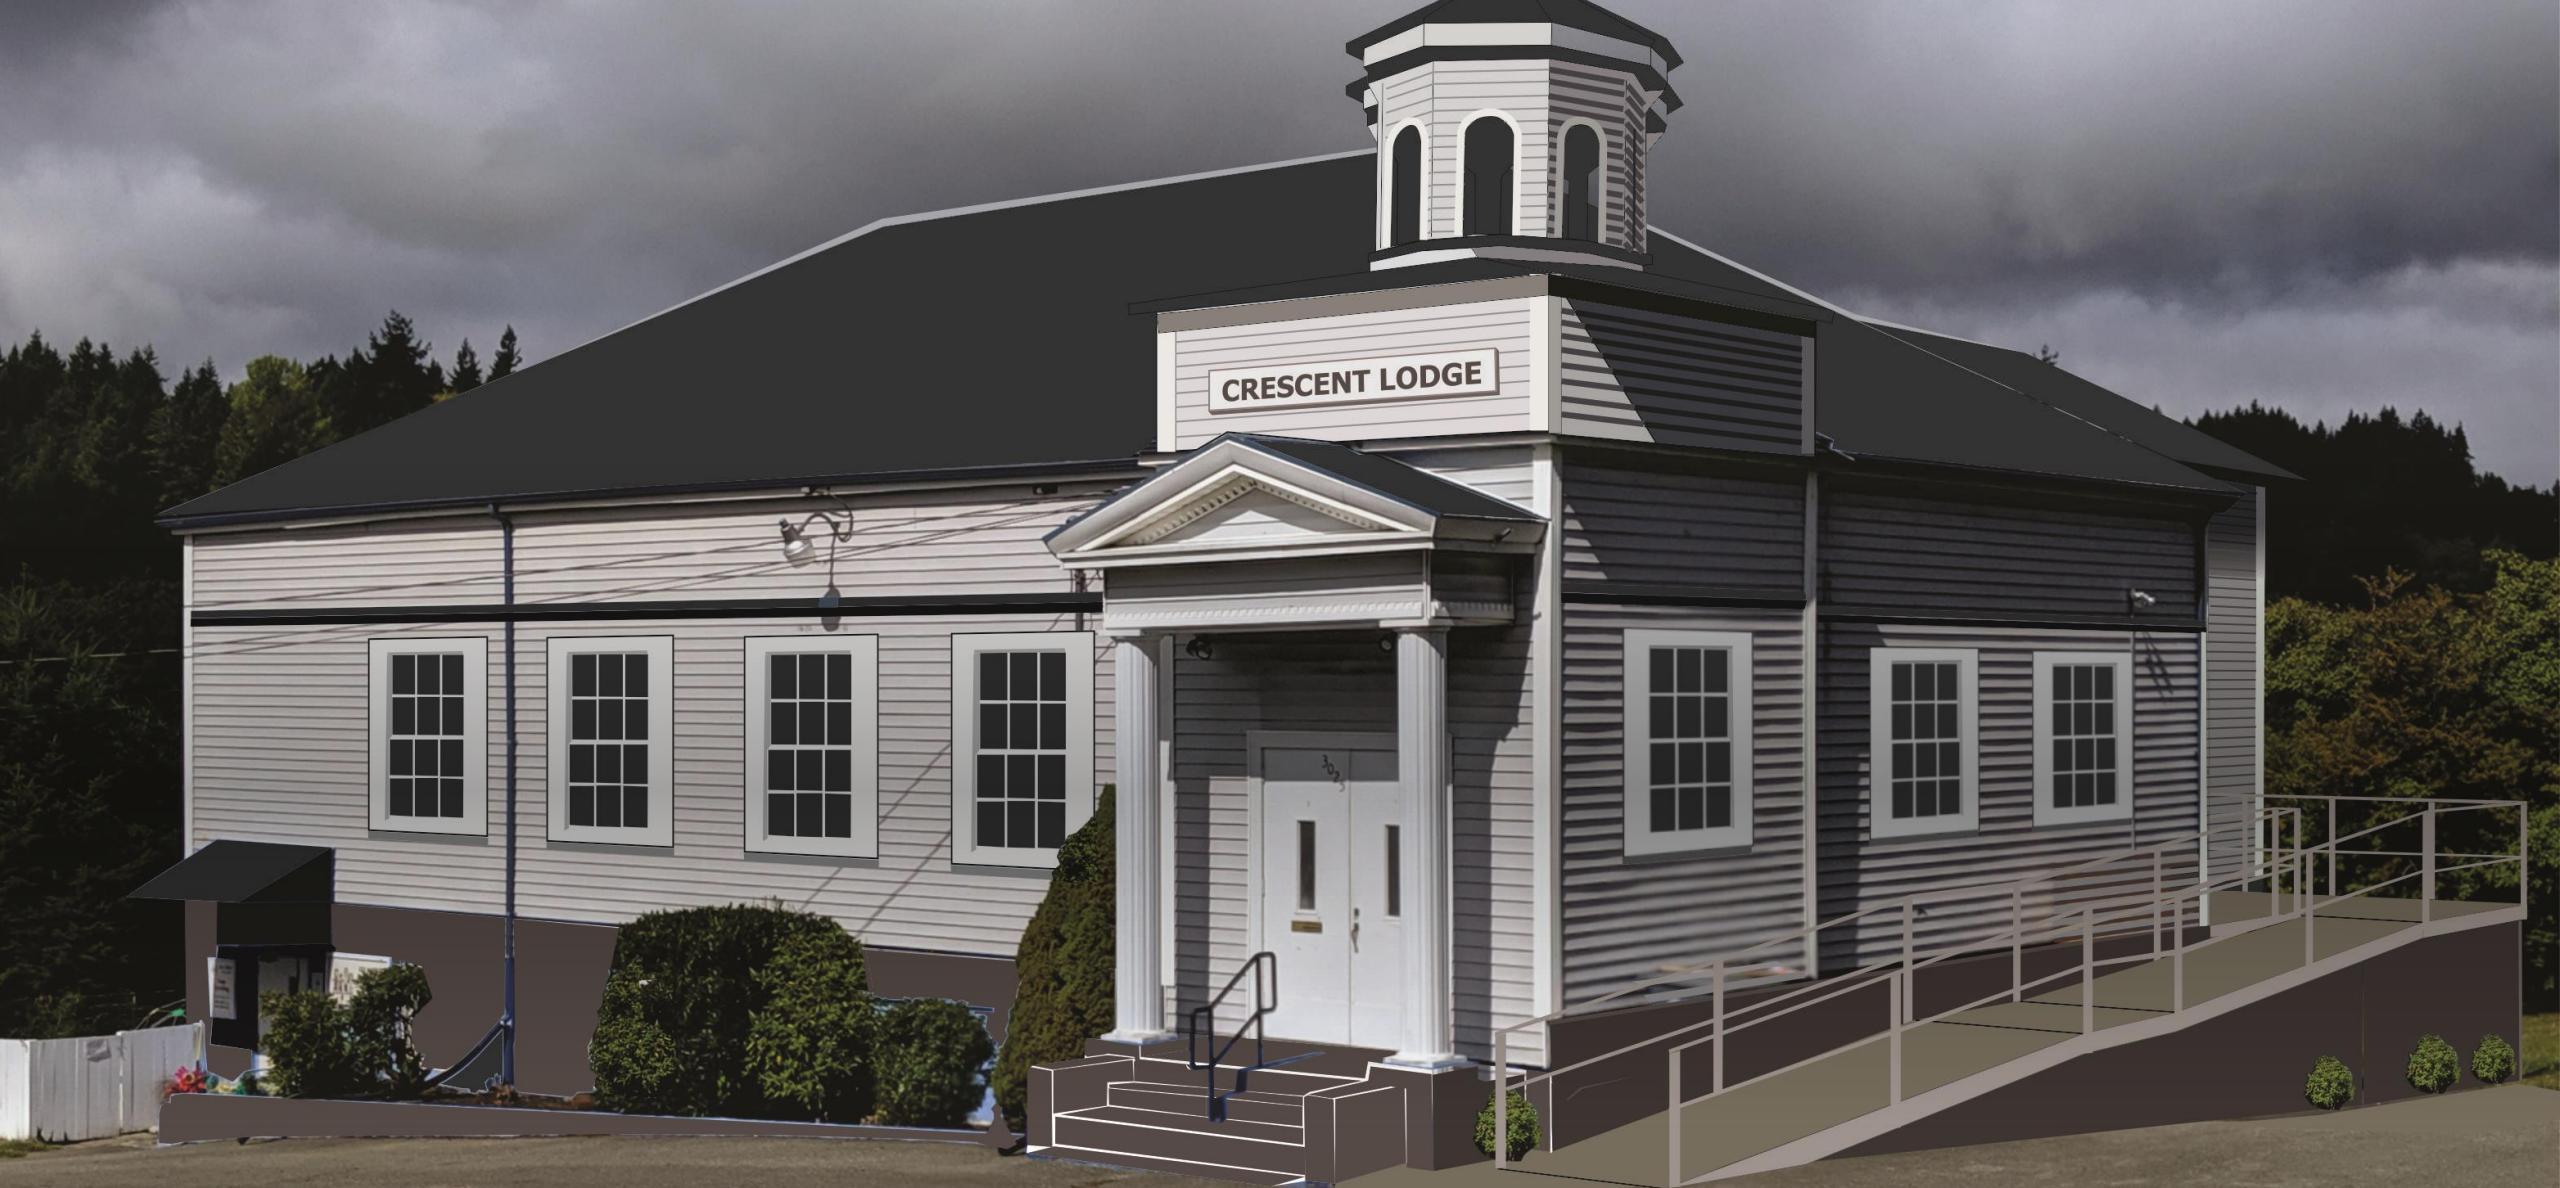
The exterior would pay tribute to both Crescent Valley School and the Masonic Lodge. ADA access addressed via new ramp.

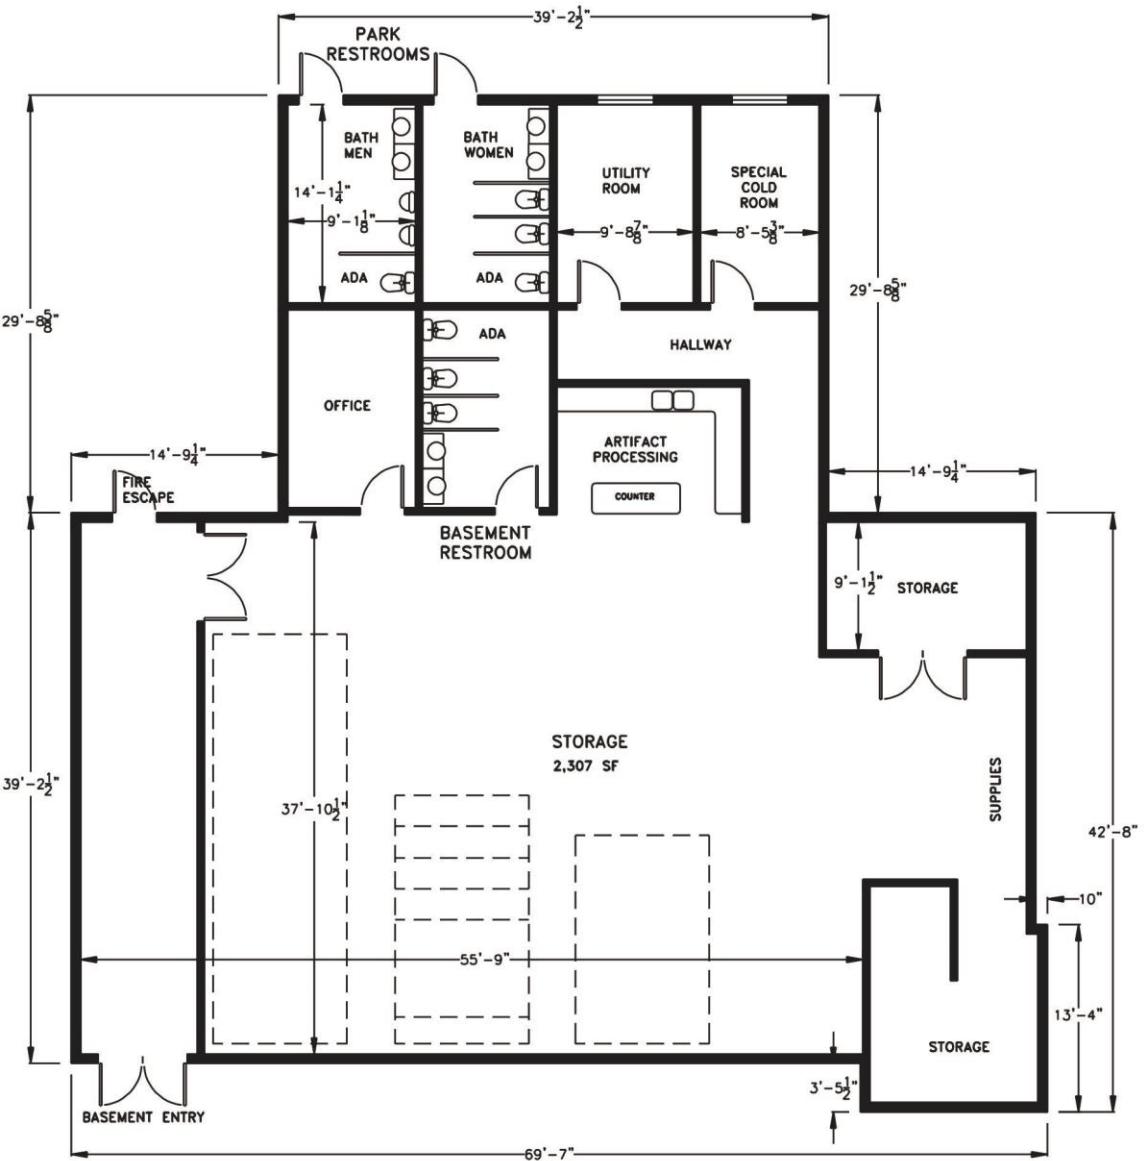
Schoolhouse v.7

BASEMENT: PLAN VIEW
3,727 SF OVERALL
