MASTER PLAN & PHASING PLAN

Final Master Plan

ARCHITECTURAL MEMO

Re: Masonic Lodge

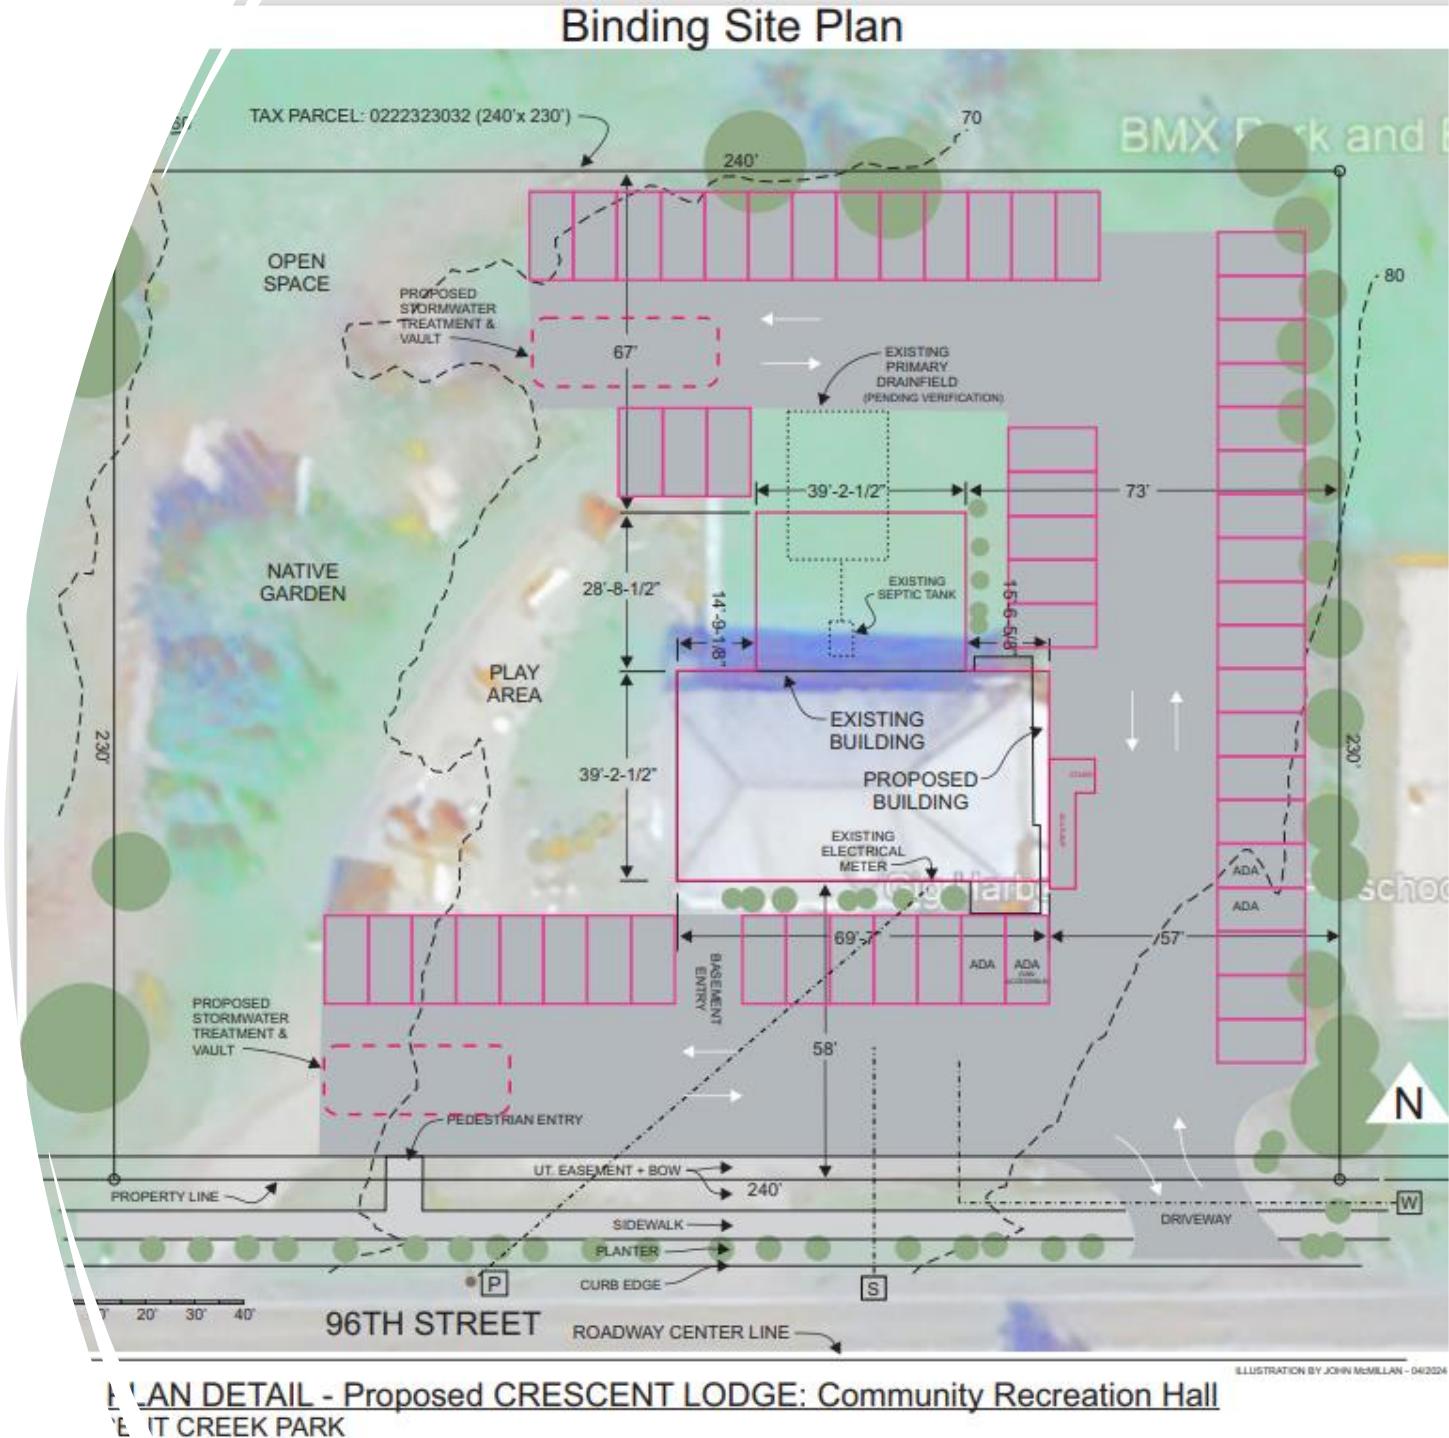
- **Alternate Option** for integrated parking reduces impact on Lodge surround and provides more parking for other use areas.
