Summit Pointe Preliminary Plat  
PL-PPLAT-21-0002 et al  
Hearing Examiner 11.07.2023  
Exhibit O

# SUMMIT POINTE

## PRELIMINARY STORM DRAINAGE REPORT

May 19, 2023

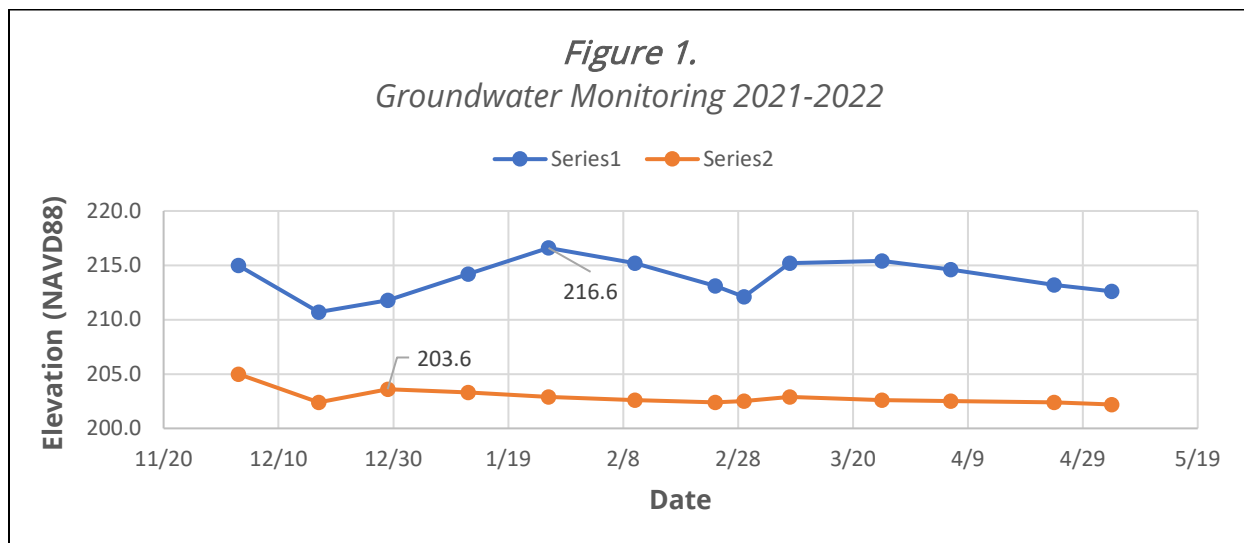
Two of our borings at the site were completed as groundwater monitoring wells and which were monitored twice a month for the duration of the wet season. Based on our wet season monitoring, seasonal high groundwater occurs at Elevation 203.6 to 216.6 feet (NAVD 88) at the locations monitored, approximately 18.4 to 37.4 feet below the ground surface. These levels were last measured on May 4, 2022. Figure 1, below, summarizes the groundwater levels recorded as part of our groundwater monitoring program during our monitoring period.

Based on review of the 2021-2022 groundwater monitoring data, we interpret the observed standing water and shallow groundwater encountered in our test pit explorations to be indicative perched groundwater that develops atop finer grained/more dense layers within the shallow reclamation fill and the groundwater encountered in our borings/groundwater monitoring wells to be indicative of the regional groundwater table, most likely founded on the deeper denser glacially consolidated advanced outwash deposits. This is further confirmed by the lack of seepage on the native eastern slope.

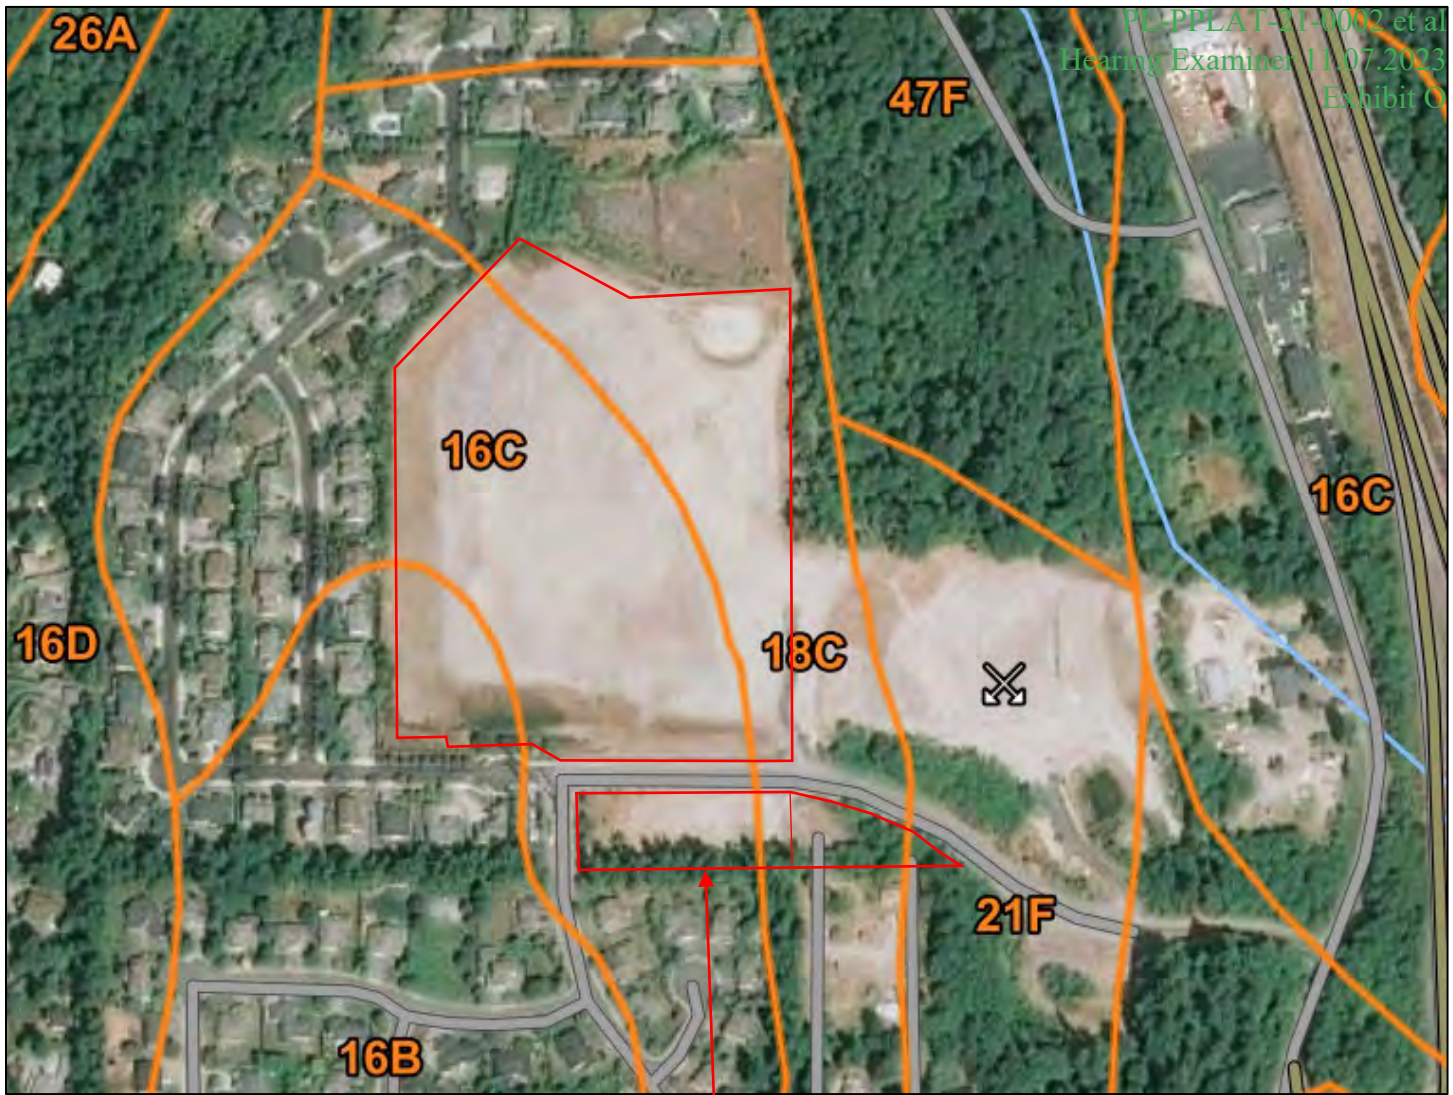
Figure 4

Map created from Web Soil Survey (<http://websoilsurvey.sc.egov.usda.gov/App/WebSoilSurvey.aspx>)

### NRCS Soils Map
