July 2006

PREPARED FOR :: The City of Gig Harbor

Anderson Boatyard

This Historic Structures Report was commissioned by the City of Gig Harbor to guide planning and work in rehabilitating the Eddon Boatyard.

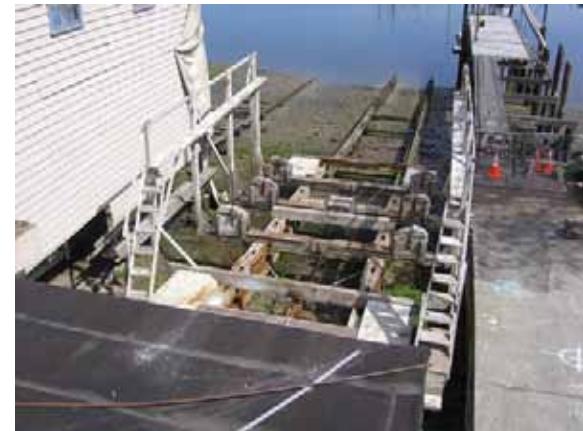
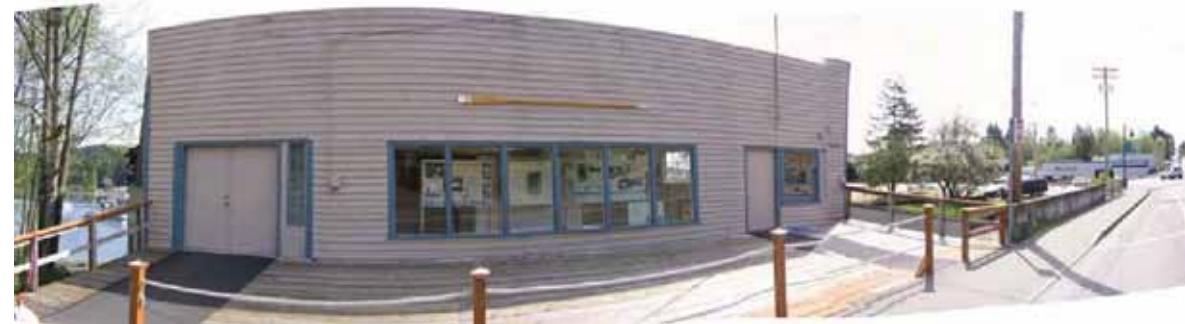
Two pairs of steel rails extend out across the mud flats beyond the low water tide level. One begins in the Enclosed Way and the adjacent is in open air, running parallel to the south. The northern rails are heavier and clear span cross ties. The southern rails are set on heavy wood timbers. Both have concrete bases. There is

considerable deterioration of the wood and in many sections, it has collapsed or members are missing.

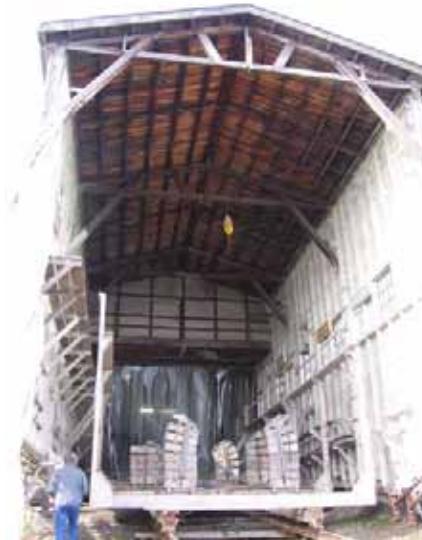
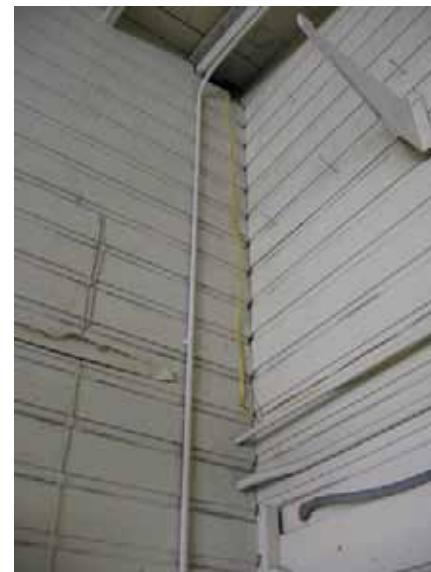
The original roof truss framing is minimal, incorporating 2x rafters with 2x web members nominally twenty-four inches on center. There is solid board decking above. Curiously, the bottom chords are not continuous, full span but break above an intermediate beam and post line. There is clear evidence of overloading occurred. Beam fibres are crushed at a pair of 4x4 wood posts and the beam has seriously deflected. A pair of recent 2x beams was placed above the older beam, at the point of greatest apparent failure. It is strapped structurally to the older member below providing support.

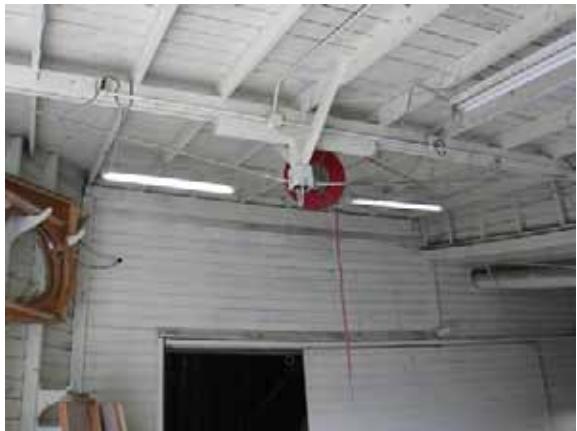
A historic, non-original, extension of the Loft extends across one truss bay into the Enclosed Way. The more elaborate trusses in the Enclosed Way are approximately ten feet on center. The timber and steel rod truss that historically formed the end of the loft remains. The typical bottom braced struts that extended below the horizontal chord of the truss appear to have been cut away.

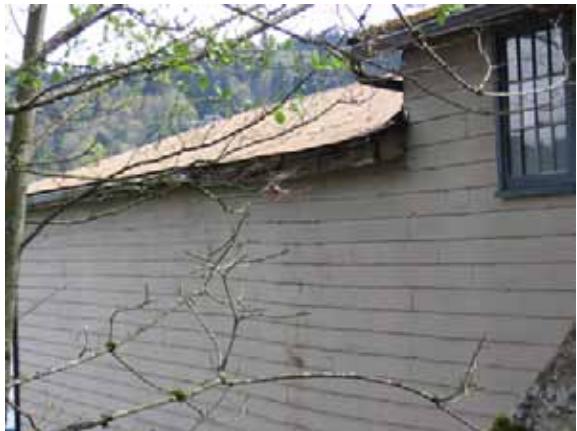
The south elevation shed roof extensions at the lower level are of a similar construction. Half trusses of 2x lumber extend uniformly from the east end to just beyond the south man door. The members of these trusses appear to have been salvaged, as numerous ends are irregularly cut and there is a regularly spaced pattern of discoloration on some along with uniform nail holes.

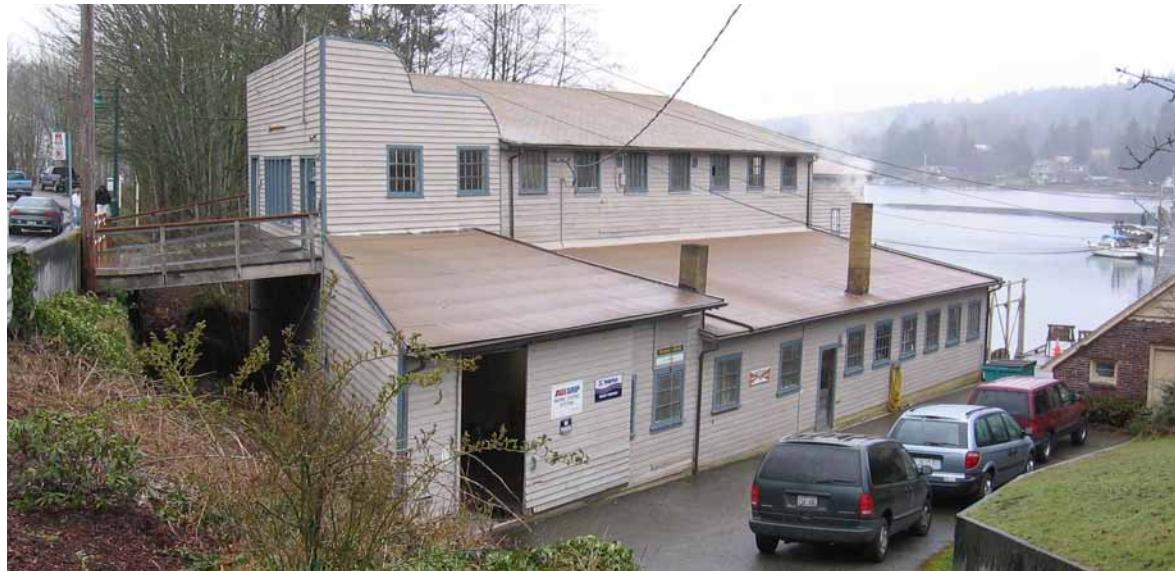
All windows typically have 1x4 wood casing trim jambs and head and an integral solid wood sill, cut to slope, with a 1x4 wood trim apron. Some windows are missing their apron trim boards. Occasionally, a pane is missing or broken and window putty is regularly cracked or missing.

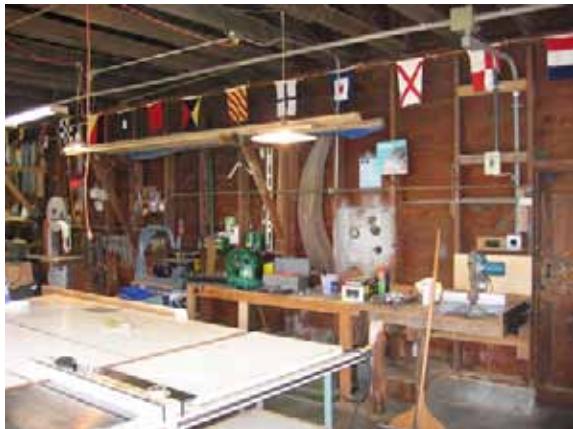
There is an access door in the north elevation from the boatbuilding area at the edge of the Enclosed Way. It was saw cut directly into the

exterior siding. Three heavy metal hinges are surface mounted on the exterior. An irregular plywood ramp pitches from the sill steeply to grade.

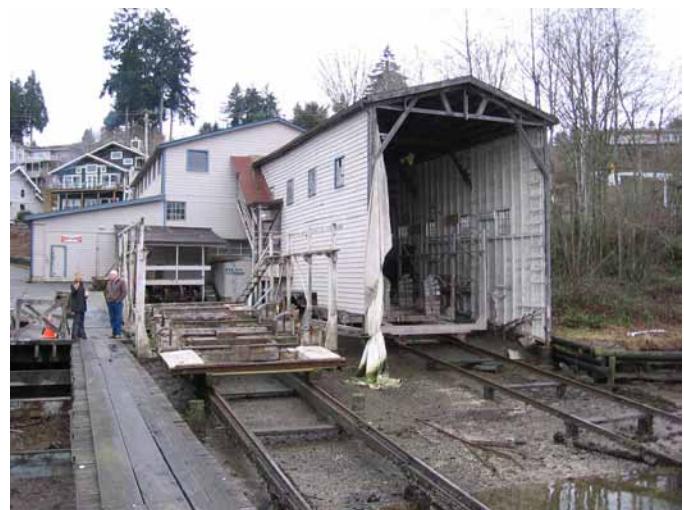
CP 5

SOUTH FAÇADE, LOOKING WEST. APRIL 2006.
SOURCE: EYSAMAN & COMPANY.

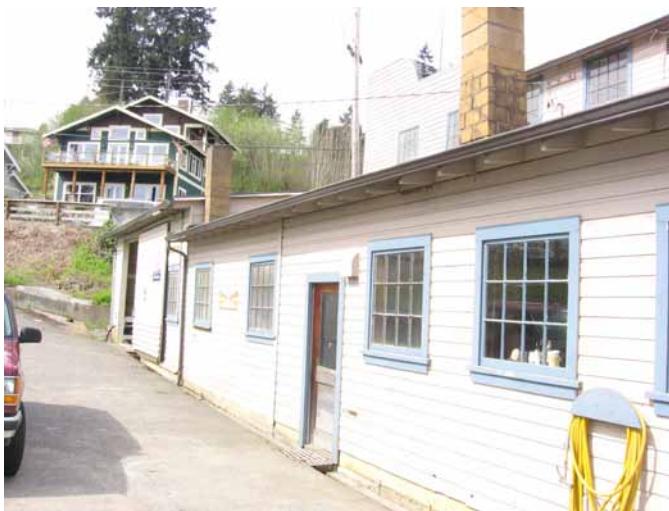
**CP 7**

NORTH FAÇADE. APRIL 2006. SOURCE: EYSAMAN & COMPANY.

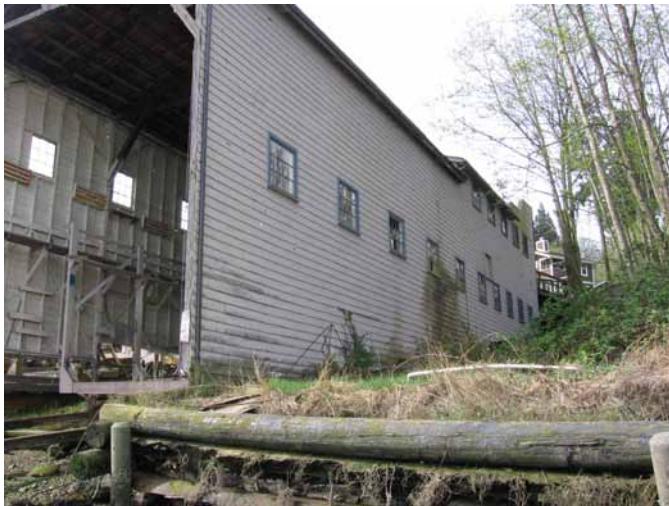
**CP 6**

WEST AND SOUTH FAÇADES. APRIL 2006.
SOURCE: EYSAMAN & COMPANY.

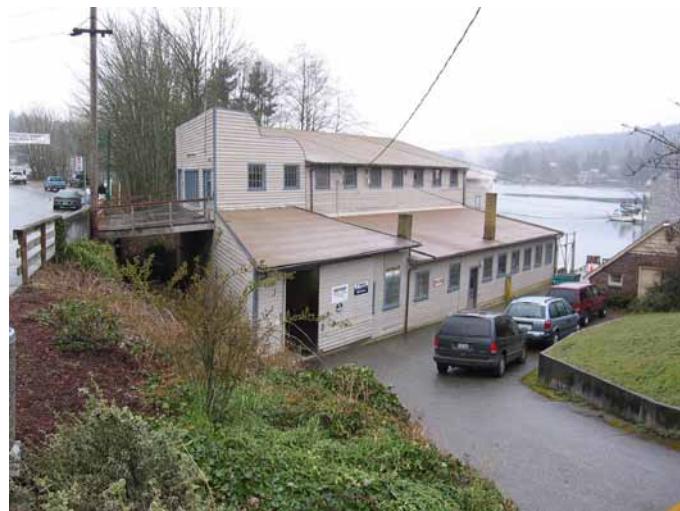
**CP 8**

EXTERIOR CARRIAGE SPACE. APRIL 2006.
SOURCE: EYSAMAN & COMPANY.

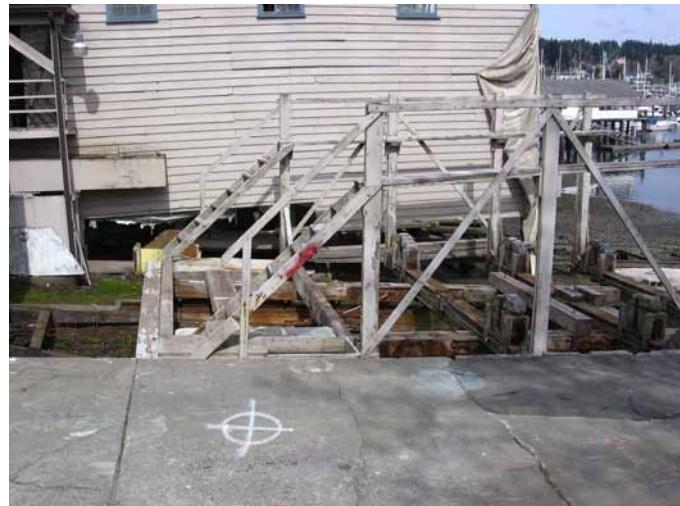
CP 9

EAST FAÇADE. APRIL 2006. SOURCE: EYSAMAN & COMPANY.

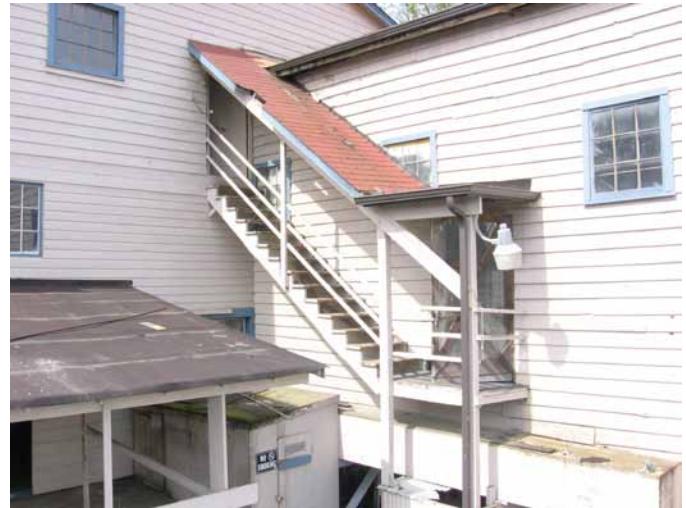
**CP 11**

EAST END OF BUILDING. APRIL 2006. SOURCE: EYSAMAN & COMPANY.

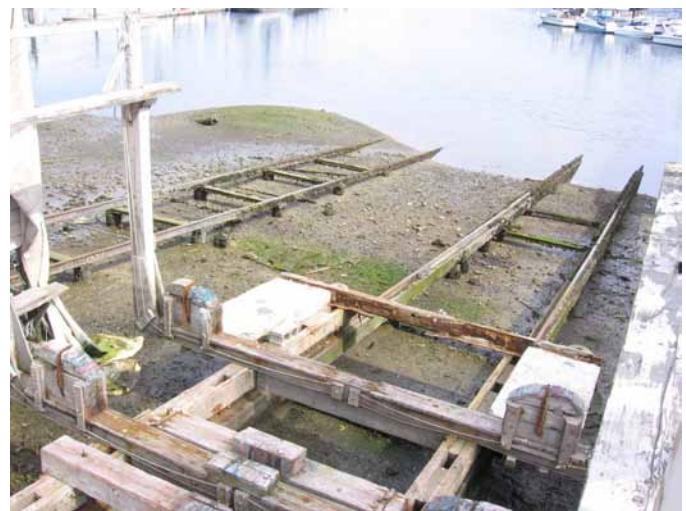
CP 13

EXTERIOR CARRIAGE.
APRIL 2006. SOURCE:
EYSAMAN & COMPANY.

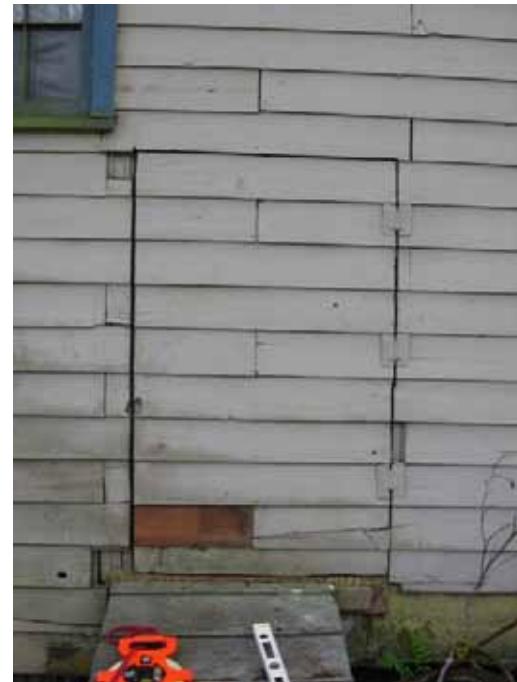
CP 19

NORTH WALL CONDI-
TIONS. APRIL 2006.
SOURCE: EYSAMAN &
COMPANY.

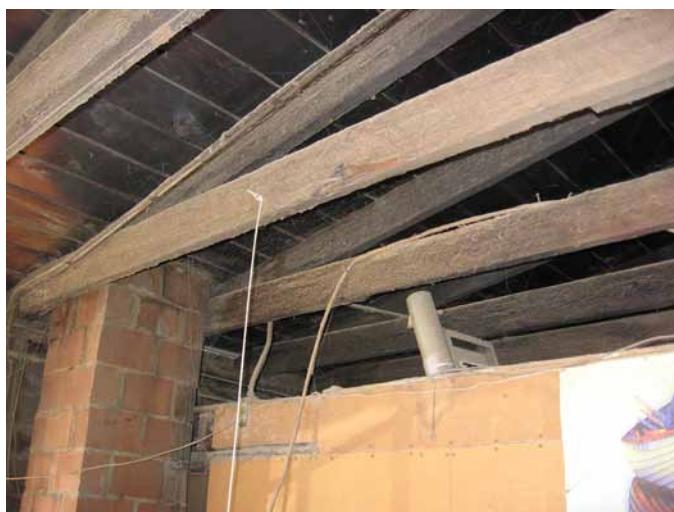
CP 36

ATTIC CONDITIONS. APRIL
2006. SOURCE: EYSAMAN
& COMPANY.

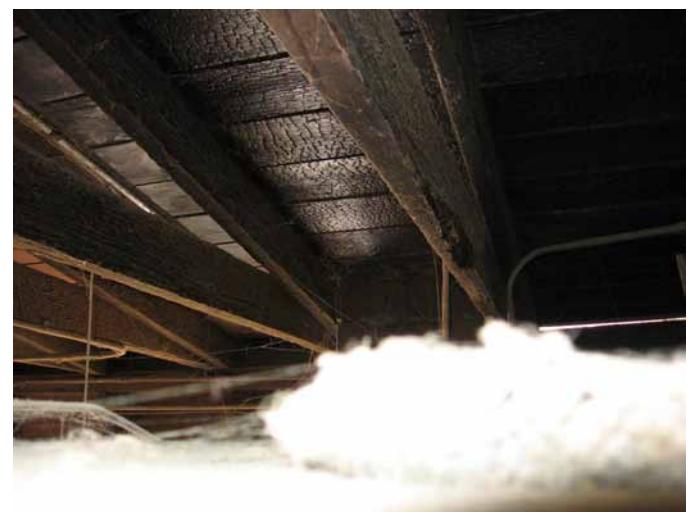
CP 37

RIDGE CONDITIONS.
APRIL 2006. SOURCE:
EYSAMAN & COMPANY.

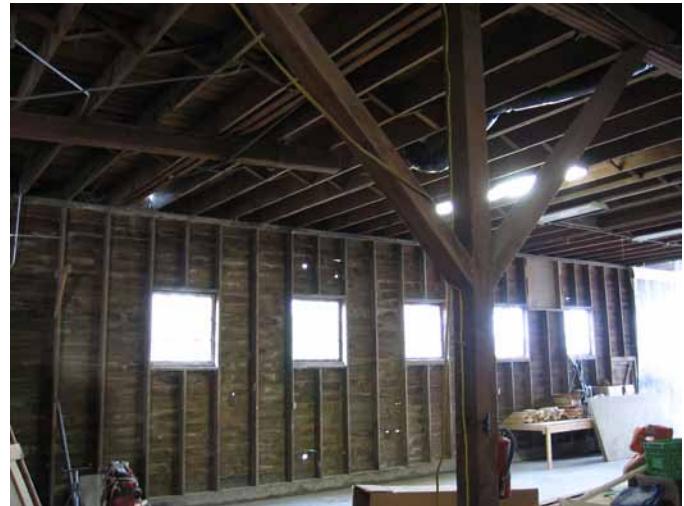
CP 43

INTERIOR SPACE CONDI-
TIONS. APRIL 2006.
SOURCE: EYSAMAN &
COMPANY.

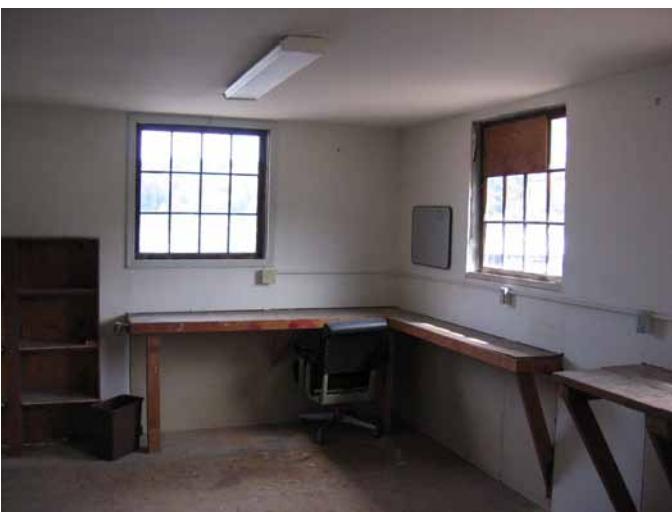
CP 44

INTERIOR SPACE CONDI-
TIONS. APRIL 2006.
SOURCE: EYSAMAN &
COMPANY.
